**Toddbrook Reservoir  
Independent Review Report  
By Professor David Balmforth**

**10 February 2020**

Overall, I have determined that the most likely cause of the failure of the auxiliary spillway at Toddbrook Reservoir on the 1st August 2019 was its poor design, exacerbated by intermittent maintenance over the years which would have caused the spillway to deteriorate.

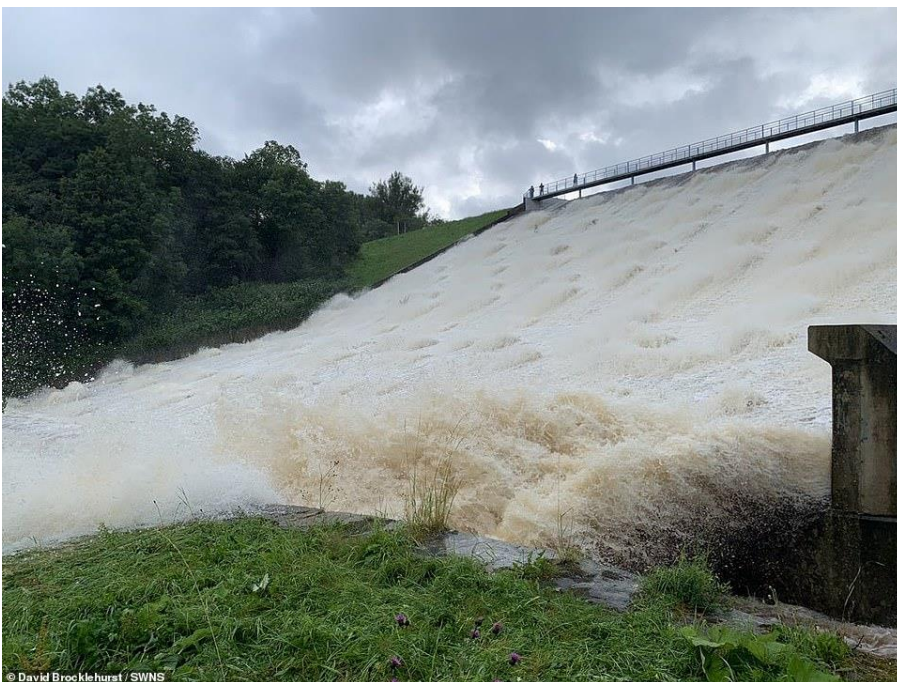
**Figure 4. The Spill at its height on the 31st July 2019**

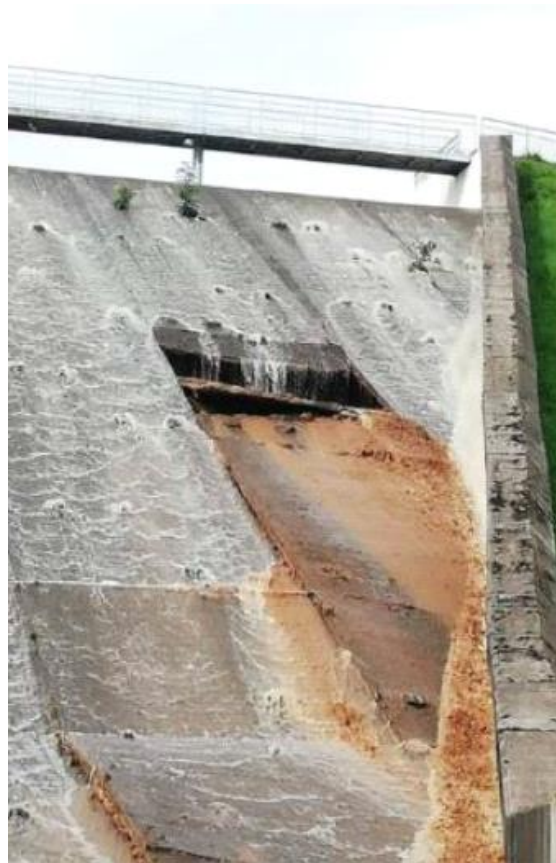
Around 9:00am the first panel is thought to have collapsed (fig 5). This was reported at 9:45am by a second member of the public as a section of concrete about “15ft x 20ft” being broken away and that the “earth bank is starting to wash away”. A void could be seen to have formed beneath the slab. Note that at this stage, discharge down the spillway had significantly reduced.

**Figure 5. Collapse of the First Slab into the Void (note the slabs that have been pushed up towards the foot of the spillway chute).**

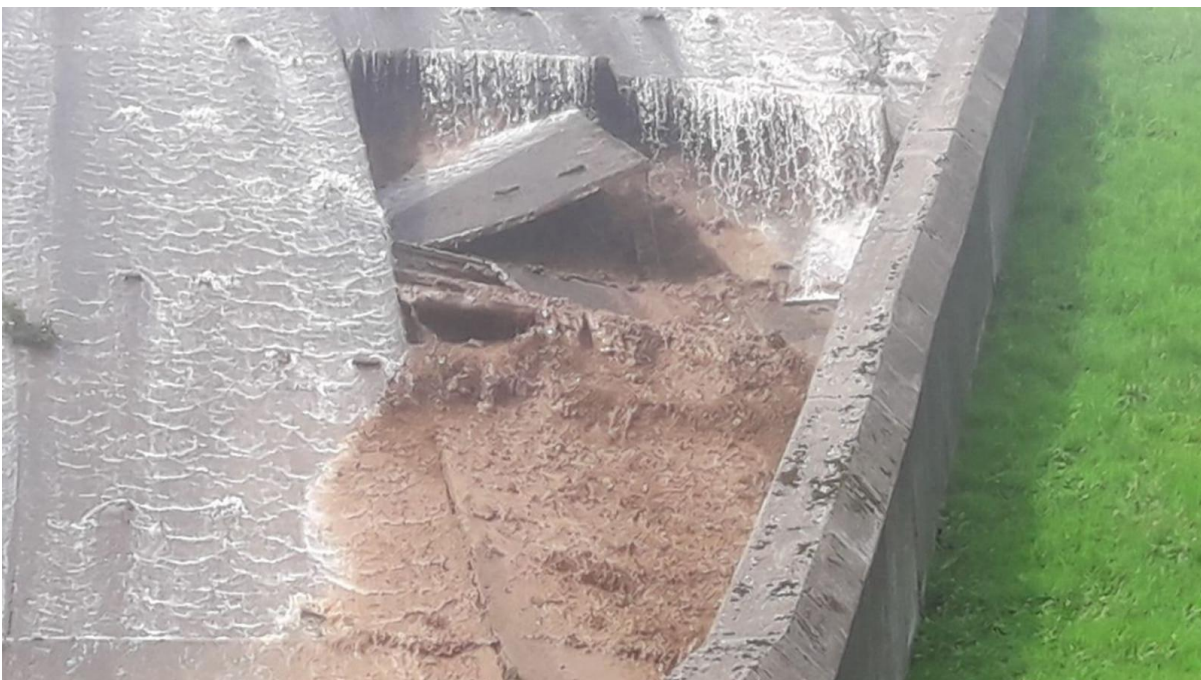
At 10:00am CRT Operations staff arrived on site and opened the draw-off and scour valves. A loud crack was heard. Four panels were observed to have fallen into the void (fig 6). A photograph of the spillway was sent by the CRT Surveillance Operative to senior CRT staff.

**Figure 6. Four Sections of Panels Collapsed into the Void**

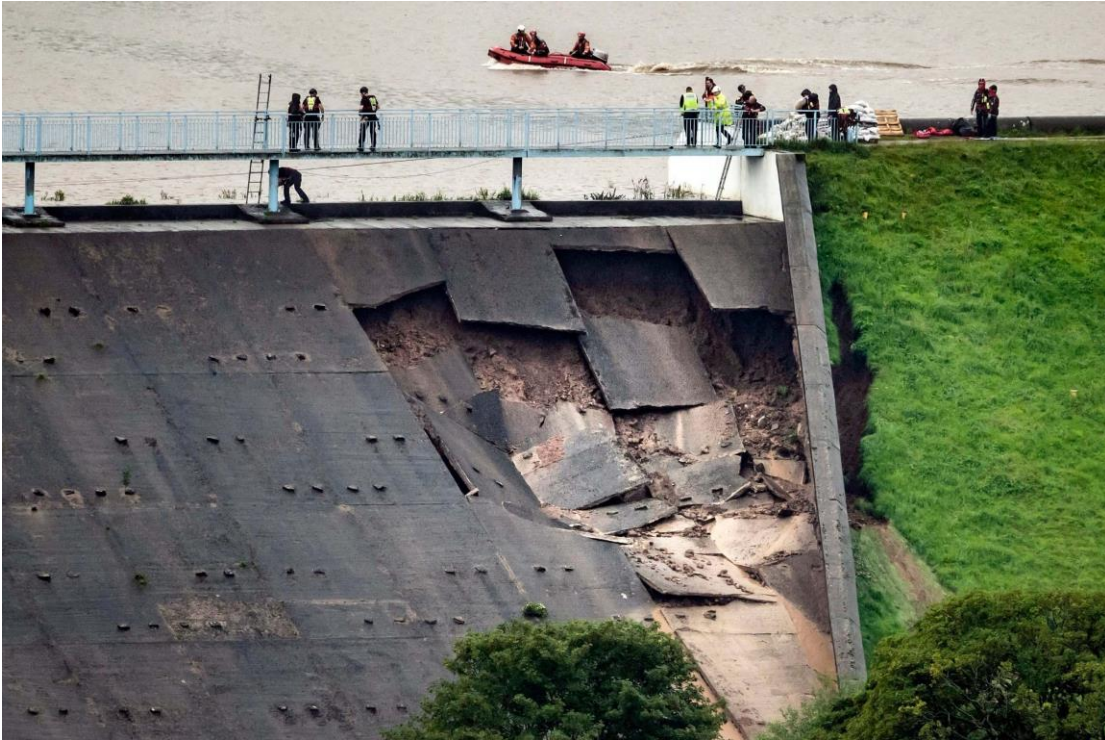
By 2:30pm the next column of panels had collapsed. The top row of panels started to collapse, and the left-hand chute wall was undermined (fig 7).

**Figure 7. The Final Stage of Collapse of Panels. Note the undermining of the left-hand chute wall.**

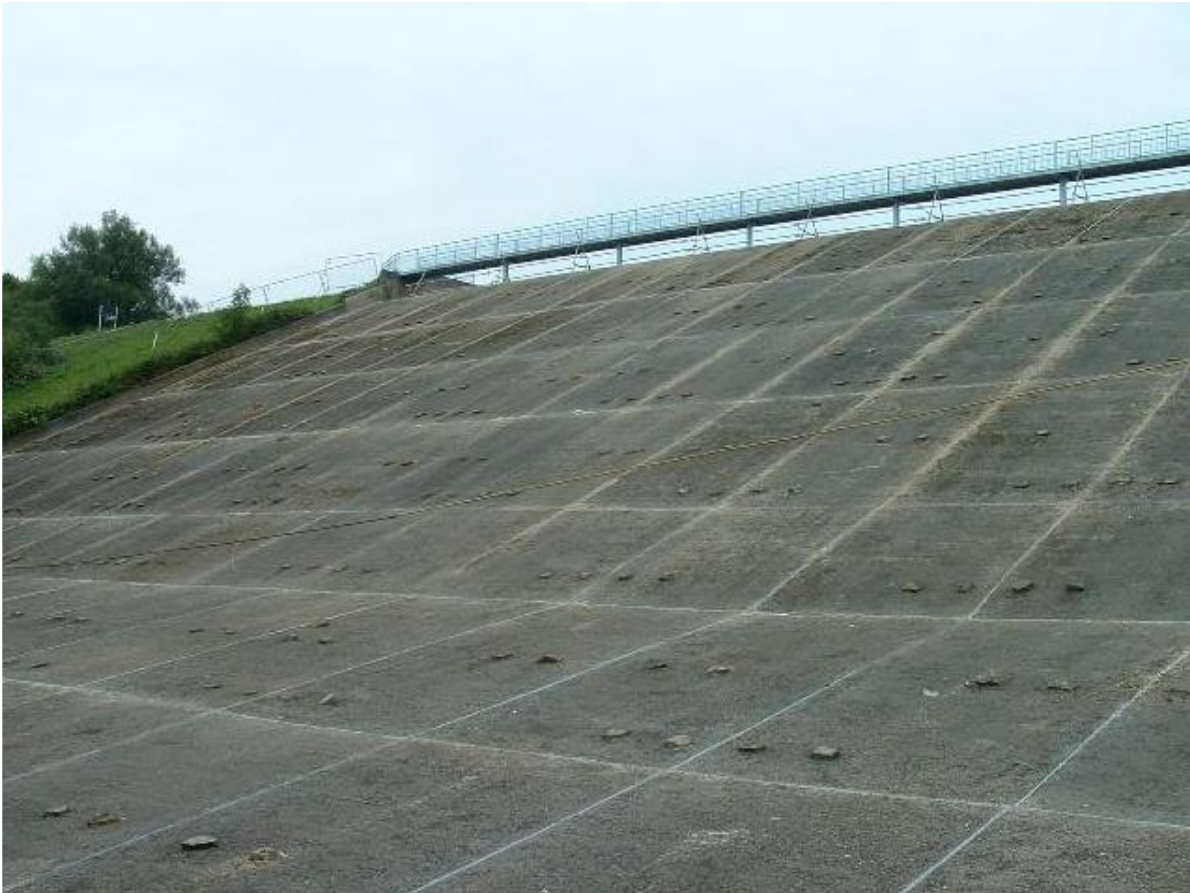
There is a long history of intermittent maintenance of the reservoir. In 2006, the Inspecting Engineer noted that the auxiliary spillway had an appearance of neglect and lack of routine maintenance. He recommended joint sealing and cleaning, removal of vegetation and patch repairs. In the 2010 inspection the Inspecting Engineer noted that the spillway appeared to be in good condition (fig 9).

**Figure 9. Evidence of Good Maintenance with Joints cleaned out and Re-sealed, September 2008**

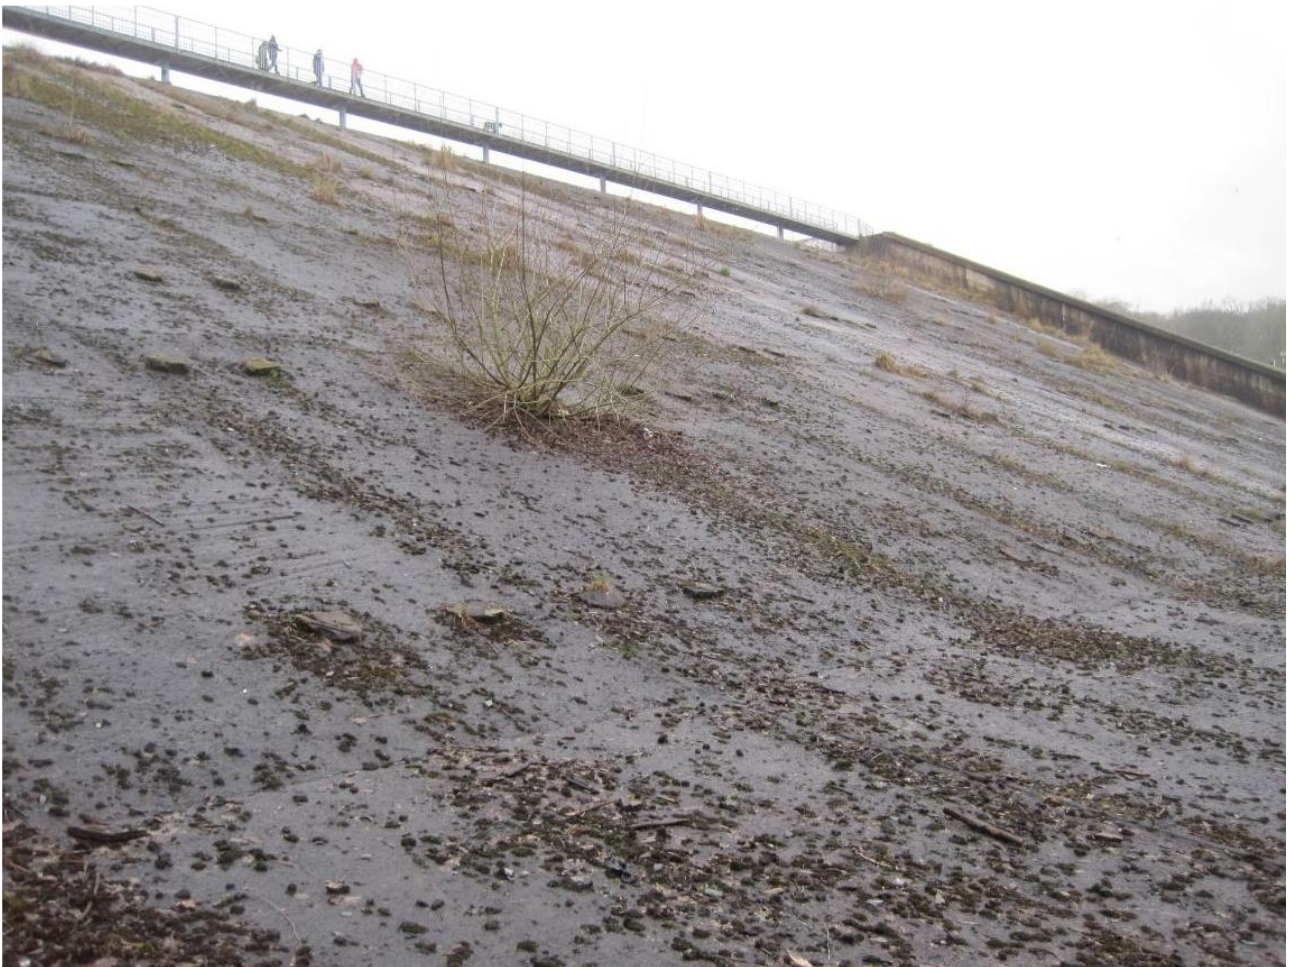
However, from 2015 to 2018 the Supervising Engineer stated, in four separate reports, that vegetation was again apparent on the spillway. There is also photographic evidence to support this (fig 10). The Panel has been provided with documentary evidence on vegetation clearance on the spillway in recent years. However, vegetation clearance is only part of the necessary maintenance. It also needs to include the cleaning out and resealing of joints, and the repair of any cracks.

**Figure 10. Evidence of Poor Maintenance with Vegetation and Saplings Growing in Joints, January 2018**

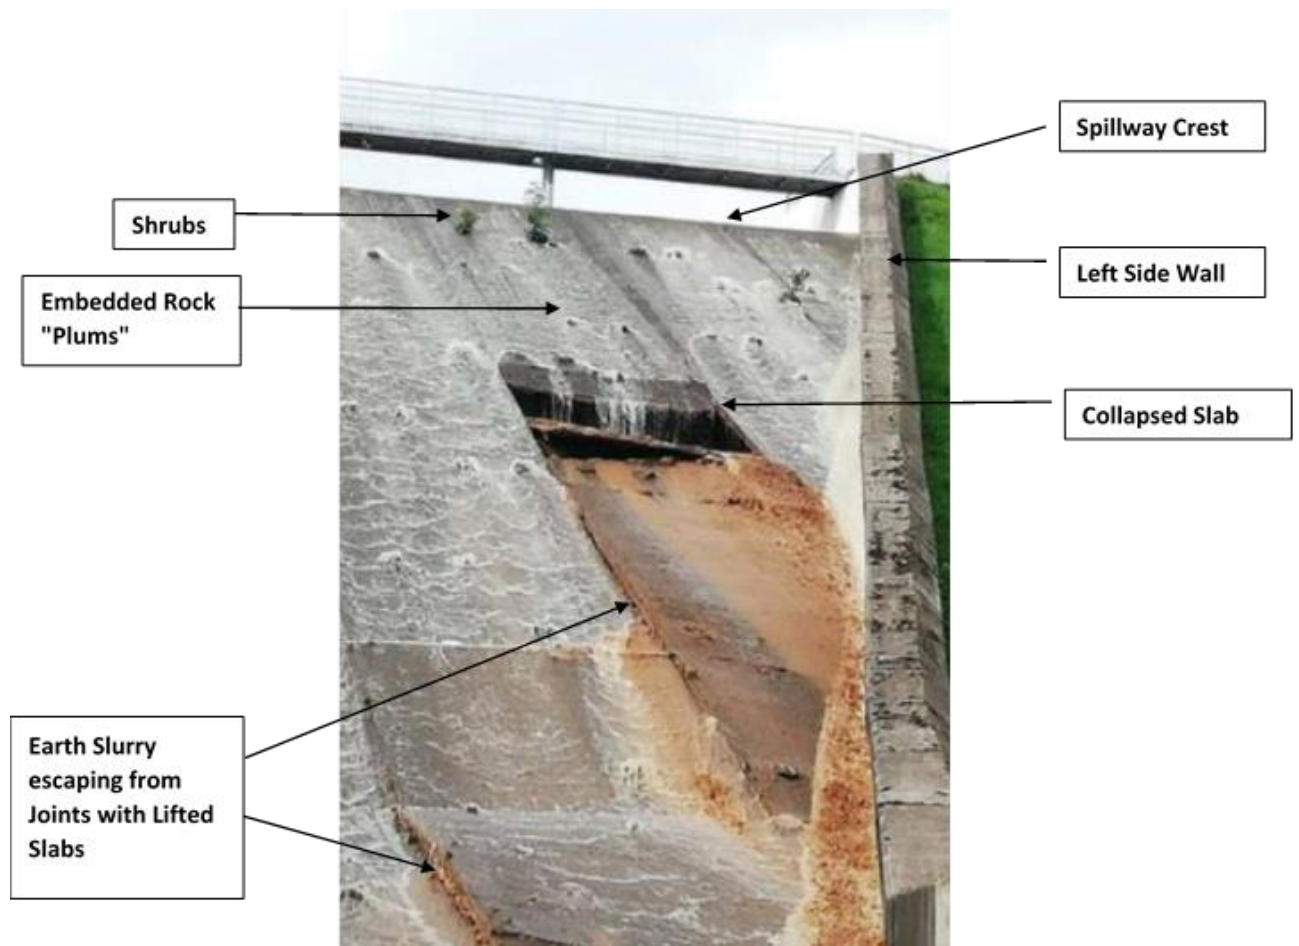
On the morning of 1<sup>st</sup> August some residual flow continued over the spillway chute. At 08.30 a member of the public reported seeing silty water coming from lower joints in the spillway (assumed to be from the sides of lifted panels rather than through joints as such). At 09.45 a hole is reported in one of the upper parts of the chute (fig B2).

**Figure. B2 The initial slab collapse**

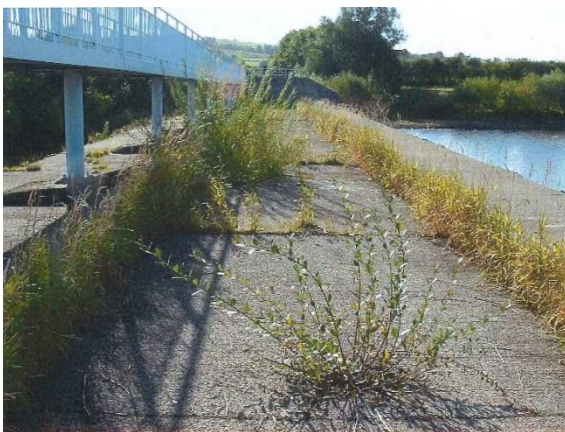
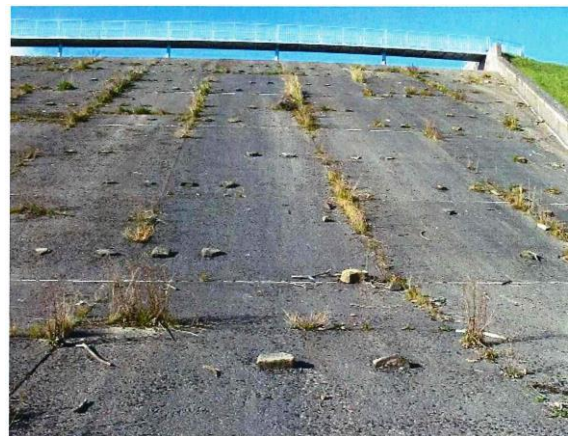
**Figure. B4 Well established vegetation on the crest slabs and on the chute in 2007**

Interestingly one photograph dated September 2007 shows lines of extensive weed growth laterally across the chute immediately above the slab which initially failed (fig. B4). One of

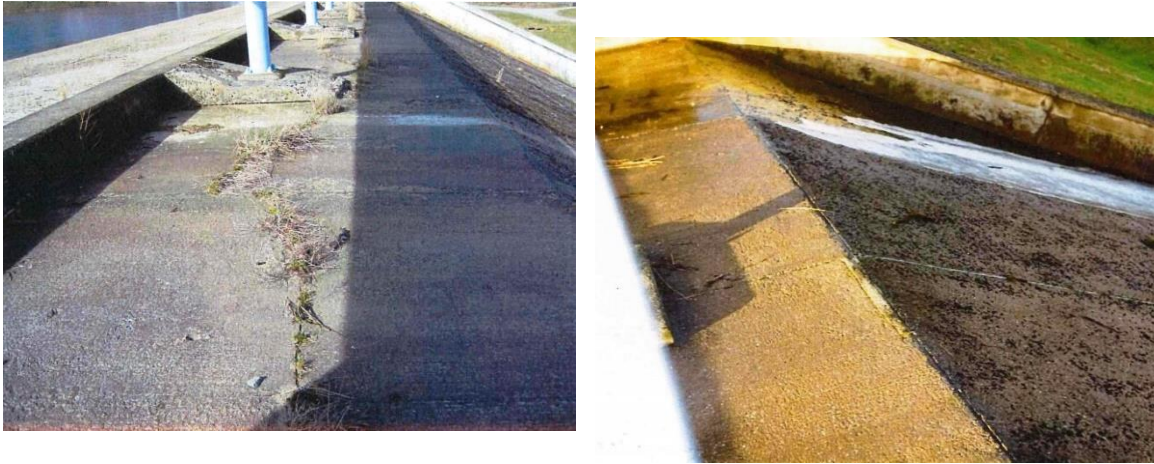
All these features would allow water to ingress at times of chute flow, and some indeed even at times when the water was high but not actually at auxiliary weir crest level. There is evidence of this occurring at a number of places on the crest, including at both left and right ends and the centre, but more prominently on the left (fig B5).

**Figure. B5 Historic crest cracking and isolated seepages on the left side on the chute**

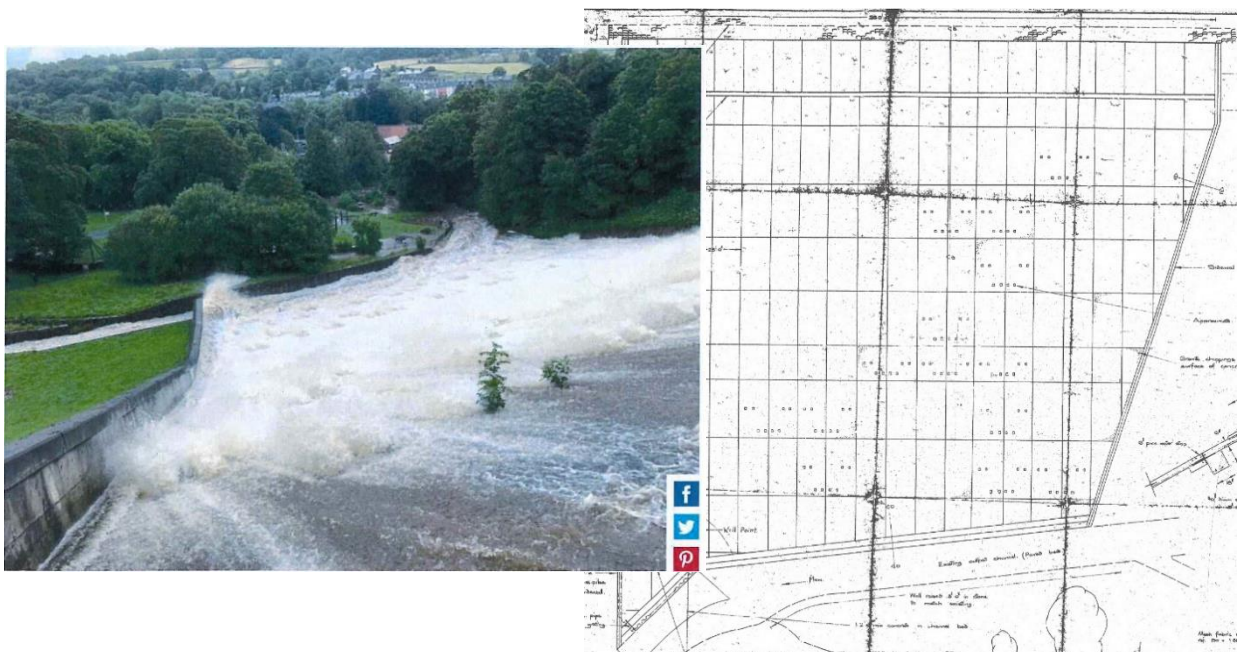
Although the left hand wall tends to increase the local flow depths and turbulence along its length (fig B7), it would not appear to have had any particular influence on the nature of the slab collapse which occurred some distance away from it and away from the turbulence that the wall creates. The view of the Panel is that the scour initially originated at the third row of panels in from the left and that it spread laterally, eventually undermining the wall foundations, causing them to collapse inwards rather than being eroded outwards. This also reflects the thoughts of the engineering staff on site at the time who witnessed events as they unfolded.

**Figure. B7 Plan of the auxiliary chute and photo of flows impacting against the oblique left side wall**

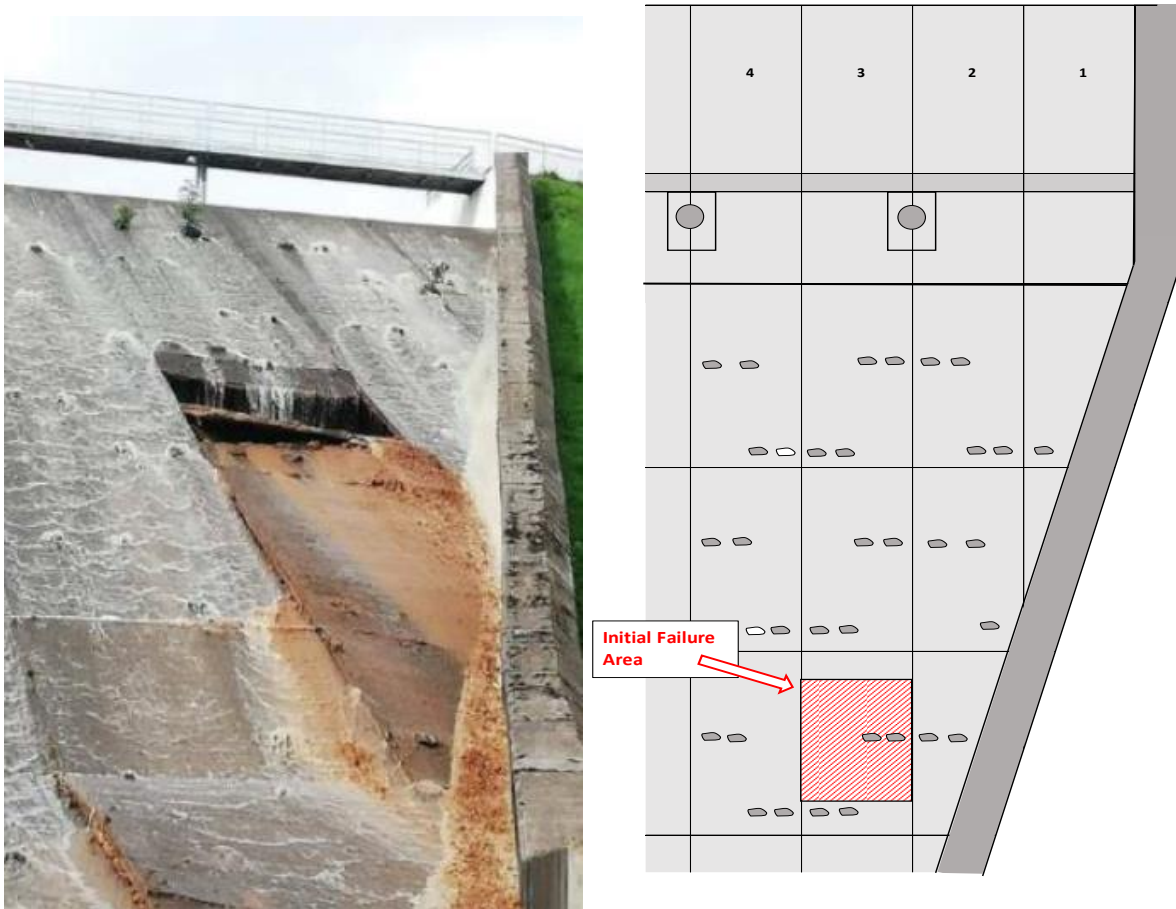
Earth slurry in the form of what appears to be silt, clay and sand can be seen exiting through open joints due to raised slabs, further down the chute. It has clearly “flowed” from the scour hole above implying a fluidization of the fill in the area of the scour hole. This in turn implies that considerable volumes of water had reached the scoured area during the course of the earlier flows down the chute. The earlier descriptions of events and of silty flows leaving the chute during the flood, see above, indicates that this process had been going on for most, if not all of the preceding day, during the main flood event.

**Figure. B8 Location of initial slab failure**

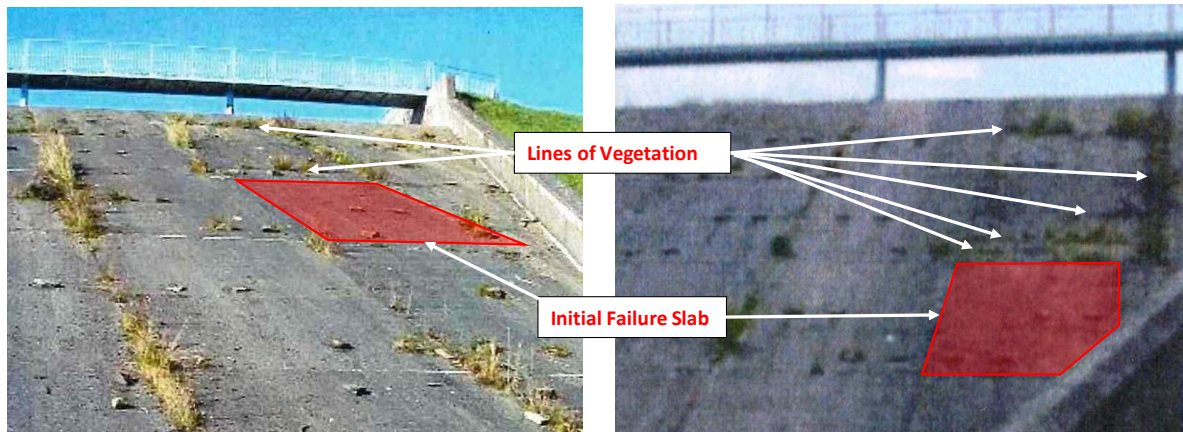
It should be stressed that these values are not definitive as the slabs in question are no longer either intact or available for inspection. However, it is clear from historic photographs showing lines of established vegetation, that at least three such cracks and/or joints existed across the panels immediately above the panel which initially failed (fig. B11). The mechanism demonstrates a means by which water would have potentially been available during spillway flows, to target exactly the foundation area concerned and in sufficient quantities to accomplish much of the substantial erosion and soil liquefaction which occurred on the day. It would also explain why large amounts of silt/earth colouring was apparent in the spillway flow but not in prior drain outlets and other seepages when the spillway was inactive.

**Figure. B11 Lines of vegetation in 2007 and 2016, implying open cracks/joints immediately above the slab which failed initially**
