TODDBROOK SPILLWAY FAILURE

**Review of the reports into the failure and damage to the
dam on July 31st. 2019**

Graham Aldred.

24/2/2021

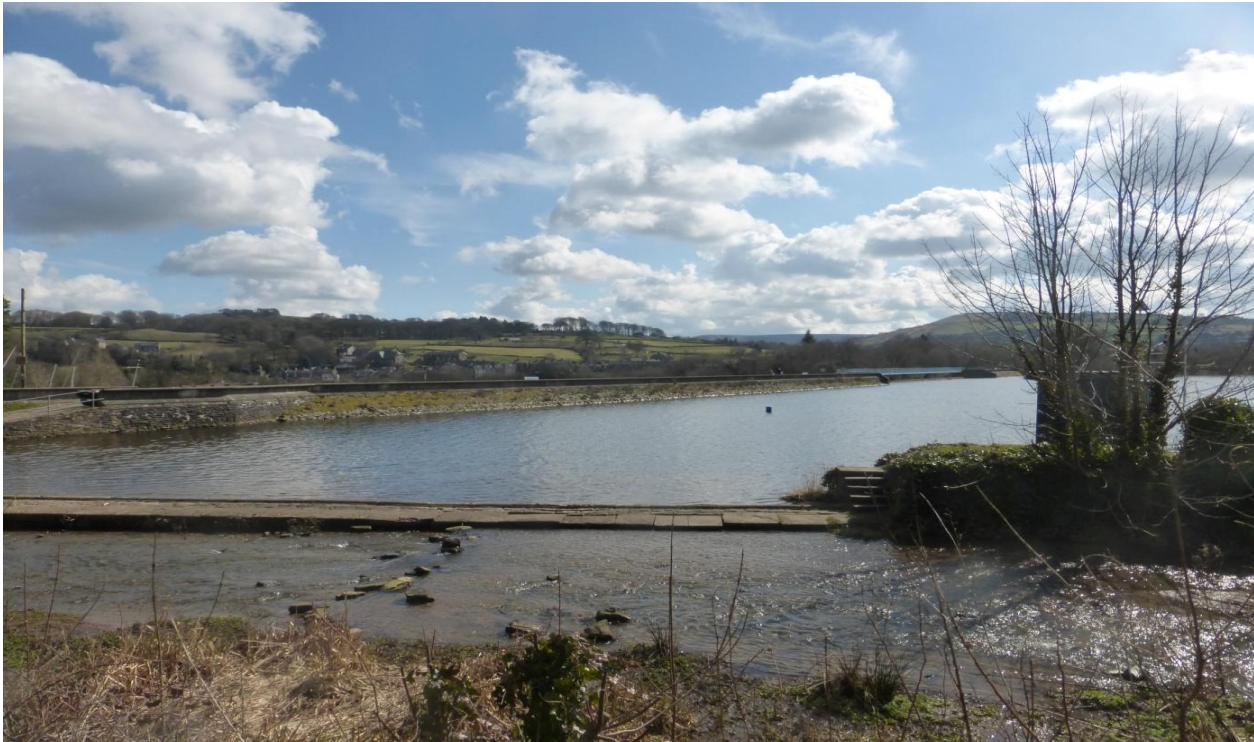
Photo GA1. The very shallow Convergence Basin viewed from Reservoir Road showing the upper end of the primary weir with a drop into the Basin of only 4 in. overall. The Bypass flow here is about 2 in. deep. A large mud bank is in the foreground taking up valuable capacity..

This report asserts that the fundamental problem at Toddbrook is that the main overflow at the primary Cill will be blocked or 'drowned out' at the most critical times of major overflow. If the Bypass channel is even in moderate flow then water cannot leave the reservoir, it has nowhere to go. There are two reasons for this.

1) The reservoir overflow has to share the Bypass channel which is a dangerous and rare feature in historic reservoir design, it does not have its own dedicated channel. In addition the critical capacity of the 'very shallow' convergence basin is reduced to around 50% caused by at least 25 years build up of mud banks, reed beds, trees and shrubs, stones, branches and various debris.

2) The fall (or drop) of the main reservoir overflow into the Bypass is insufficient at only about 4 in. at the crucial RH upstream end of the Overflow Cill (*at the steps in photo 2*). This is where the powerful bypass flow is being guided to turn by the side wall. But the wall ends, so the Bypass flow stops turning and will flow unimpeded into the reservoir. If the reservoir is attempting to overflow at the same time it will be blocked. That is the state reported in 1964 (and witnessed in 2019 by me and others) with the reservoir level 1m. above the primary cill.

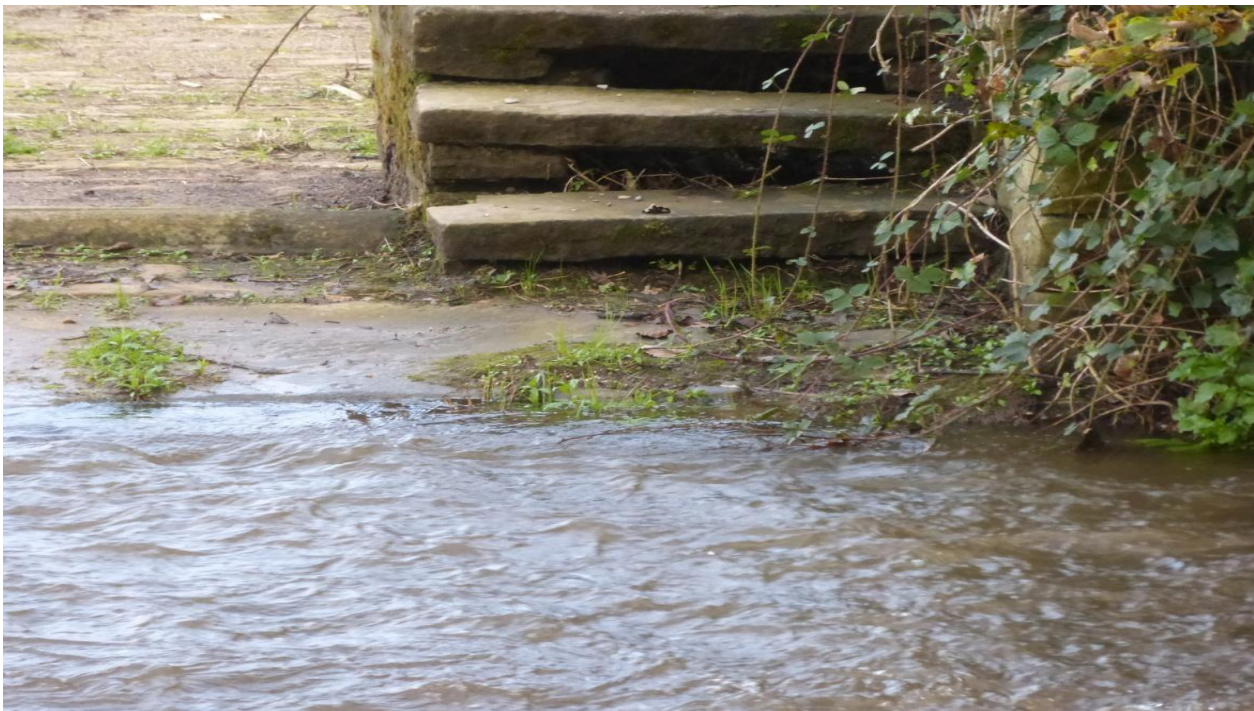
Photo GA2. Here the Bypass flow has risen, now full to the brim at about 4 in. deep, flowing to the left. If it rises by another 3 in. it will flow over the Primary Cill 'backwards' to fill the reservoir !

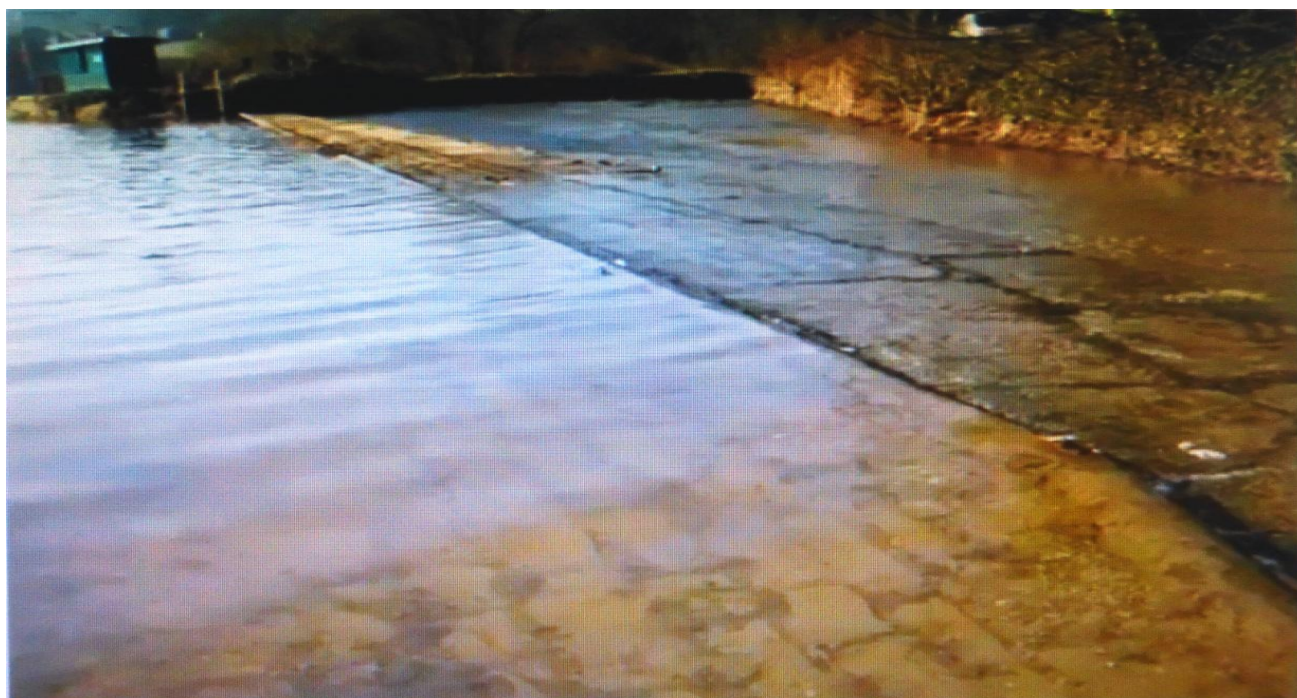
Photo 3. The view upstream showing a modest low volume overflow from the reservoir over part of the Primary Cill. (*Photo ex July Seminars*)

The photo clearly shows that the primary cill is not level as might be expected. I believe that about half of the primary cill was deliberately tapered towards the downstream end by about 6in. Probably ordered after 1840 by John Wood the Design Engineer to alleviate the overflow contention upstream as we have just described. Here, at the downstream end, the fall from the primary cill into the Bypass is more than 18in. (because the convergence basin floor itself was built sloping downwards). The lowered Cill defines where the initial reservoir overflow occurs and the greater drop temporarily avoids the flow contention at the shallow upstream end seen as a patch of dry weeds in the photo above.

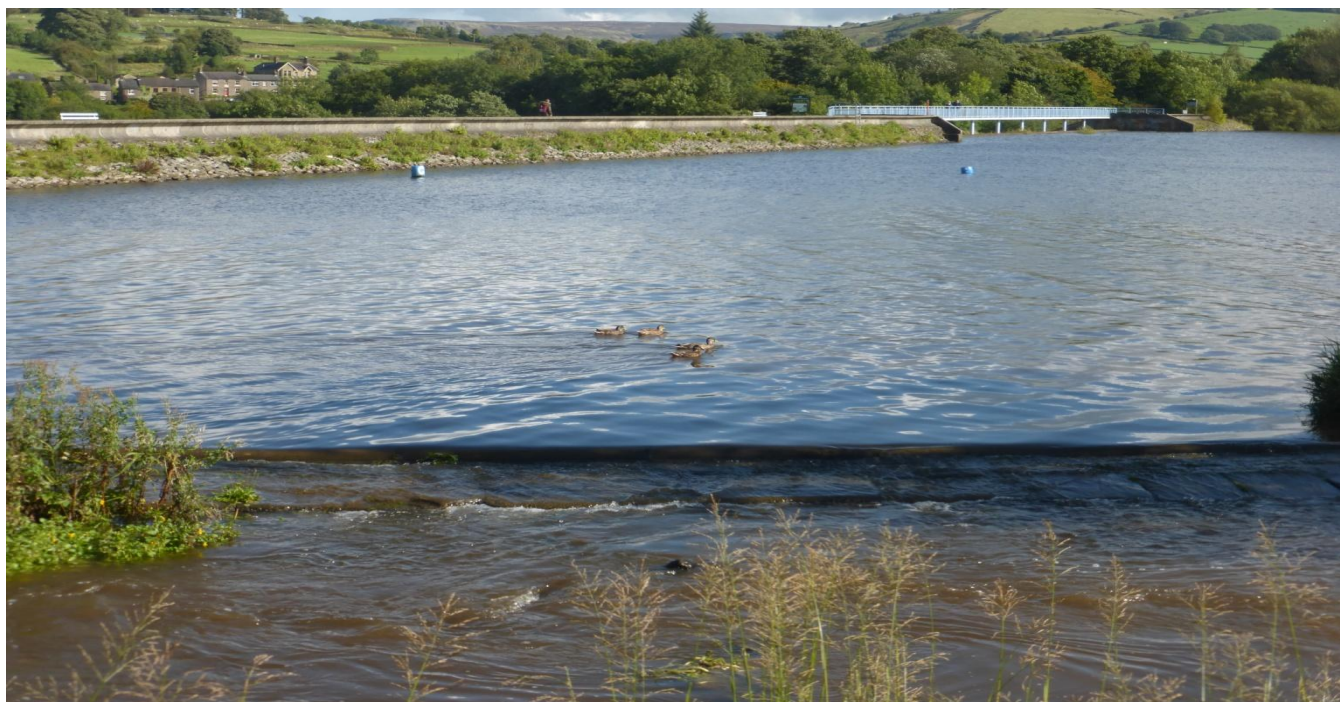
Photo GA4 shows the imminent critical state at the RH end (viewed from Reservoir Road). The reservoir is already overflowing at the LH end as in photo 3, currently only wave wash is coming over the primary cill which is higher at this RH end. The Convergence Basin in the foreground is only about 5in. deep here it inherently has insufficient capacity further exacerbated by mud banks and weeds seen here. Eventually the Bypass flow blocks the Reservoir overflow.

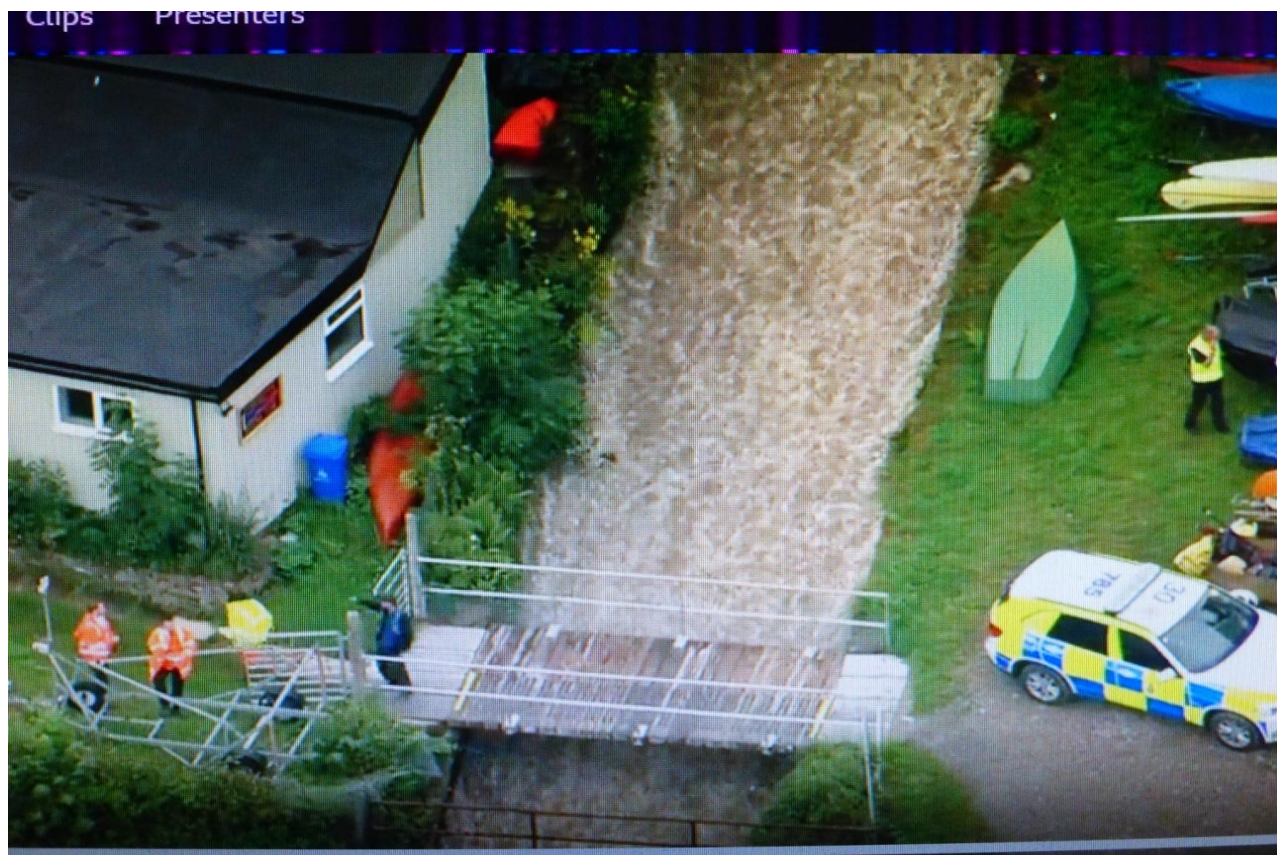
Photo 5 illustrates the potential volume of water speeding downstream of the Convergence Basin (Aug1). Here the Bypass channel is 4m wide and at least 1.5m deep. It is this mass of high energy water which completely blocks the Primary Reservoir Overflow. Exactly the same blocking effect is repeated at the two discharge culverts from the valves immediately lower down.

Obviously the existing primary overflow will never function without human management unless it is given much more free fall (at least 1.5 m.) and it will not function unless it is given a huge increase of dedicated Bypass channel capacity. Lowering the reservoir level permanently (1.5m.) and deepening of an overflow Channel is a standard, cost effective practical modification carried out on unmanaged reservoirs with earth/clay dams. (Also proposed by Mott Macdonald in 2008). Destruction of the dam by the addition of a defective auxiliary concrete spillway is not a solution to the functional inadequacy of the primary overflow design. It was not the solution in 1970 and it will not be the solution now in 2021.

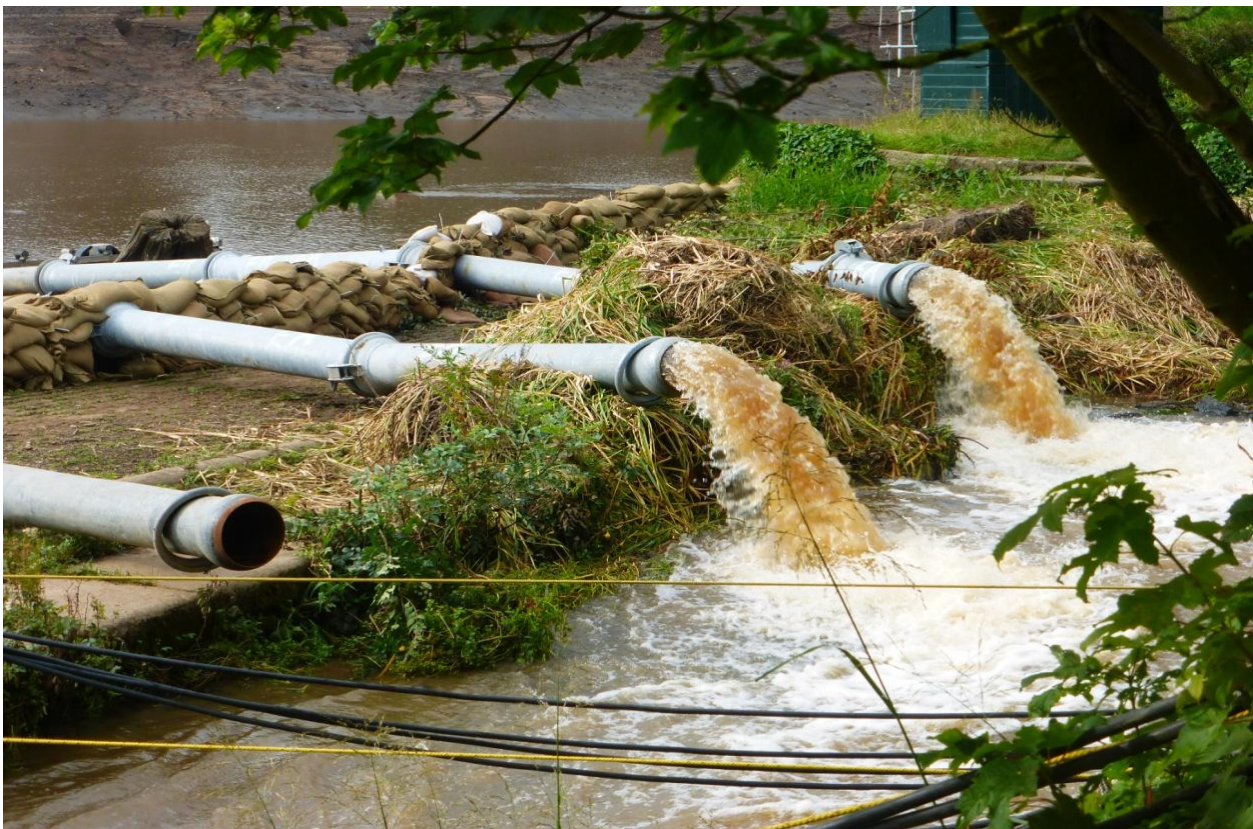
Photo 6. Emergency pumping arrangements further illustrate this deficiency as described.

This shows that accumulated mud bank material which had to be urgently cleared from the basin to increase capacity was beneficially exploited to provide a temporary wall to prevent the Bypass flowing into the reservoir in the first 1-3 days. This temporary wall also gave the pump discharge pipes some beneficial elevation above the Bypass flow, equivalent to deepening the convergence basin (which is what is required). Note the sandbag wall behind that was required earlier to prevent water from flowing back into the reservoir when the Bypass was 1m. above the Primary Cill (as in photo 5).

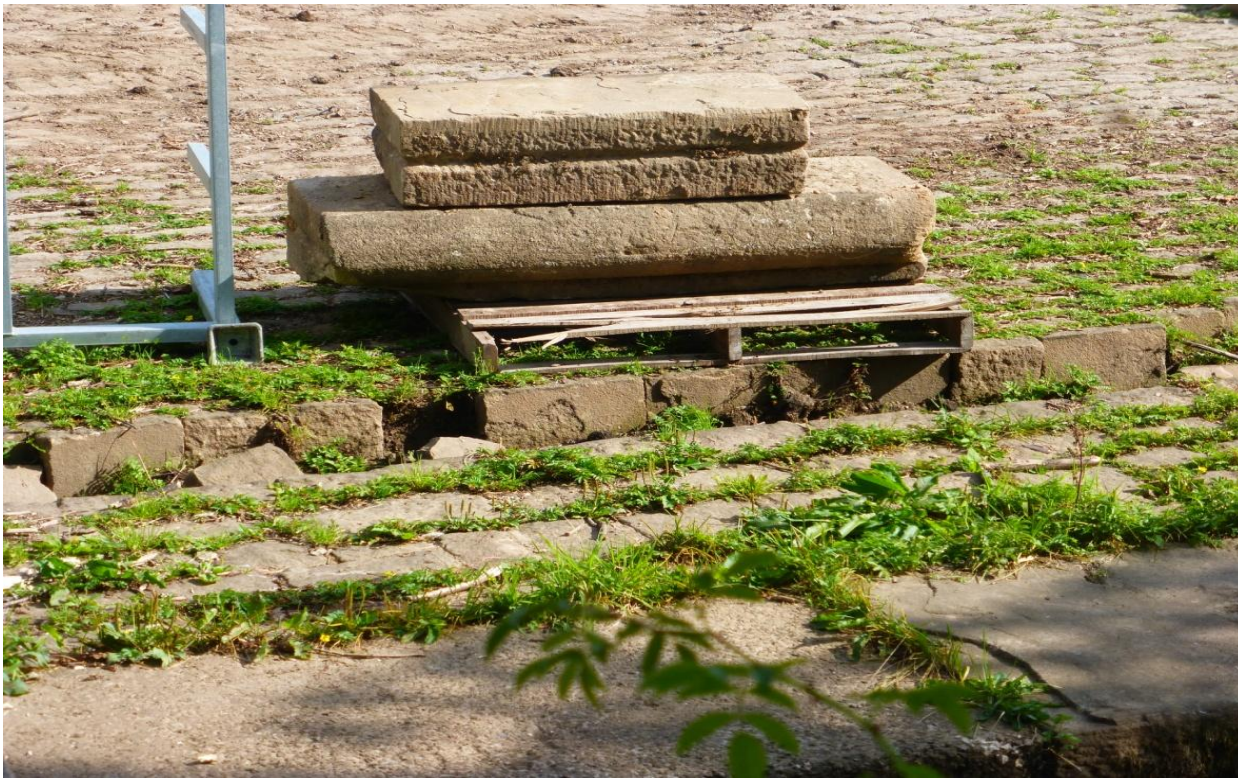
Photo 7. The Weir Blocks of the Primary Cill.

The Emergency Team had to prevent the Bypass from filling the reservoir at the RH end as shown in photo 6 but at the same time had to assist the outflow from the reservoir at the LH end of the Cill, this was where the cill had been cranked down long ago. Once the lower cill limit was reached natural outflow would stop. Quite logically the Team decided to extract the weir blocks at the LH to lower the reservoir by another 3-4 in.

Although it was very necessary in the emergency this means that the exact amount of 'cranked' drop of the cill cannot ever be measured now. The cill was not level, it had a 'knee joint' . I believe this was deliberate as explained above but it has wider ramifications which relate to the construction of the Auxiliary Spillway which is said to be a vague '12-15in.' higher than the primary cill defined by these weir blocks. But the weir blocks slope downwards (either by settlement or design). This slope makes the datum used for the Aux Spillway weir quite uncertain!

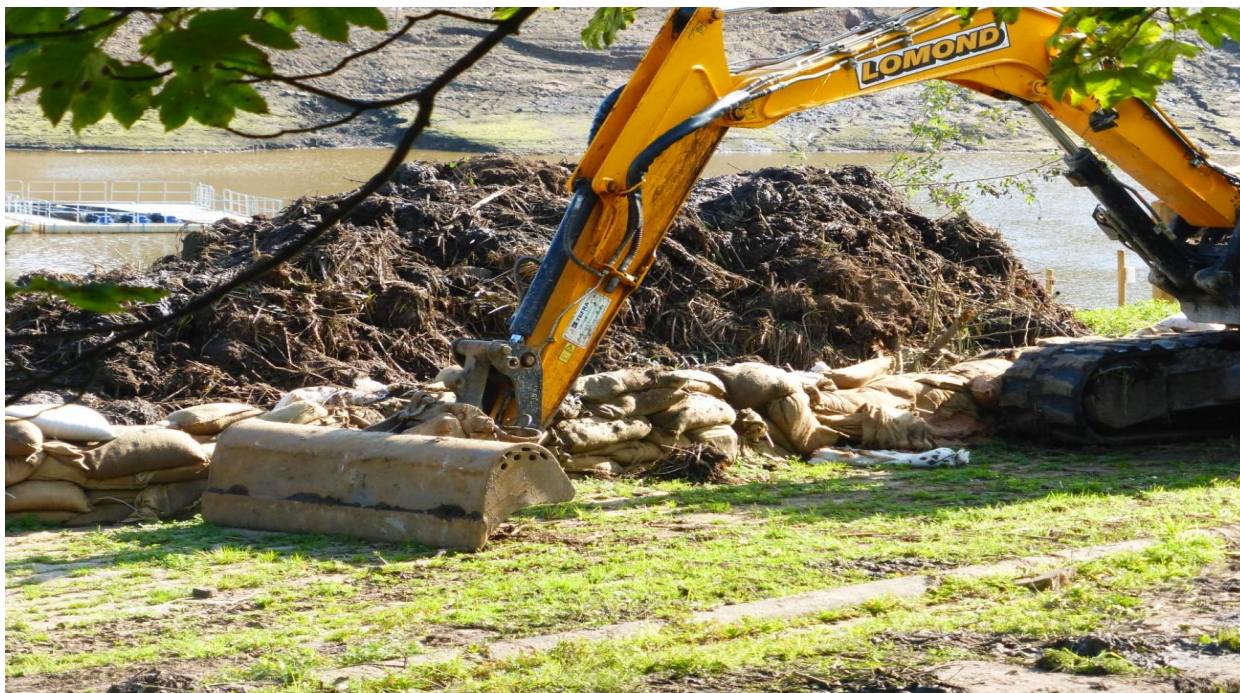
Photo GA8. Here are the many tonnes of mud, weed and stone that had to be cleared from the convergence basin immediately in the crisis, critical to saving Whaley Bridge from considerable destruction. It illustrates the huge loss of capacity and the undeniable systemic neglect of routine maintenance at Toddbrook in all the channels and culverts which are fundamental to the effectiveness and safety of the system. (see GA2 many other photos)

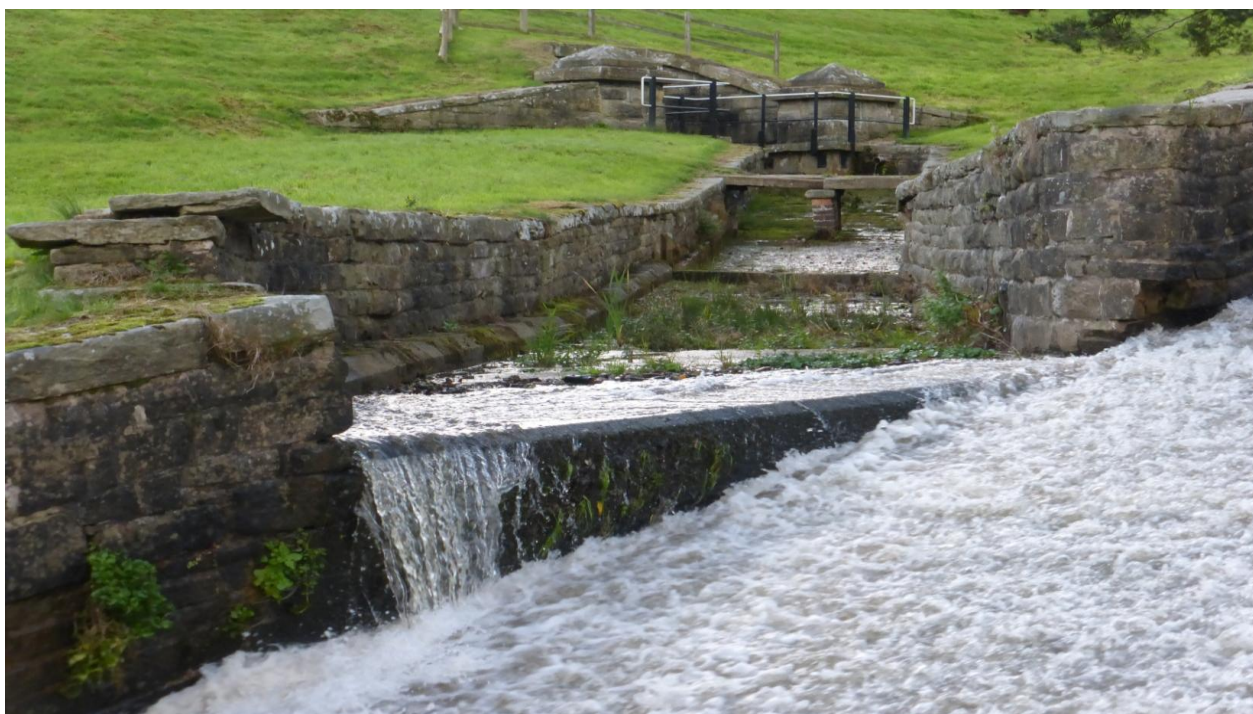
Photo GA9. The discharge culvert for Valve 1 into the Bypass provides a clear demonstration of the Primary Overflow dysfunction but on a smaller scale.

Downstream of the Convergence Basin, this is the discharge culvert for Valve 1 (not discharging here). The Bypass water is only a few inches deep but very fast. At the RH end there is no 'drop' so water runs unimpeded into the mouth of the culvert, collects itself at the LH end and falls out. But imagine that the Bypass flow is 1.0 -1.5 m high as in photo 5, the wall of very fast high energy water will flow across mouth and block the culvert. This is exactly what happens at the Primary Cill but on a much larger scale. Here the Bypass flow will prevent the discharge by Valve 1 at exactly the time when Valve 1 should be in maximum discharge to draw down the reservoir. Discharge culvert No2 suffers from an even worse blocking a little further downstream.

Summary. The existing system cannot function without human management. In GA3 I have described a radical modification in detail which will resolve this Primary Overflow failure and remove any requirement for an over crest spillway. The Reservoir TWL must be lowered and so must the Convergence basin.

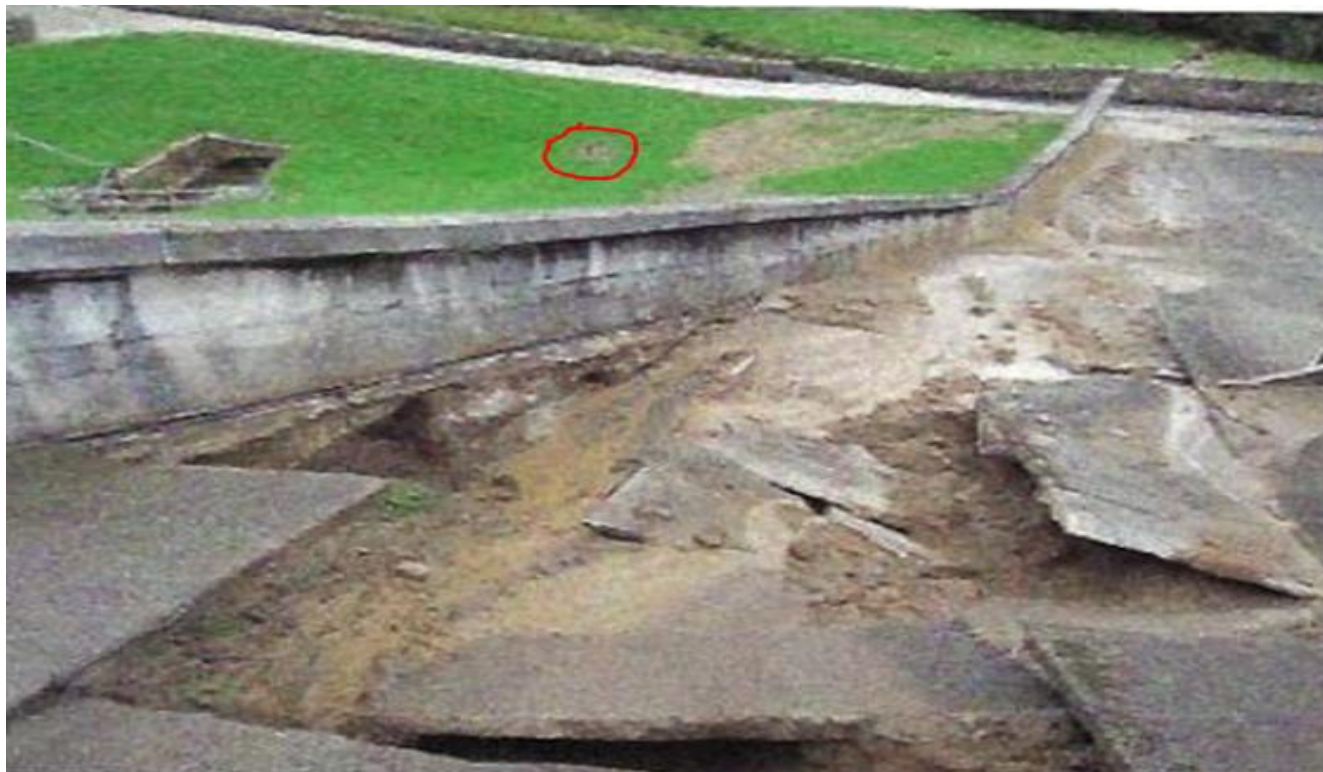
The debris field in the grass indicates where a straight wall would have to be and it exposes the other complications of making the LH guide wall, straight and parallel with the RH wall. This photo also reveals the appalling 'saw tooth' side wall footings which provide numerous paths for erosion channels to make an easy side exit onto the embankment and eventually to carry away an estimated 600-700 tonnes of fluidised earth, clay and stones from the dam itself as the debris field shows.

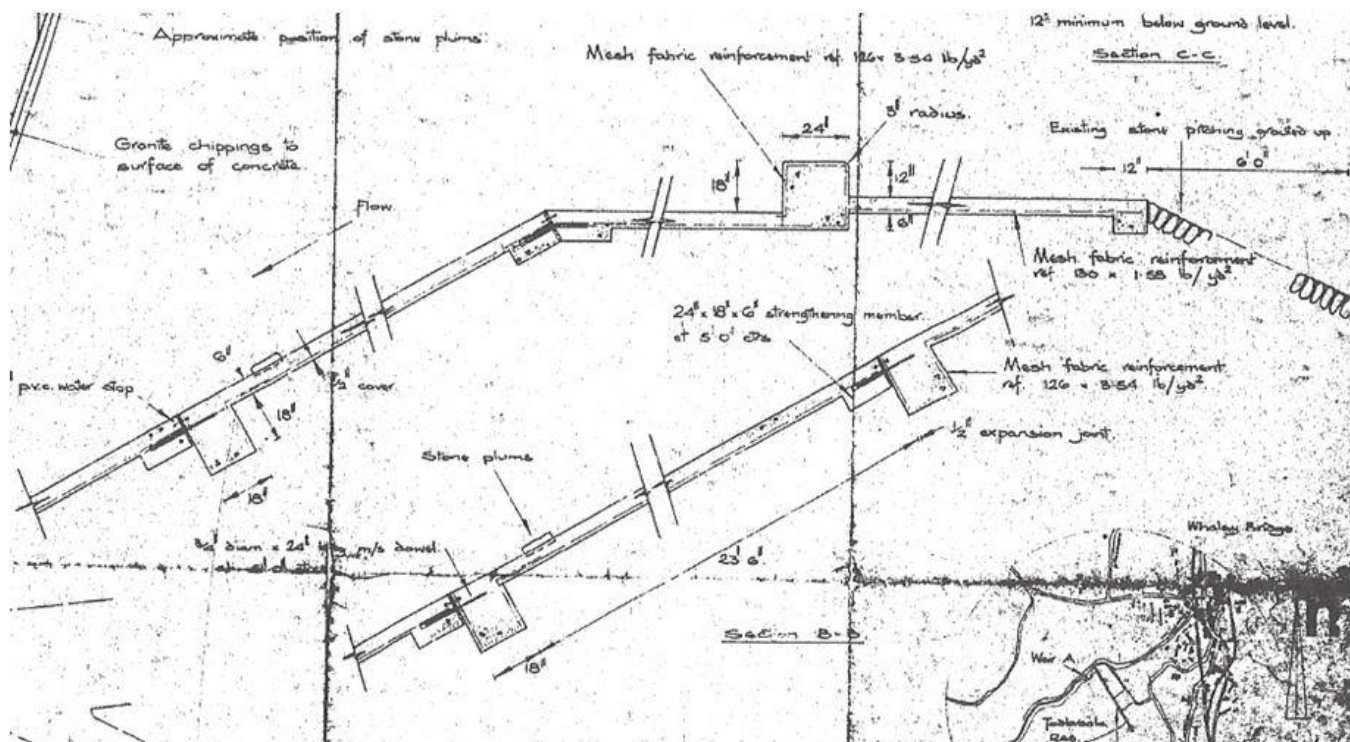
Fig 1. This poor incomplete drawing suggests how the auxiliary spillway was supposed to be constructed. It is hard to believe that this was the only specification of such a major destructive project to a Dam. It lacks numerous details defining the Apron. It would be expected that the BW Archive of Documents which the CRT inherited should have many other relevant documents including, Design Approval and especially a Risk Assessment. This is the drawing being referenced when it was claimed by the Inspecting Engineer (in 1970) that:-

This drawing initiated the reckless destruction of an otherwise safe earth clay dam in 1970. This was a modification that has subsequently caused a continuous catalogue of failures and defects on the dam from the outset and which led directly and irrevocably to the near catastrophe in Aug 2019.

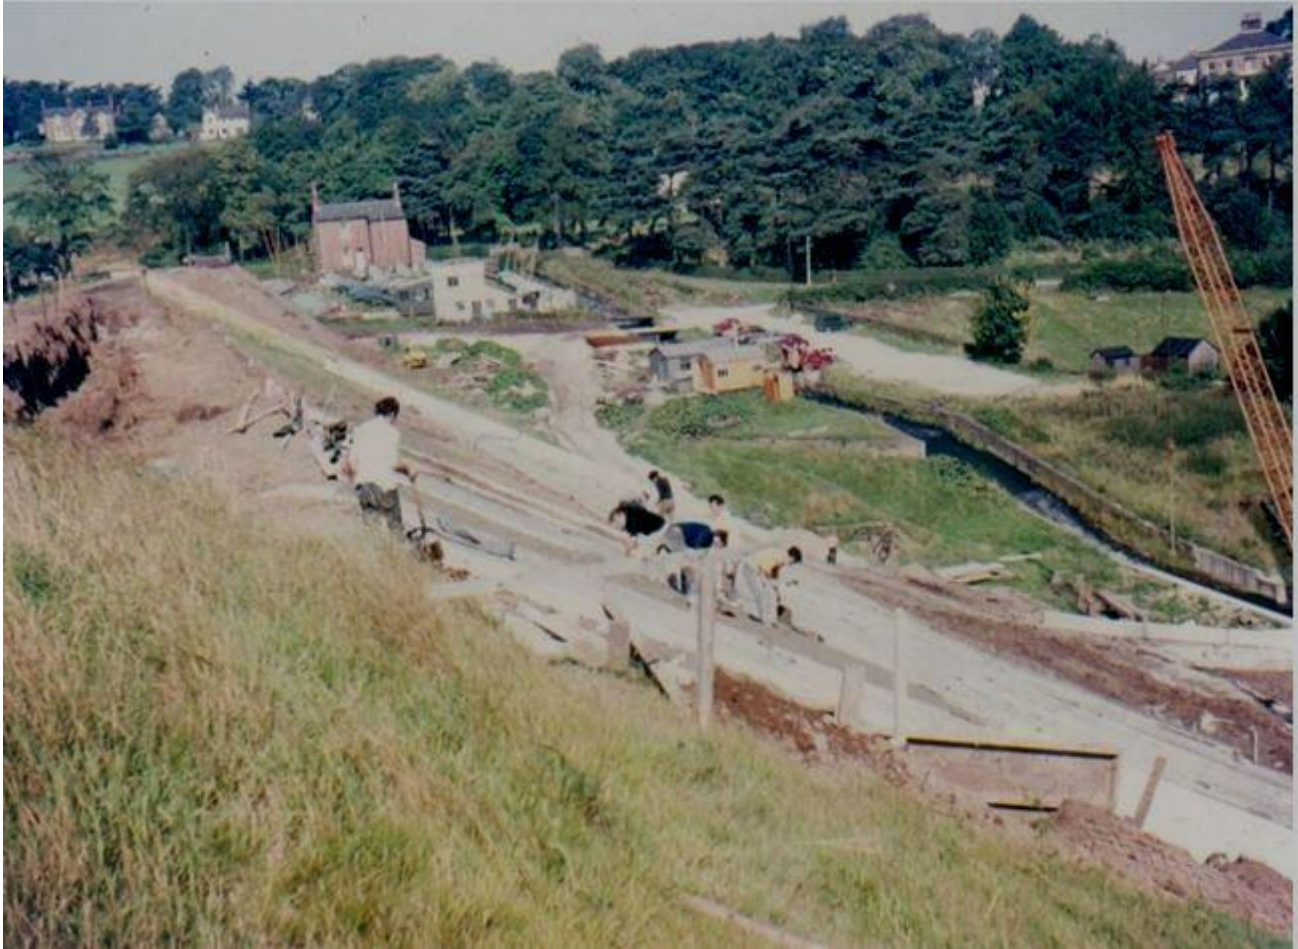
Fig 2 A gang of only 6 men are at work on the steepest part (26 deg.) of the Toddbrook Dam on a rare sunny summer day. The rich colour of the clay core (top LHS) is exposed at the crest, partially dug out as the vital safety margin of the dam is destroyed. The infamous angled LH side wall, originally very low, is partially constructed with a gap for the crane to escape. The construction roadway had to bridge the discharge culverts and avoid the valve houses. (*Photo DB/16*).

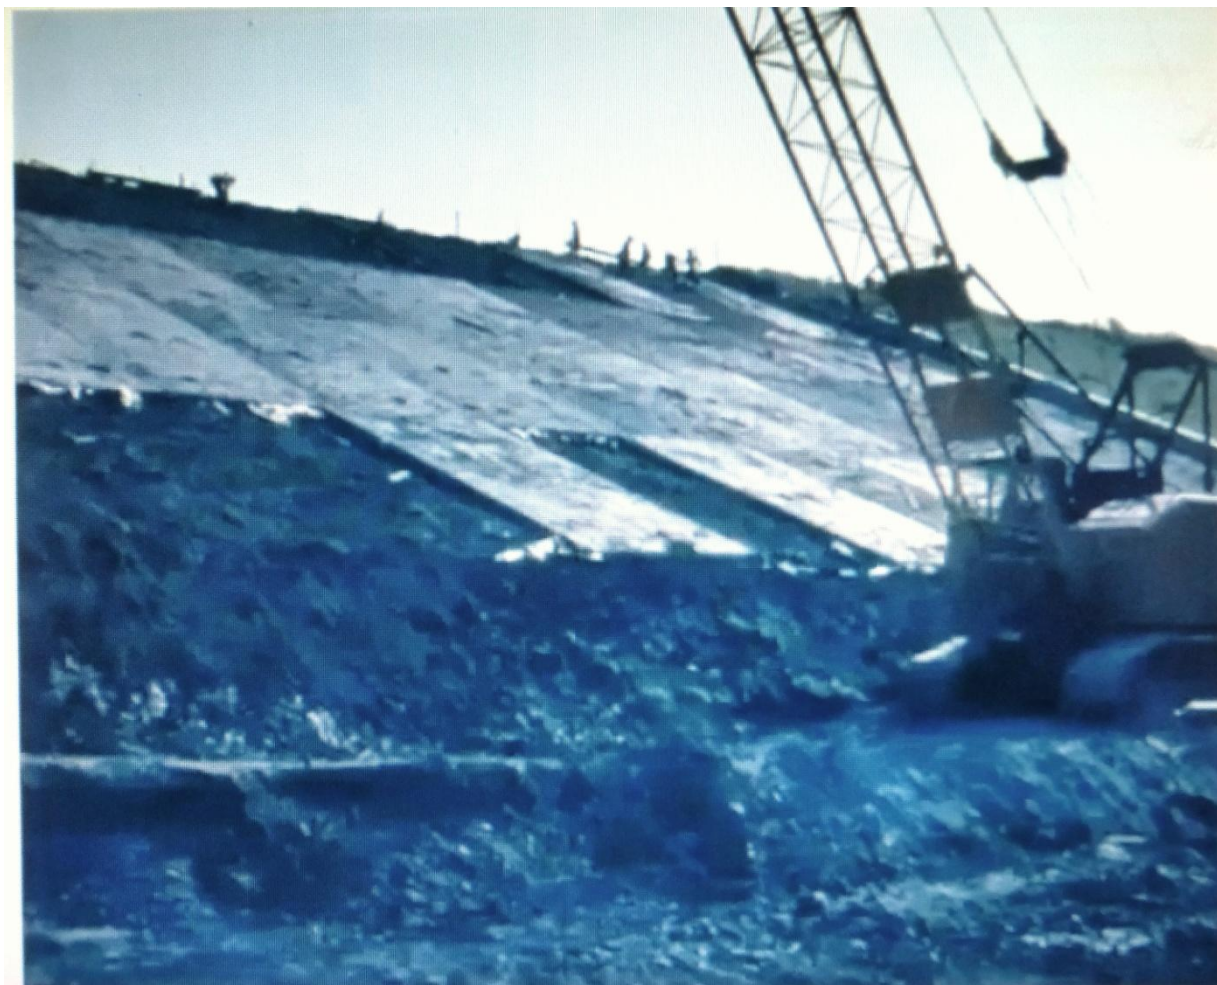
Fig 3. indicates the construction sequence (top down) for casting the spillway panels and the unavoidable damage to structure at the foot of the dam done by the crane. The earth fill of the shoulder exposed here contains a surprisingly high proportion of big stones which provide excellent routes for erosion channels to develop. (Photo ex July seminars)

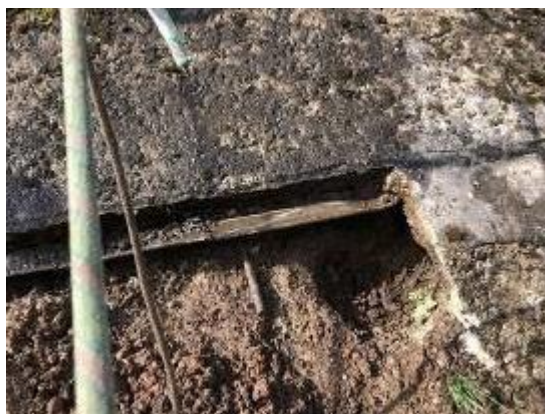
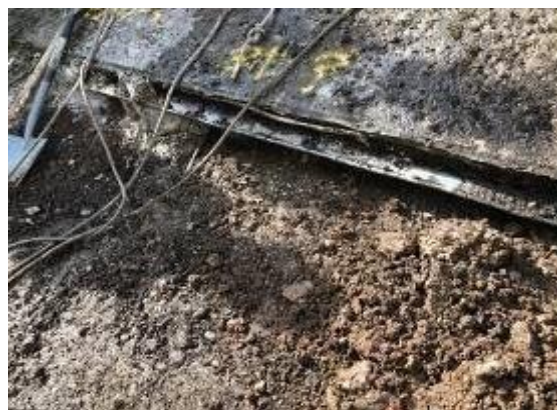
But some transverse water bars were fitted because Prof. Hughes found some at the top on the far RH side of the spillway. Photos showing one flange of a water bar and one dowel bar protruding below it. Pieces of sealing strip are visible near the cables. Photos (AH/27)

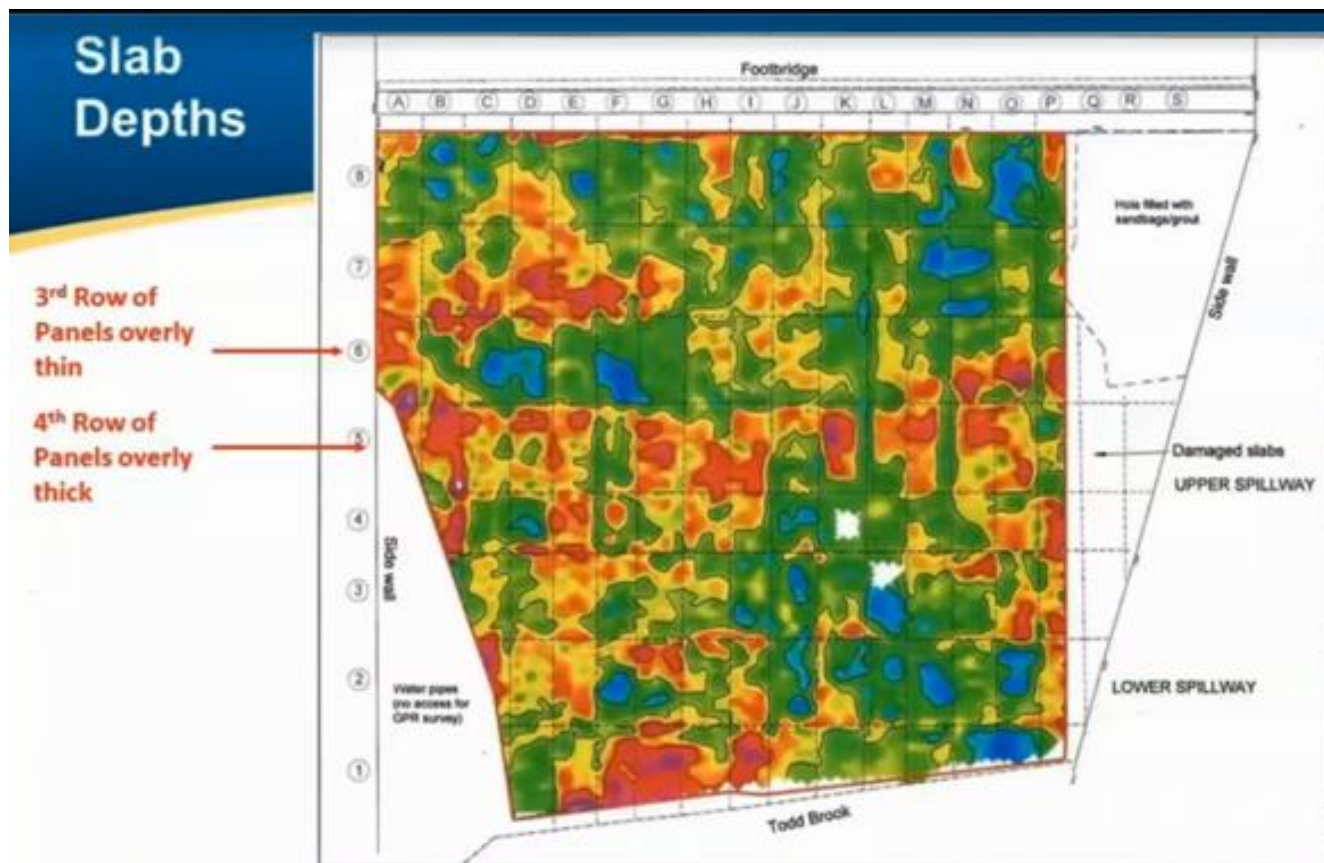
The image below shows a GPR survey of the varied concrete thickness of the panels that were accessible after the incident (*Peter Mason, July Seminar.*) It covers a range from Green/blue thin, about 70mm, (3in.) to red/orange, thick around 200mm (8in.) This image confirms the huge difficulties of laying slabs manually on a 26 deg slope. It confirms the predominant thinness of the top two rows. These panels, without proper reinforcement, were as brittle as wafer biscuits for their size, many of them had parts only 3in. thick with little or no chance that a waterbar would be embedded and therefore would leak.

Blue, green and light yellow mean that the concrete is thinner than the required 6 inches.

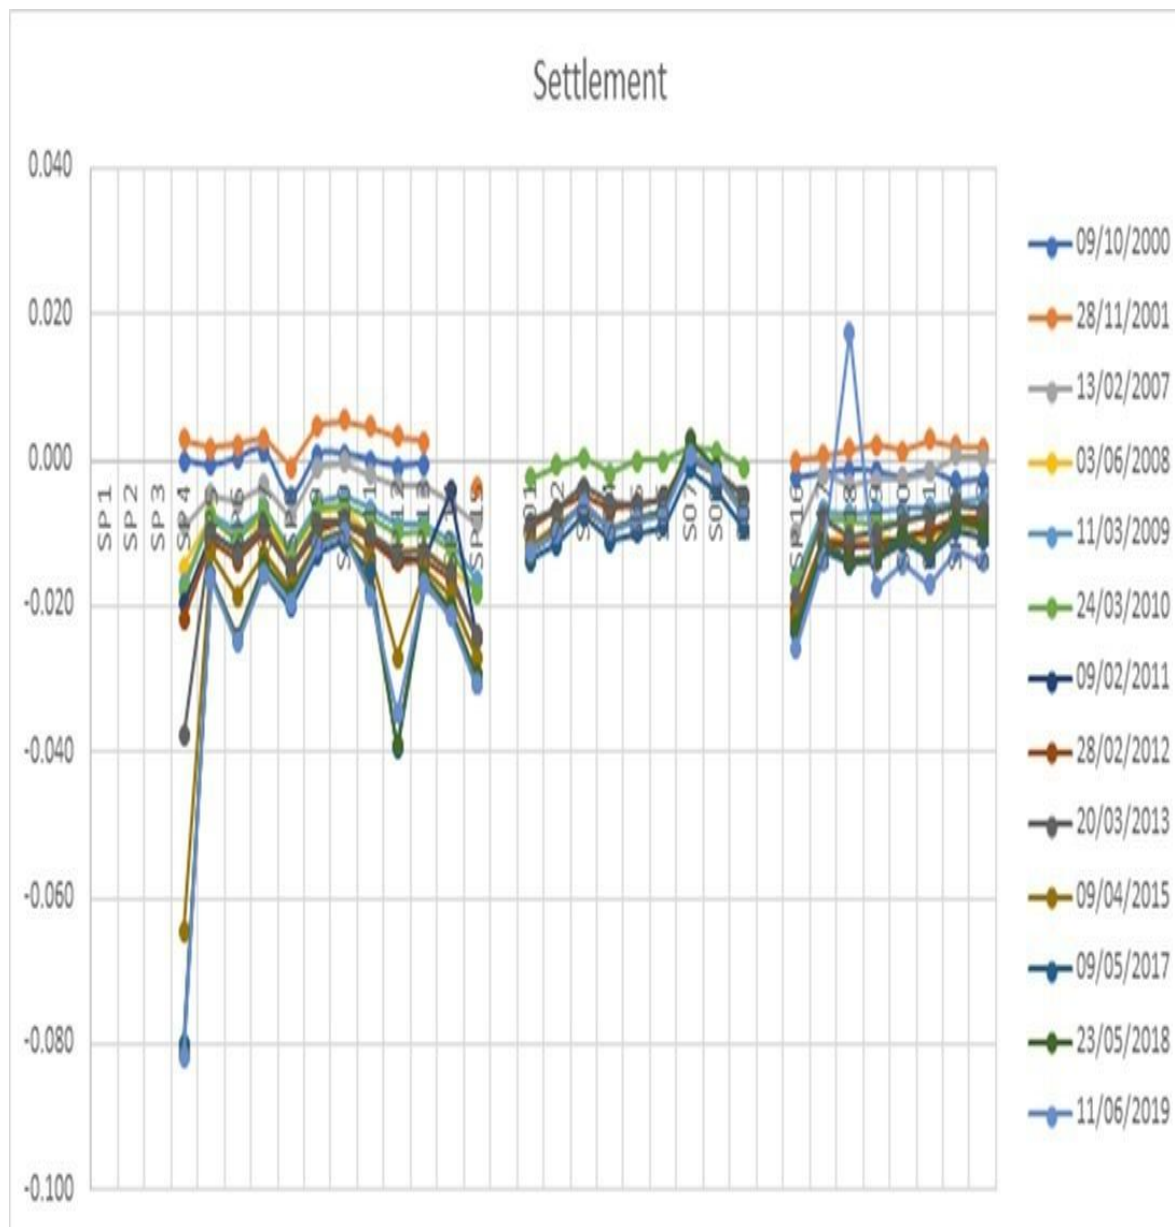
Looking downstream, the group of pins in the middle, SO1-9, are on the Auxiliary Spillway. For some reason their records only start in 2010 and have only been read **3 times** since then. Pins SP1 to SP15 are on the LH side where the damage occurred, with up to **9 records** from year 2000. Pins SP16 to SP23 are on the RH side.

SP15 which is adjacent to the LH abutment wall has dropped 30 mm in 19 years, SP 16 at the RH side is nearly as bad. This strongly suggests greater local slump due to erosion channels exploiting the cross dam trench dug for the construction of the abutment walls. This is almost certainly a critical cause of the damage, evidence that has been available for **10 years** but not physically investigated (on both sides of the abutment wall), despite extensive cracking of the Apron there. All the other pin variations demand an explanation especially SP04 (which is behind the sailing clubhouse), it has dropped 80mm since 2001. SP1 to 3 are never read for some reason even though they are on the dam embankment, critically near the Bypass channel.

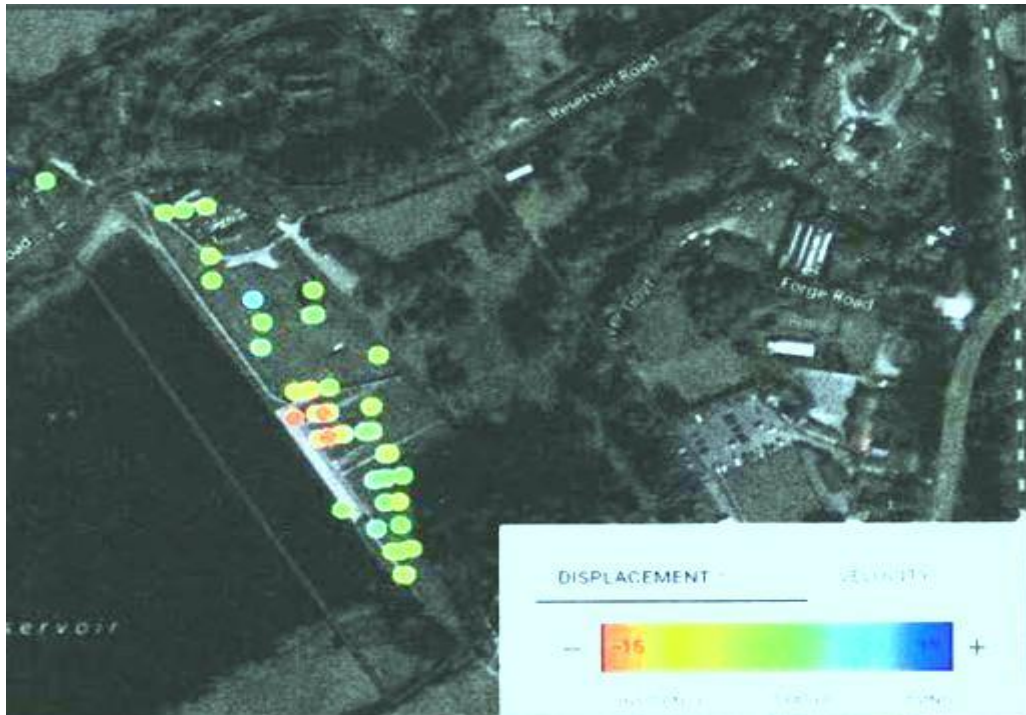
Copernicus Satellite surveillance has been used to duplicate terrestrial surveys of the pins (AH/45). (taken before the damage event.) The location of the pins on the dam is shown on this satellite picture. The yellow and red pins have all moved noticeably in the LH corner where the damage was to occur in future.

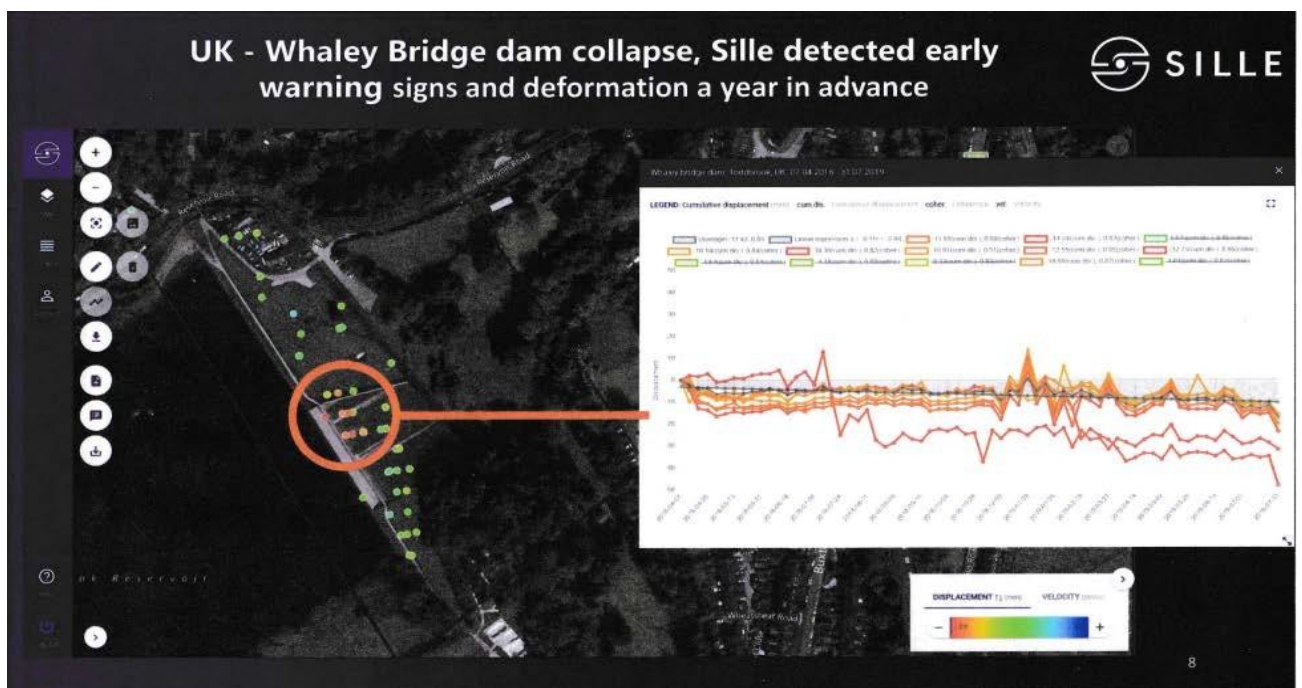
The fuzzy graph (screen photo) shows that most pins are behaving roughly the same as each other but two pins have dropped (ie parts of the dam dropped) in July 2018 and Jan 2019 by 30 mm, both on the LH side of the spillway. This indicates that there were significant drops in the dam structure 11 and 7 months before the Aug 2019 so there was a warning a year in advance of deformation which was not heeded by, at least, drawdown. This raises some questions:- What caused the Toddbrook Dam to be monitored by satellite for over a year ? Who requested it? Was the CRT aware of these drops ? Was dam survey pin data given the attention it merited?

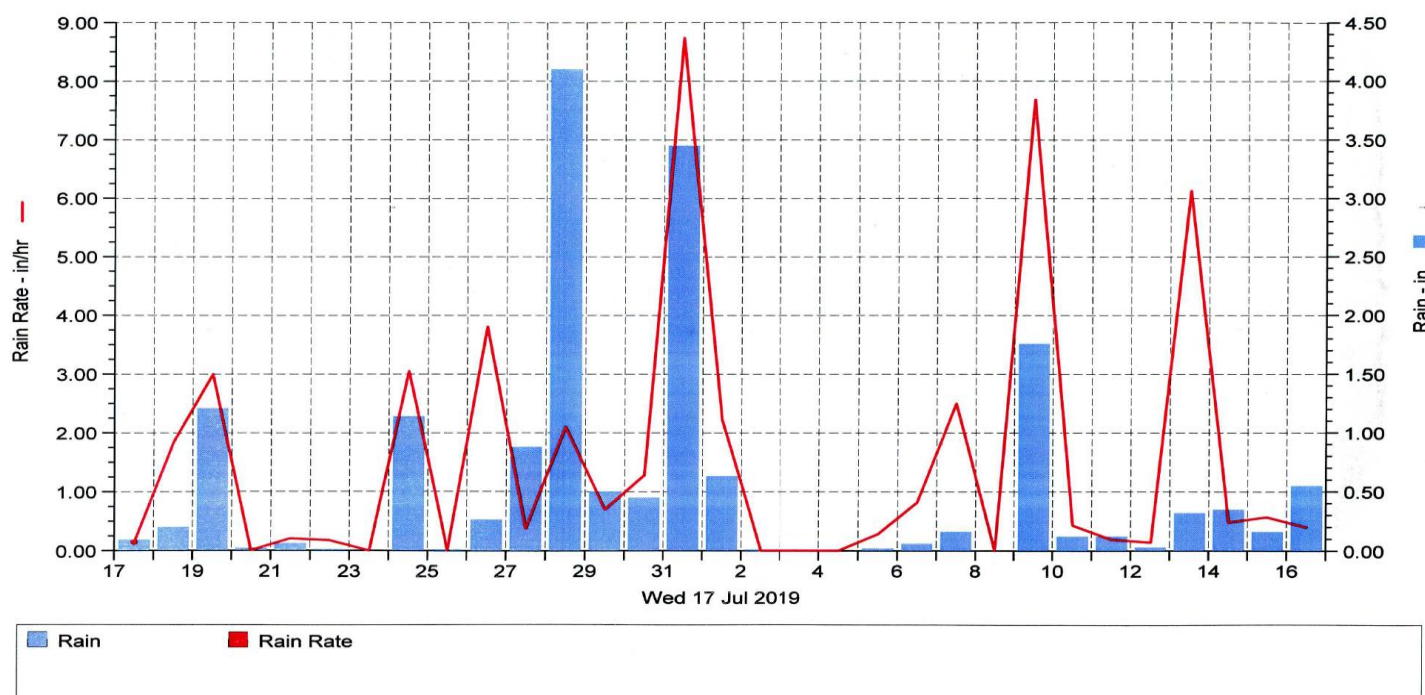
Fig. 1 Local Record showing the 2 rain events on 28th and 31st July. Note the 7 virtually rain free days that immediately followed the collapse and allowed the reservoir to be slowly drawn down and thus saved Whaley Bridge. (I have permission to use these records of a local climatologist who lives just north of the catchment.)
