TODDBROOK SPILLWAY FAILURE

**Review of the reports into the failure and damage to the
dam on July 31st. 2019**

Graham Aldred.

24/2/2021

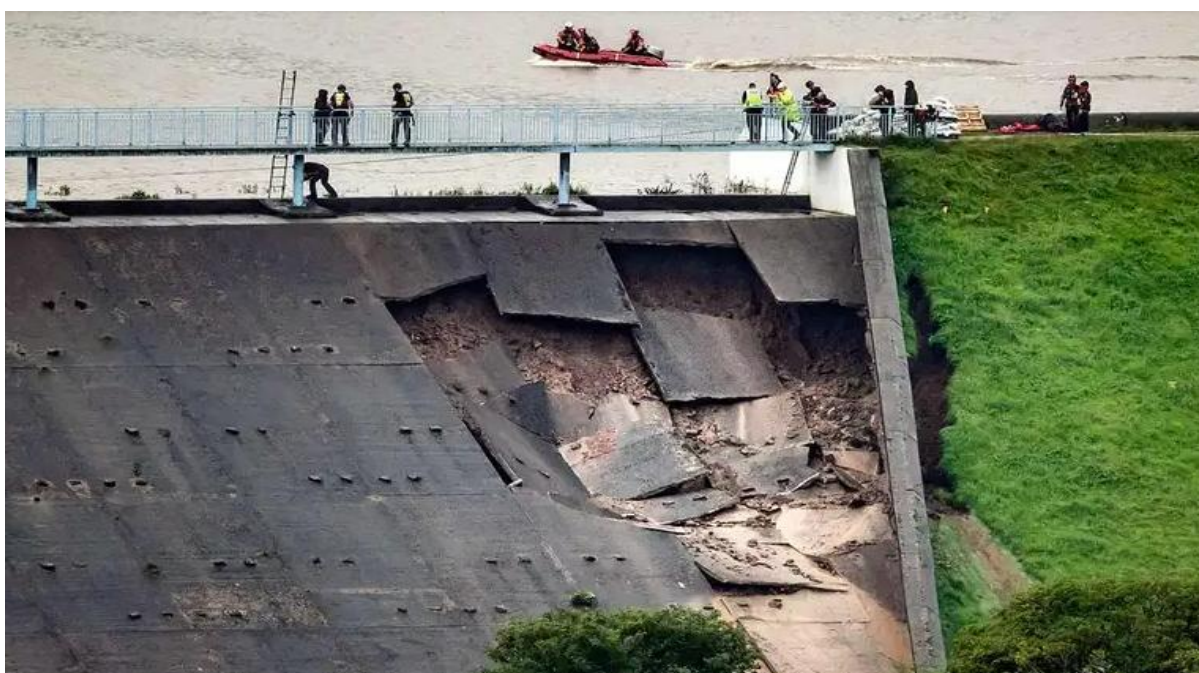
(Photo AH). The LH abutment wall is the horizontal white wall under the majority of men. Due to its unequal loading by the surviving crest of the original dam, this wall should have required deep footings (1-1.5m) and steelwork. These deep cross dam footings provide a deliberate trench, cut through the clay core in 1970, from the wet side to the dry side of the Dam, the very worst thing you would do to an earth clay dam. These footings are without any cut off as is the whole of the 80m.long spillway. They are more frequently underwater more than even the Apron itself because they have to be much deeper, so they provide the most probable and most well developed erosion channel site on the whole dam.

The dark earth track on the outside of the wall in the photo at the very top is evidence of the powerful exit flow under the cross dam footings. Inspectors over the years have reported 'leakage and wet earth' exactly there. This led to various pressure monitors being installed there but these failed in 2008 when
