## Analysis of the Damage to the Toddbrook Dam.

Graham Aldred B Sc.(Eng)

15 Dec 2019

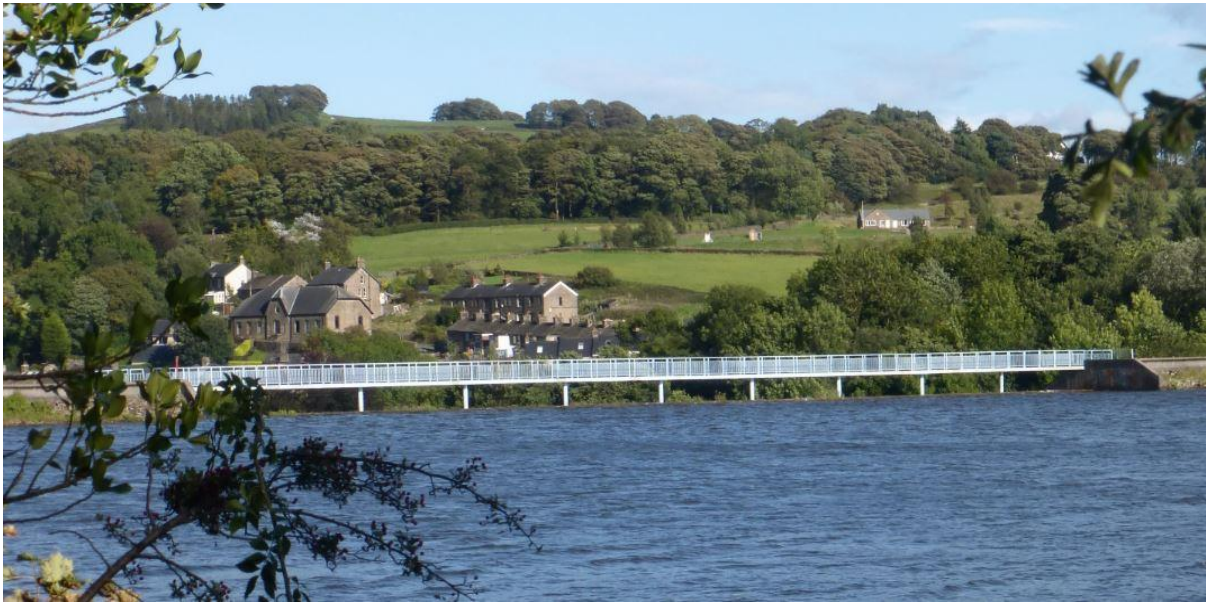
**Photo 1 (above).** The footway has 9 support legs (one hidden by the bush) plus 2 supporting abutments therefore there are 10 gaps under the footbridge. For this survey these gaps will be called Gaps 1-10 numbered from the left in this picture. The damage occurred in the middle of the dam on the spillway below Gap1.

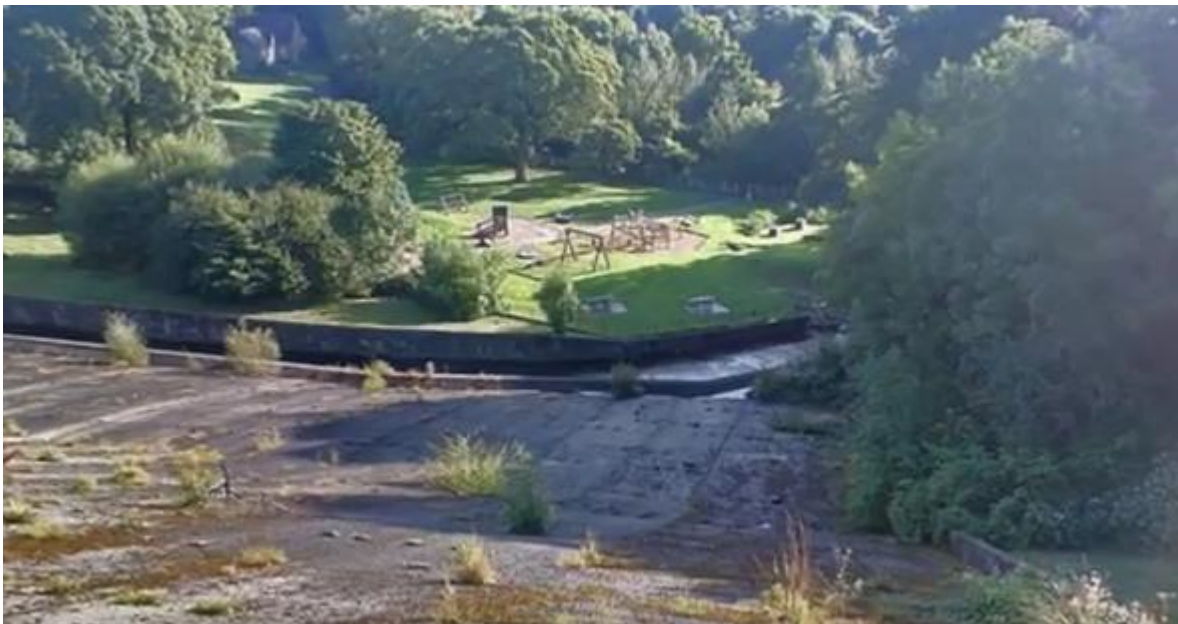
**Photo 2 (above).** A variety of weeds and shrubs have always flourished in the unsealed margins of the 170 panels of the Spillway and Apron, therefore the roots can easily find water underneath the panels. Mosses and lichens grow well on the decaying rough concrete surface.

When the spillway was constructed large stones, some visible here, (also photo 17a) were deliberately embedded in the wet concrete of the panels. It is assumed that their purpose was to disturb the flow down the spillway before it entered the Bypass channel below. The intention was to create turbulence and redistribute the forward energy of the flow so the water would be slower and be less able to jump over the Bypass channel (see Photo 8).

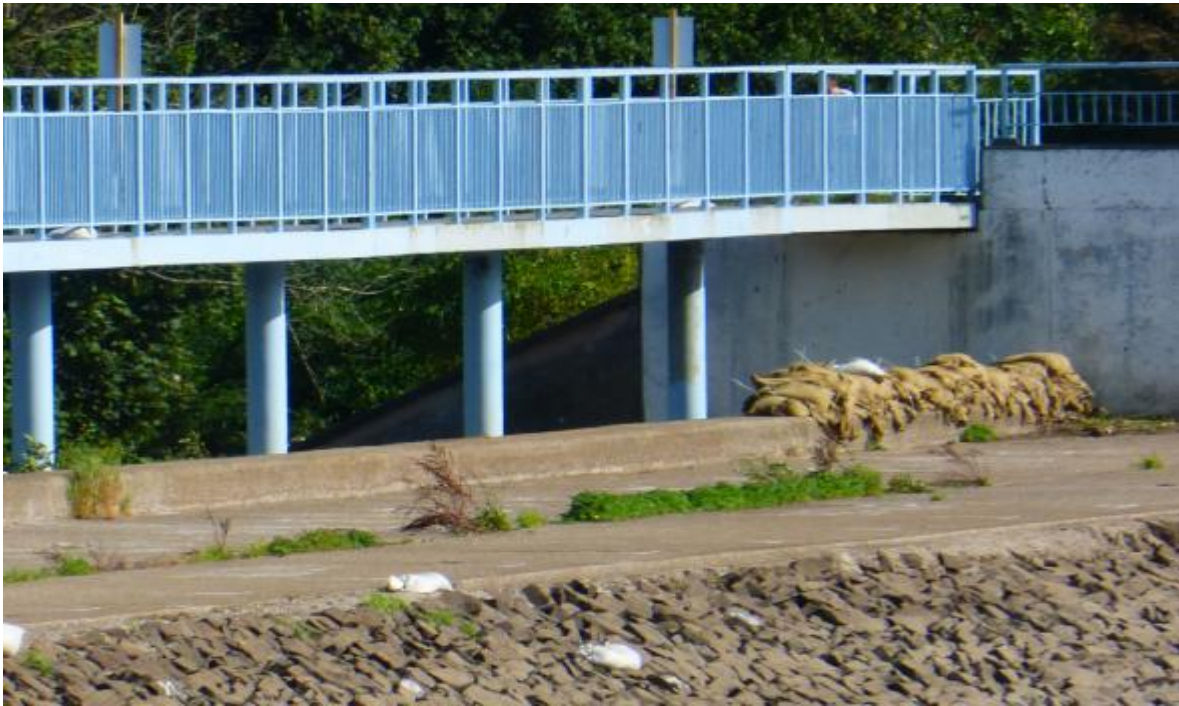
**Photos 3 & 4.** The Apron viewed from the reservoir side showing the considerable weed growth along the long junction between the mid and outer panels across the Apron. There are water erosion channels that pass underneath the Apron because water has been seen driven right through by waves (Ref1). The luxuriant weed growth did provide a good indicator for the location of the erosion channels where the roots can access water but unfortunately all weeds that provide these clues have now been removed from both the Apron and the Spillway.

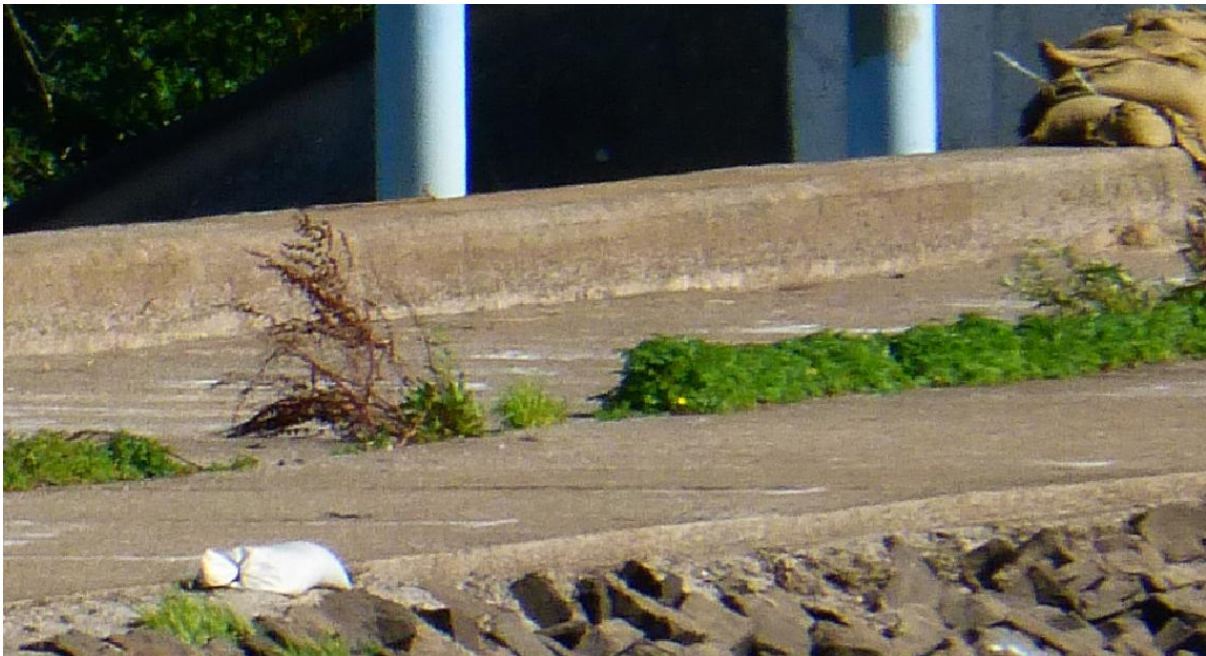
**Photo 4.** Zooming in on the well nourished flora. The Secondary Cill is the raised concrete curb in front of the footway legs. This Cill is supposed to be 12-15in. above the original primary Cill. So the reservoir has to be over filled above its design limit with at least 50,000 tons of water before the secondary Cill will operate. (The rate is 50,000 tons per foot.) This obviously overloads the dam.

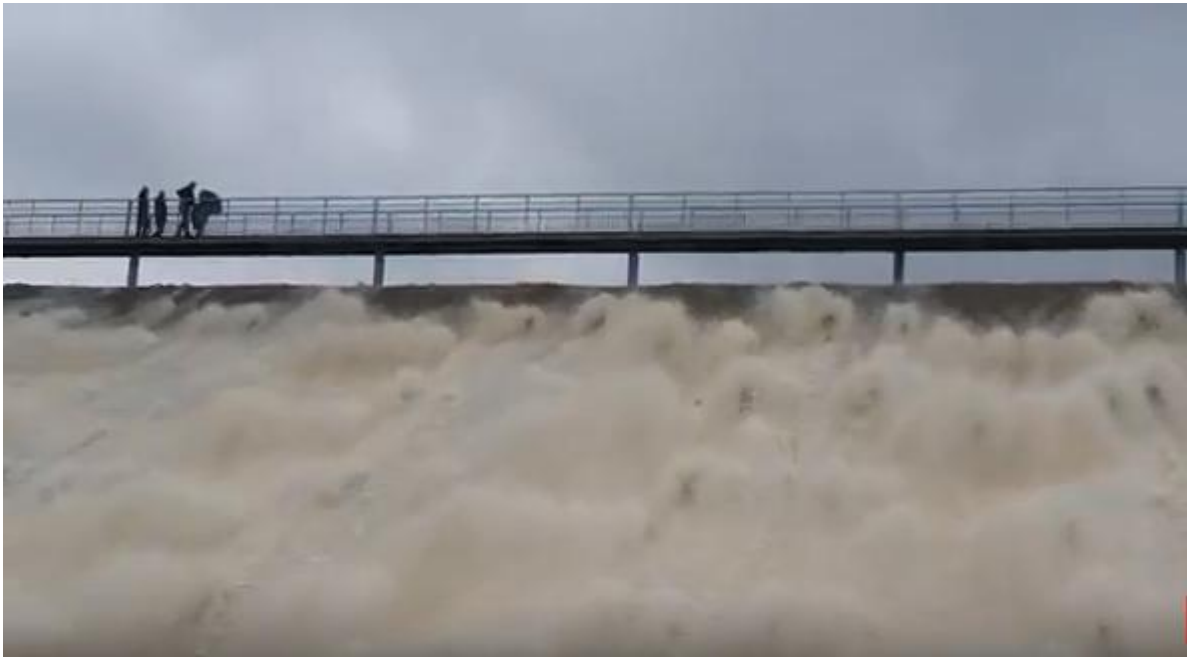
**Photo 5 (above).** Photo taken before the panels were lifted by water from underneath, (probably Wed. 31 July). Many people and their children came to experience the excitement of the power and noise of this unique waterfall. The dark lines in the water are heads of weeds amazingly able to disturb such a powerful water flow. All the other raised 'mounds' are possibly caused by the implanted stones. The weeds and stones may have been successful in creating useful directional chaos to absorb energy but now the CRT has removed most of them.

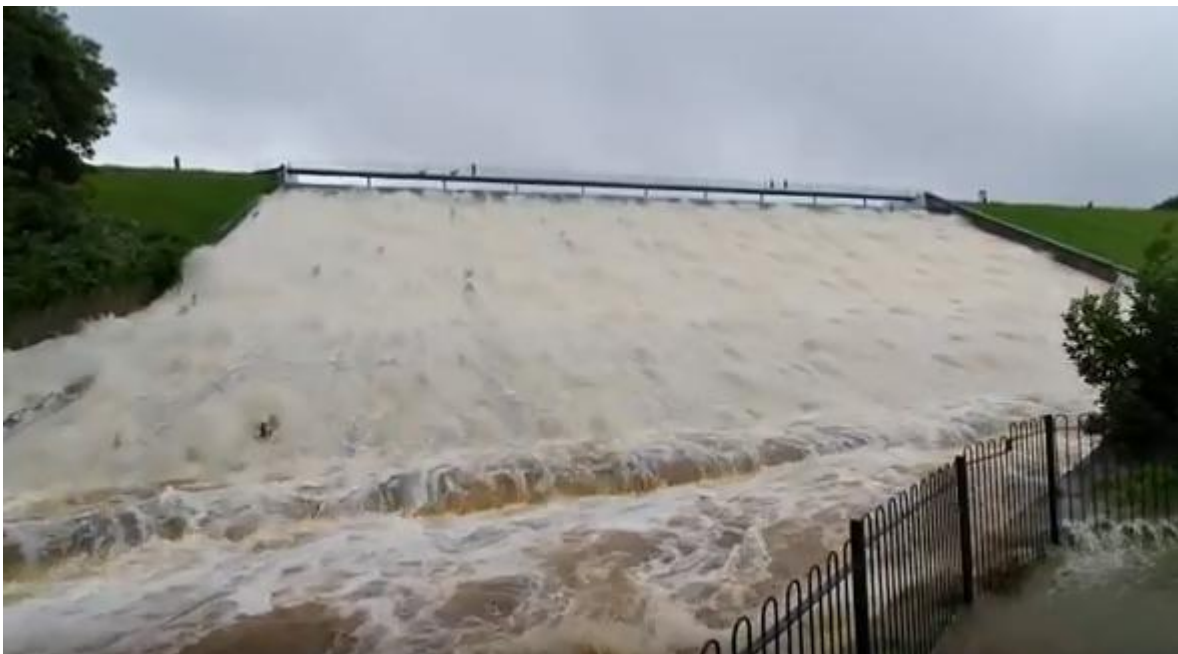
**Photo 6 (above).** The foot of the spillway before the panels were lifted and smashed. The Bypass channel in the foreground is hardly distinguishable. Water has overflowed onto the unprotected earth dam at the side wall on the LHS which for some unknown reason is lower than the RHS wall.

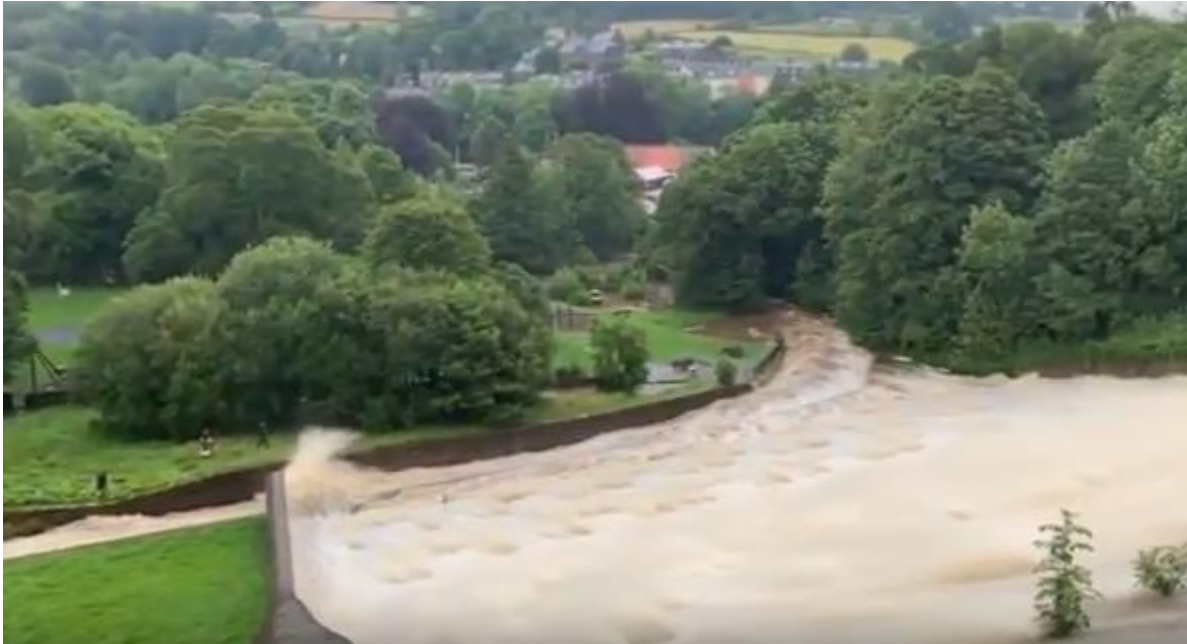
**Photo 7 (above).** The RH side of the photo shows the congestion and back up caused by the Bypass water hitting the River Goyt at right angles, in virtual opposition to its flow. This actually caused the Goyt to back up which then caused the nearby Randal Carr Brook to back up which drains the Coombs Res. Considerable damage occurred to the Randal Carr. The Bypass channel junction with the river should be re-engineered to remove this contention so that the Bypass and the Goyt converge and merge in the **same** direction.

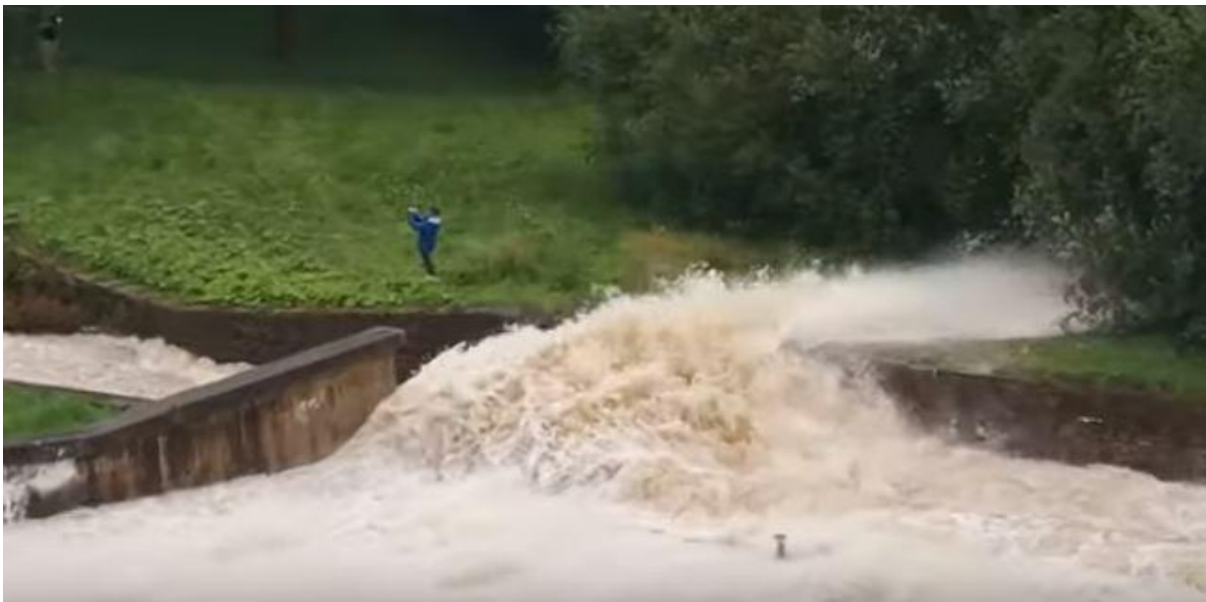
**Photo 8 (above).** At the LHS the flow jumps across the bypass channel and takes a short cut under the trees, across the playground and footpath to reach the Goyt. This is caused by the flawed design of the spillway, which is narrower at the bottom and offset from the top. Photos 7&15 show that the LHS side wall changes direction considerably to try to steer the flow but water cannot be compressed and the contention shown here is the result.

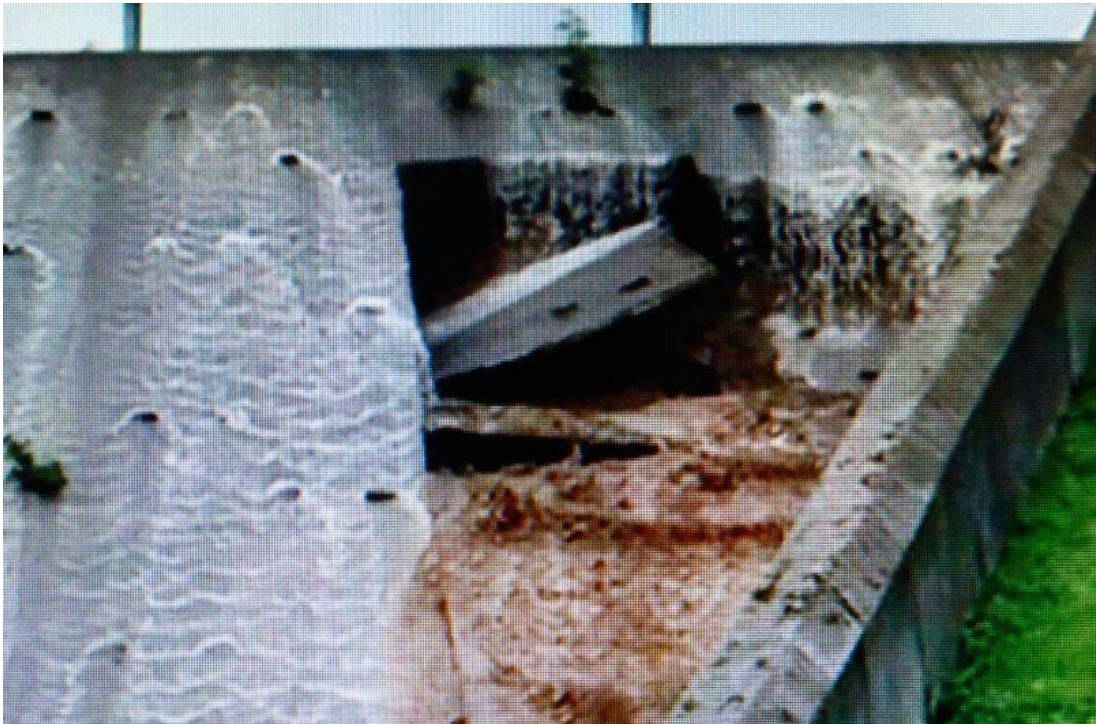
**Photo 9 (above):** Spillway below Gaps 1 & 2. It was probably taken late on 1 Aug., after 36 hours of the massive flow. Here the water is still over flowing, the first panels have snapped and collapsed into the deep hole caused initially by water flowing underneath the Apron.

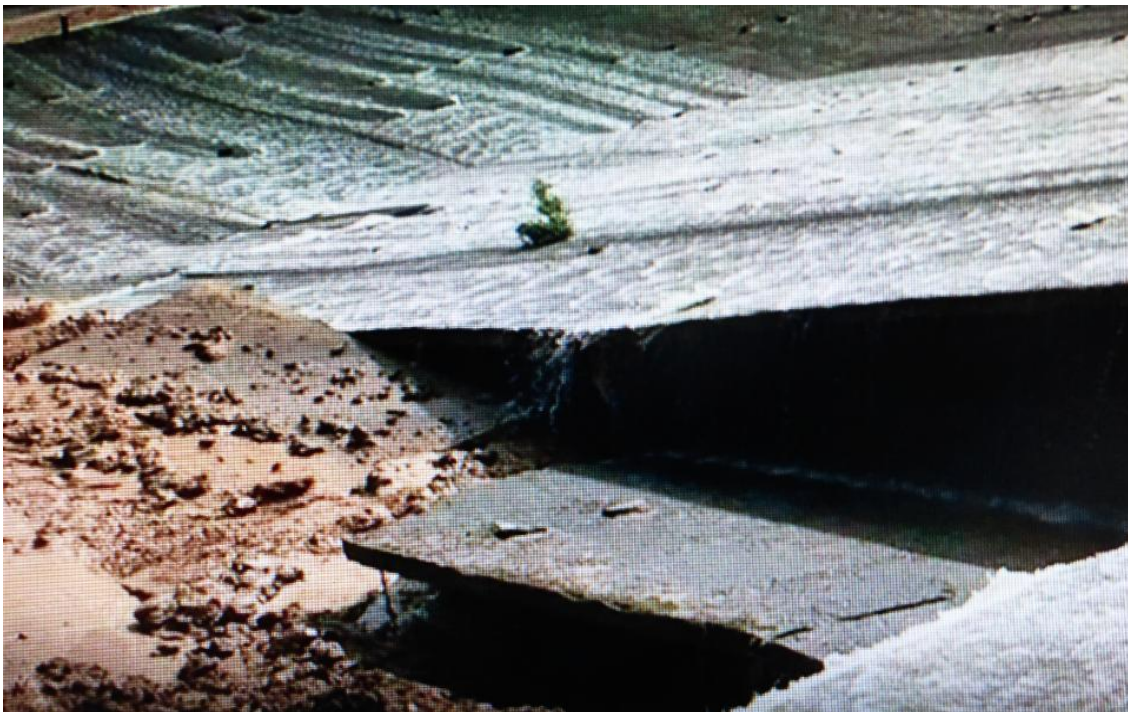
**Photo 10 (above) :** As in Photo 9 but taken from the footway looking down, showing the big empty cavity underneath adjacent spillway panels to the right where more of the clay core has been excavated which will lead to the further collapse seen in photo 11.

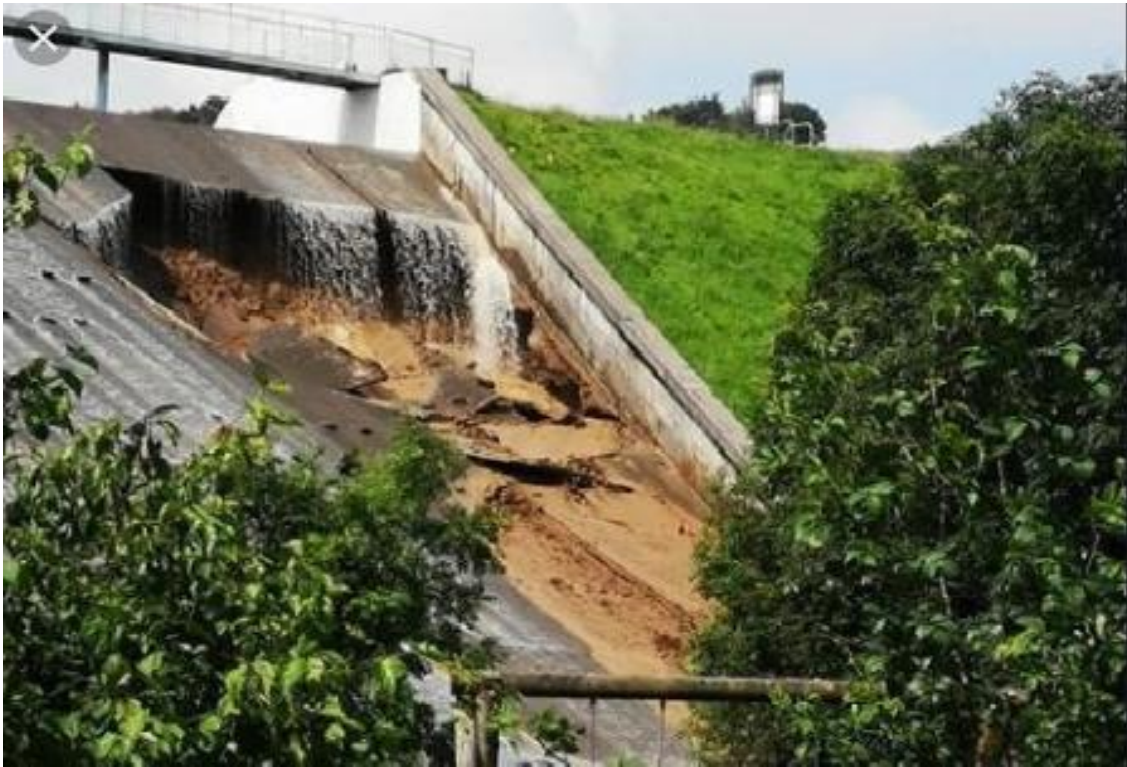
**Photo 11(above) :** More panels have dropped and the appalling inadequate footings of the side walls are exposed.

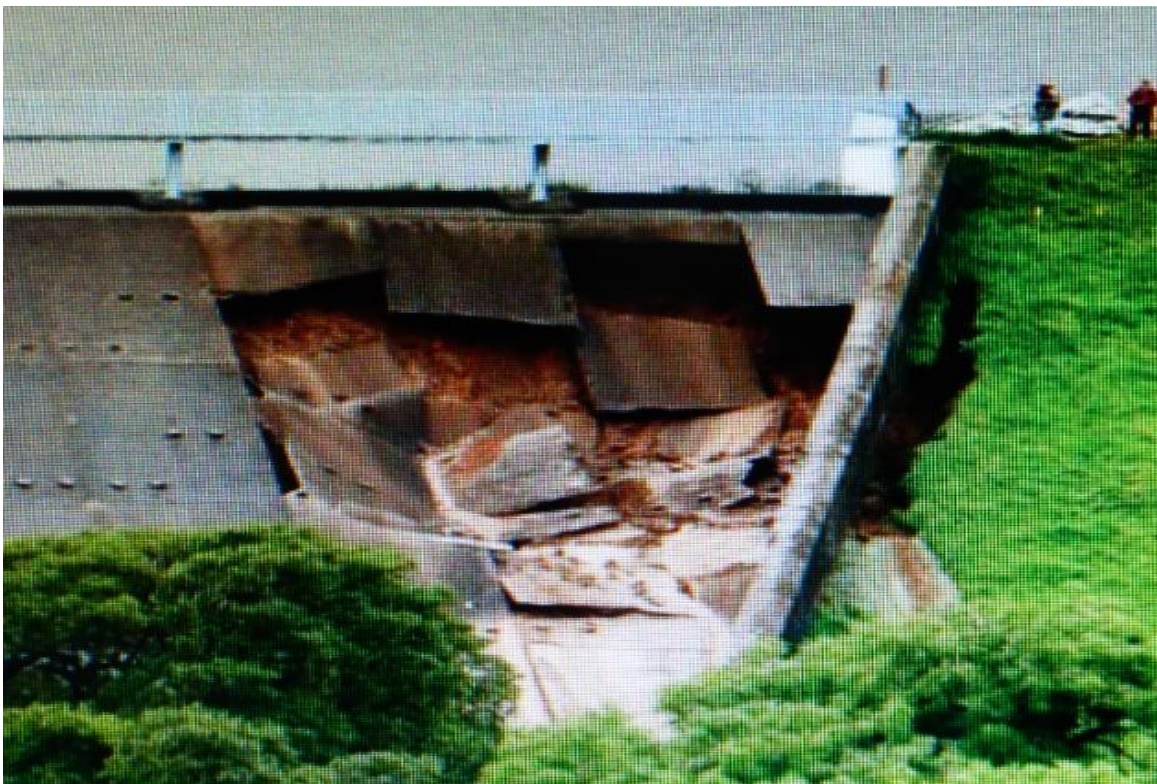
**Photo 12 (above):** The Gap 2 spillway panels have now both snapped in half and fallen into the empty void. Thin sheets of concrete without metal reinforcement and weakened by minimal water in the concrete mixture when cast are especially brittle and can easily be snapped.

**The upper spillway panels seem to have snapped in half along approximately the same line. Perhaps an inherent weakness already existed due to the 'turbulence' stones inserted in straight lines across the panels which will assist snapping along the same (dotted) line. Or perhaps their top half was supported whilst the clay beneath the bottom half was washed away. The immense weight and pressure of water would subsequently load the unsupported panels and snap them along the line of greatest weakness.**

**The concrete of the spillway panels is of poor uncontrolled variable quality , they are too thin for their large area, have limited tensile strength and are not reinforced.**

**The collapse of over 9 spillway panels into a deep cavity indicates the extent of the huge loss of clay & earth core underneath.**

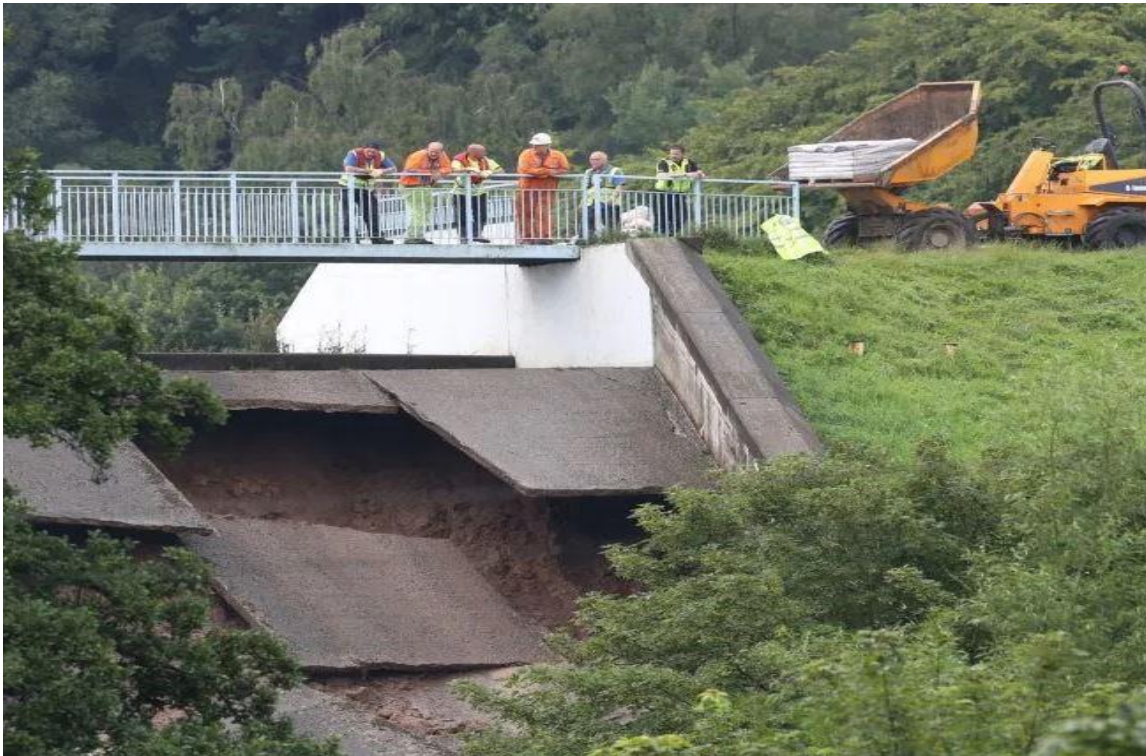
**Photo 13 (above).** A early picture taken not long after the flow has stopped. There is a significant large cavity under the RH spillway panel where the wall footing was undermined.

Concern for this particular vulnerability of the dam might explain why two pressure sensors were fitted just at the other side of the wall about 1 m apart. The two white stubs in the grass at the top of the wall in both Photos 13&14 are the pressure sensors.

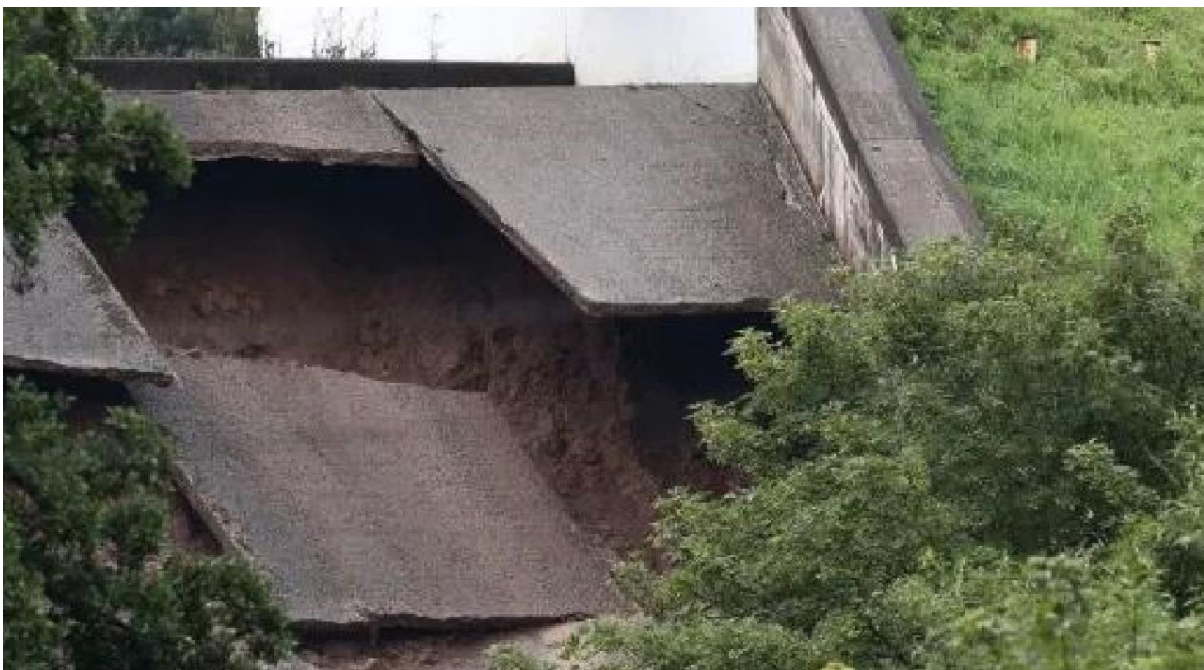
**Photo 14 (above).**

It is probable that the abutment wall footings at the top of the dam have always provided the major weakness for water erosion channels to develop. This is the region of maximum pressure on the dam, where the spillway panels have always been wet and where water was seen by me bursting through the panel gaps, pulsed by waves on the reservoir hitting the underside of the

apron. The footing for the abutment wall requires a trench which crosses the whole dam section much deeper than the Apron and Spillway and therefore provides a direct route for a water erosion channel to follow. In addition this deeper trench is more frequently below the water level.

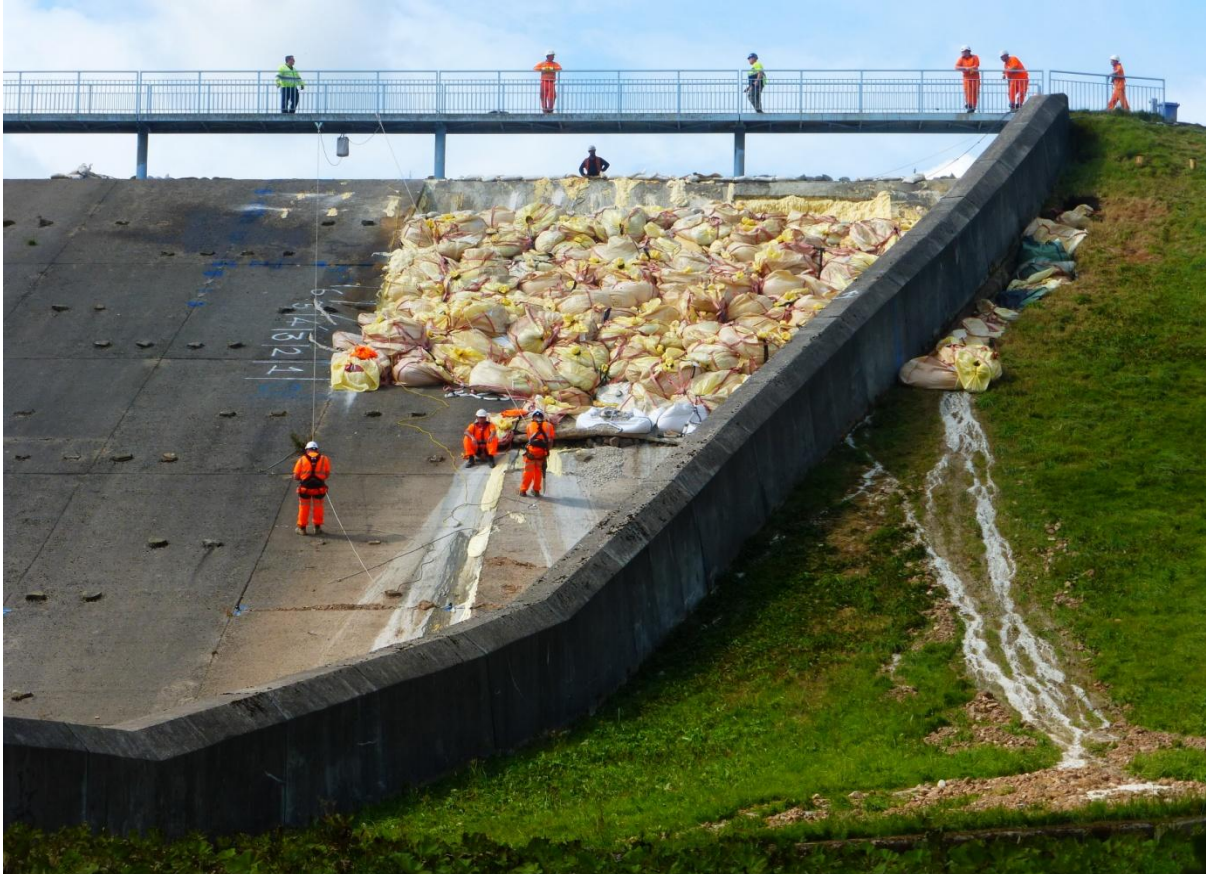
**Photo 15 (above):** This important photo provides the evidence of the undermining of the side wall at the top and the reason for the big cavity shown in Photo 13 on the other side of the wall. Videos on 31 July showed a spectacular tall fountain about 25 ft. high bursting out at the earth side of the wall at the top where the bags have filled the slot now.

Obviously the footings of that wall are ineffective and vulnerable. They provide another serious indication that the concrete overflow structure was an ill judged mistake fraught with numerous flaws which could not be demonstrated because the operation of the spillway could never be tested.

The deep trail of stones and clay in the foreground on the grass has come under the wall from the core of the dam.

The wall is supposed to contain the flow and protect the rest of the vulnerable earth dam but it failed. There is an overwhelmingly strong case to disable and remove the spillway as described in much detail in Ref 1.

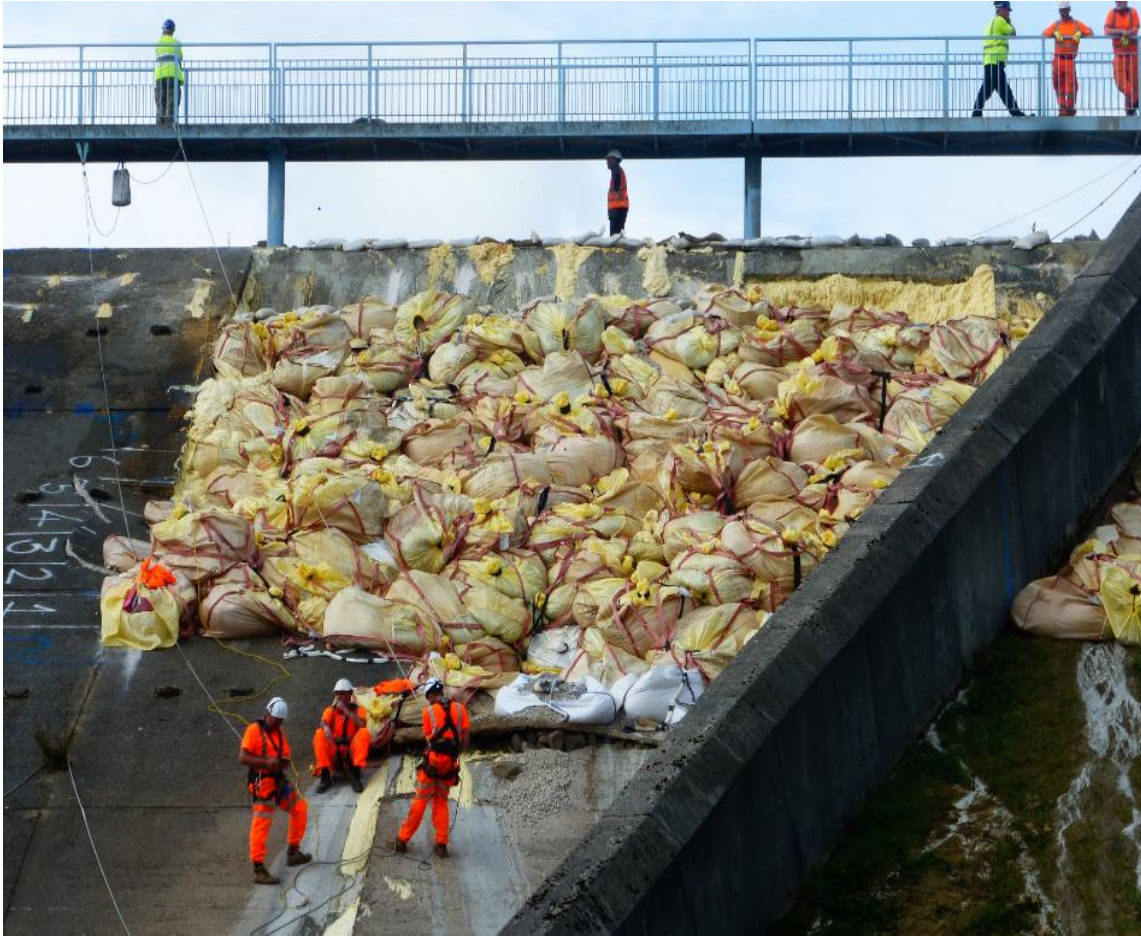
**Photo 16 (above):** The Bag Drop is complete. The volume of missing clay under Gaps 1&2 has been replaced by about 500 one tonne bags of stones and aggregate. If the volume of each bag is only 1 cu.m, the dam would have lost at least 500-600 cu.m of clay core and earth embankment material. These figures of considerable depletion contradict official claims that the clay core has 'not been damaged'.

In addition the extent of other water erosion cavities under all the other panels of the Apron and Spillway which were not lifted by the flood is completely unknown because no forensic examination has taken place.

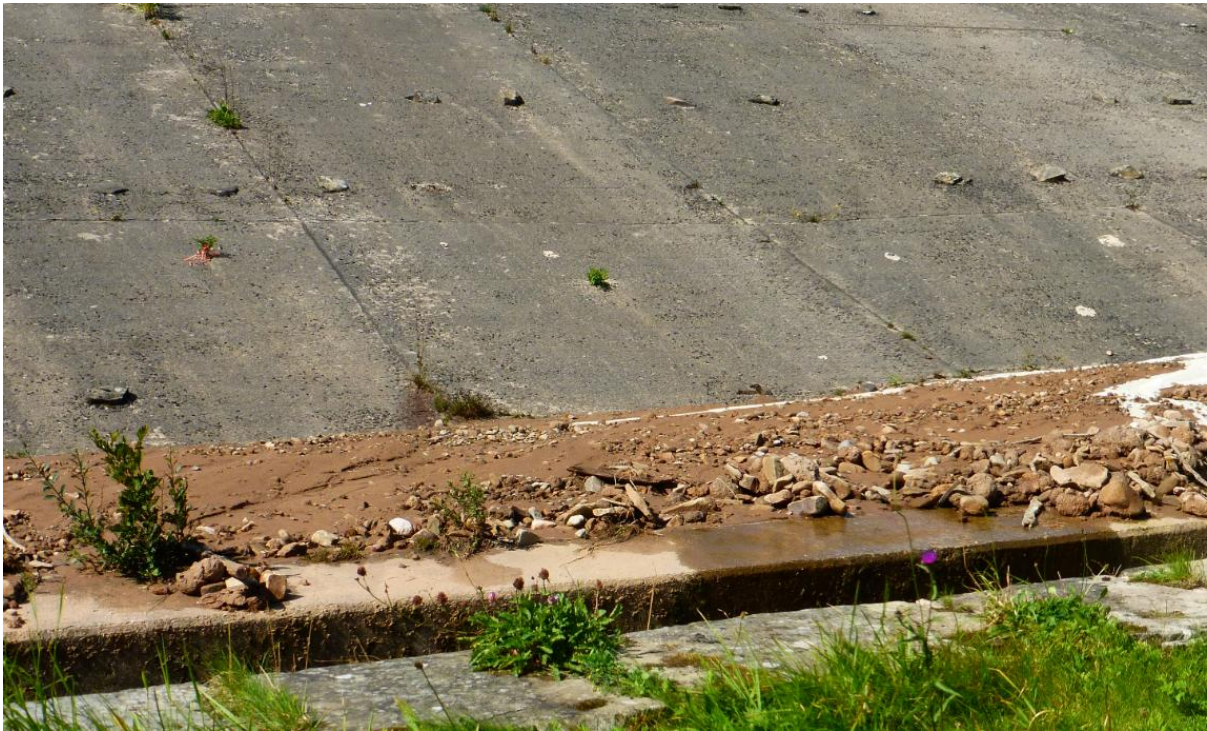
Photo 17 above & 17a. Some of the clay core on the foot of the spillway, the rest went into the Bypass and then on to the River Goyt.

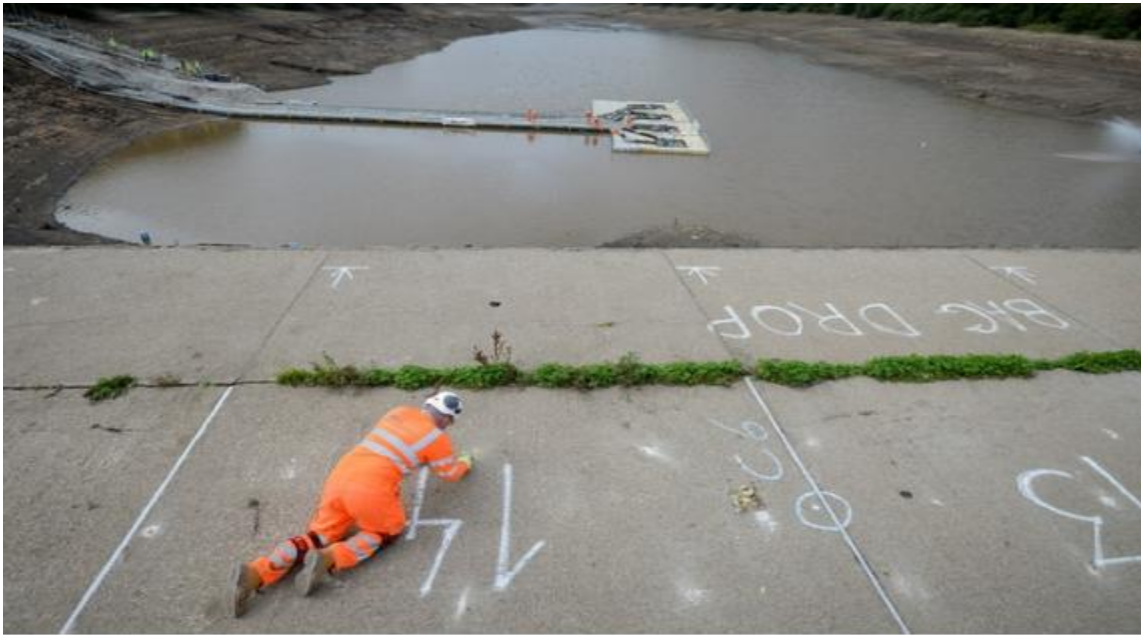
**Photo 18 (above).** *Grouting the Apron ?* All the middle Apron panels have been given numbers. There are 2 Apron panels spanning each Gap, (except that Gap 1 has 3 apron panels).

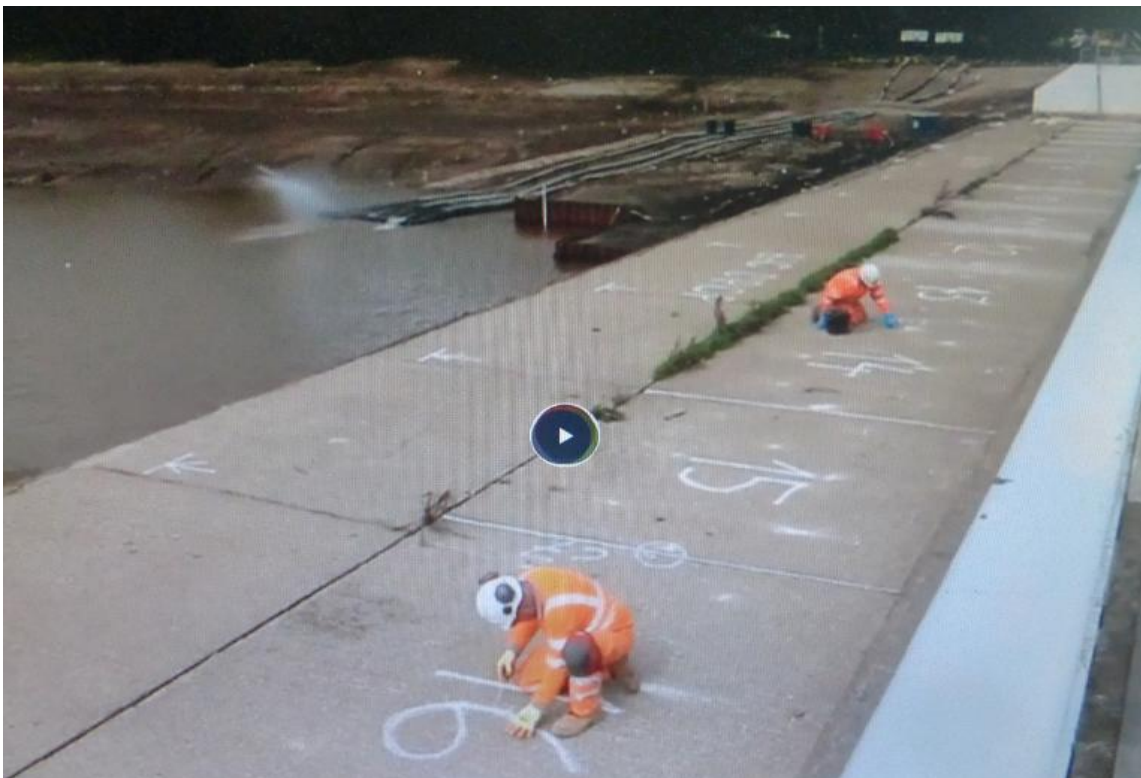
**Photos 19 (above).** The men appear to be filling small holes with grout but only in the mid apron panels. These may be inspection holes drilled deliberately in the hope that a camera would reveal an erosion channel if the hole happened to have been drilled in a

'lucky' place. They are also grouting some of the inter-panel gaps, but only the mid panels

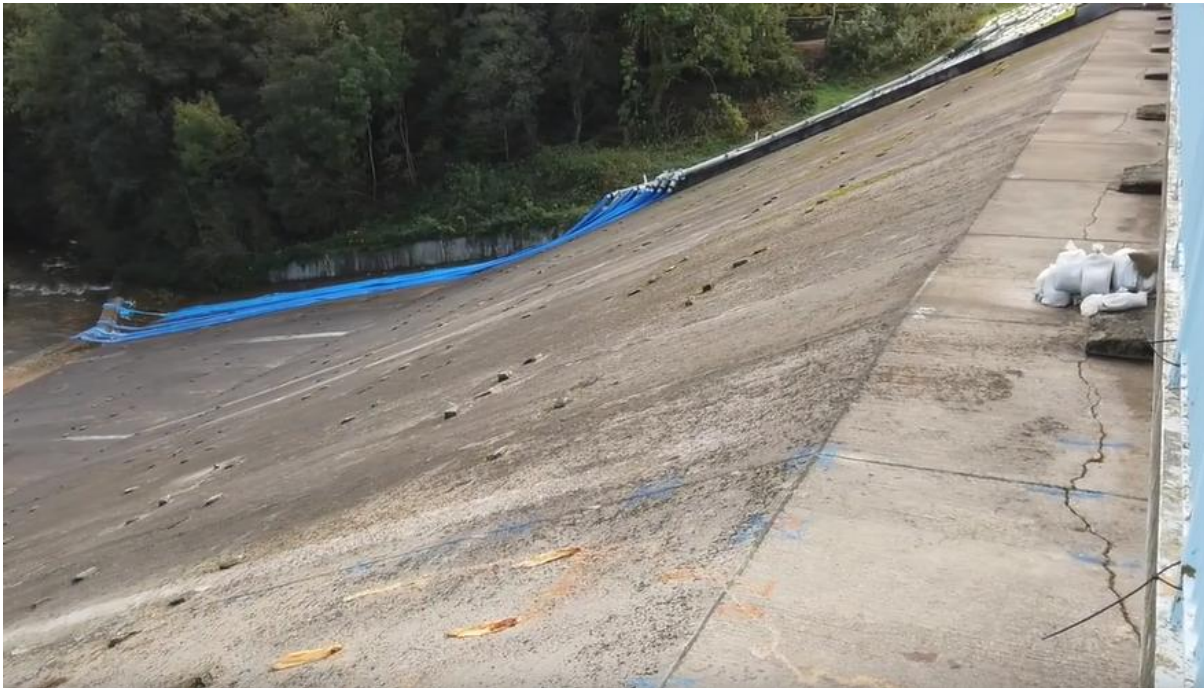
**Photo 20 (above).** Whilst reviewing the images and videos on the internet. I found this image quite by chance in some background footage on a drone video made by Foxes Afloat . It shows that there is a continuous crack which extends across several Apron panels. By counting back from the far wall Gap 3 is located in the immediate foreground of photo 20. The group of white sandbags is at the start of Gap 4 (covering up some of the crack). The regular raised slabs of concrete along the RH edge of the photo are the footbridge post footings which stand on the apron and define each gap. The blue handrail is just visible above.

Careful study of Photo 20 (and other video footage) shows that the crack extends into the distance to half way across Gap 8. It is very probable that the crack originated in Gap 1 when the major spillway damage occurred although there is no picture to confirm this.

The conclusion is that there is a long virtually continuous crack in the concrete panels which extends right across the Apron from Gap 1 to half way across Gap 8. This means that 75% of the Apron has been severely damaged by considerable forces which must be explained and reconciled with any future functional use of the ill considered concrete spillway. Given that the footway is 200 ft. long then this crack will be about 150 ft. long.

The crack is continuous across adjacent panel boundaries (Photo 20&21) and it always passes in front of the Footway Legs. These are important facts. The path is independent of individual panels, but is defined by something which all panels have in common, like perhaps a long empty void under the Apron allowing them to snap when loaded ?

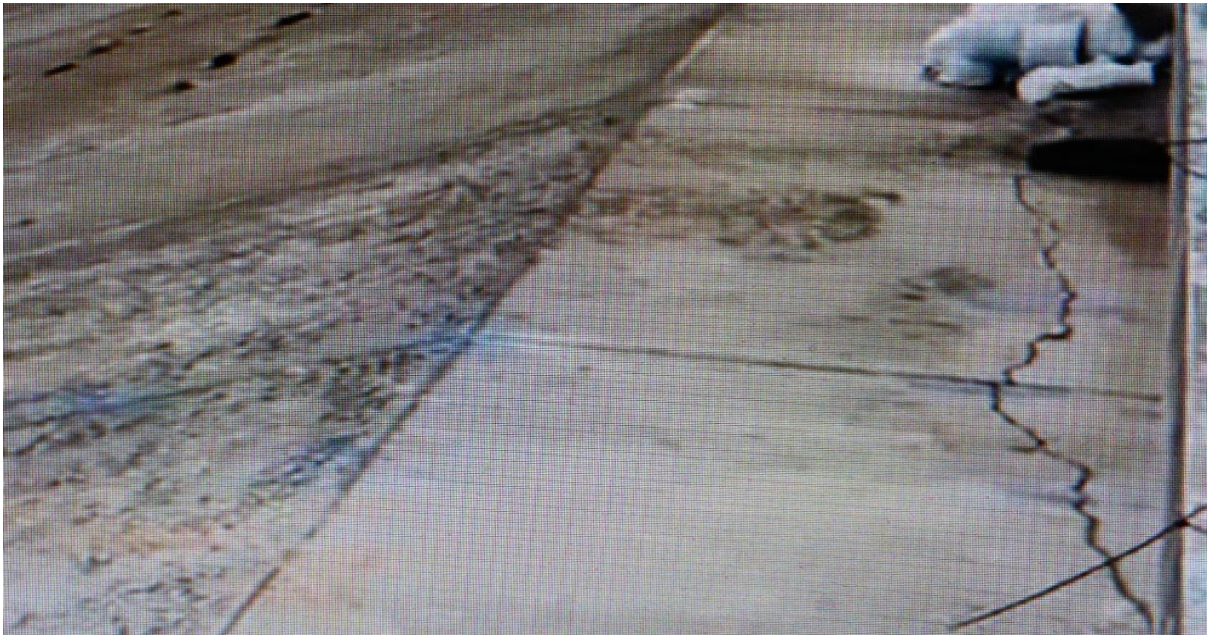
**Photo 21 (above).** Close up of the crack crossing Gap 3. Blue stripes at right angles to the crack and across panel boundaries on the spillway indicate a recent CRT investigation perhaps with expansion gauge pieces to check for relative movement. This crack was not there before the incident because it would certainly be visible to anybody who paused virtually anywhere on the footway. Later images show that this crack in the Apron has been filled with white grout !

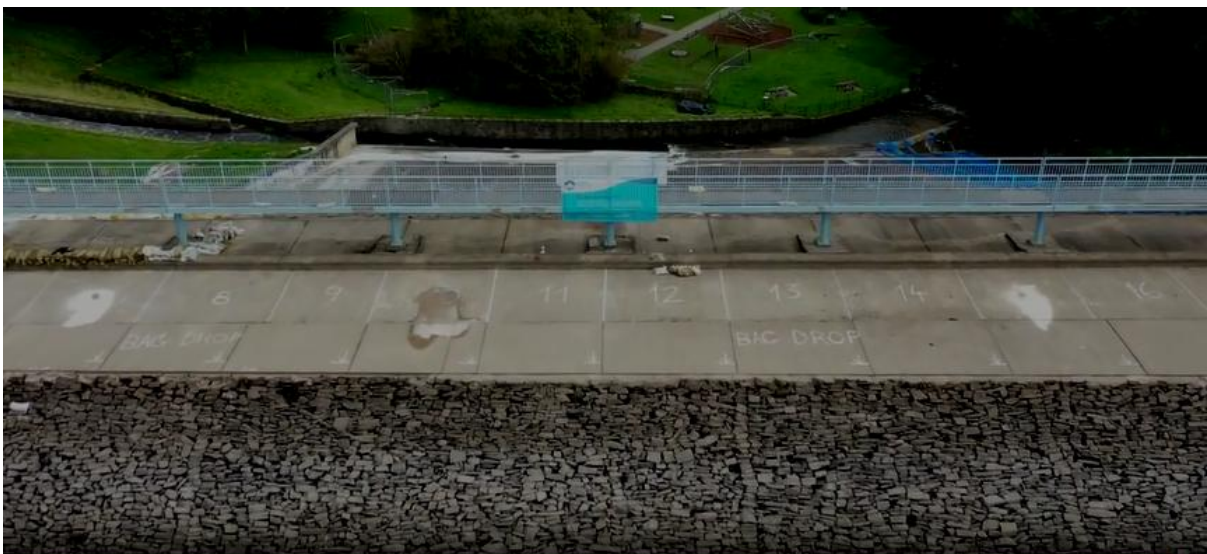
**Photo 22 (above).** Photos 22 & 23 are an attempt to demonstrate the length of the crack. To the right of the photo, Apron panel 16 is the first of the pair in Gap 8. Above panel 16 on the far side of the footbridge there is a smudgy white line on the far apron panel. This is the far end of the crack. This winding smudgy line can be followed to the left across the picture, note that it always passes on the far side of the support legs. This is the track of the crack.

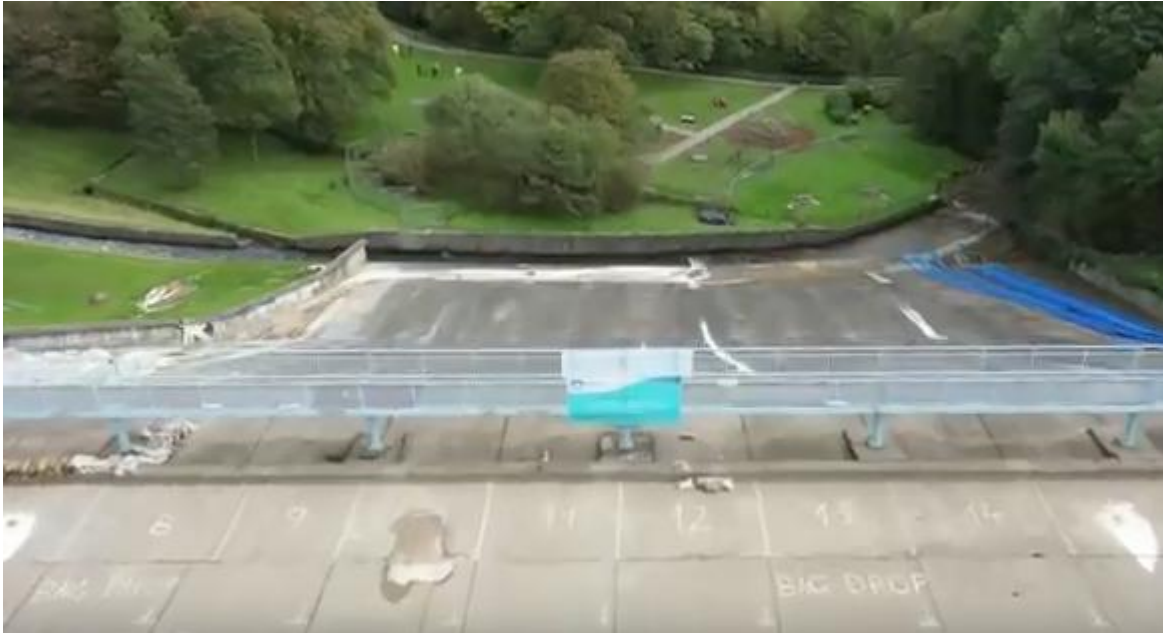
**Photo 23 (above).** This is the same photo with different contrast and brightness which may help to show the line of the crack as an indistinct winding white smudge on the far side of the footbridge. The reason for the whiteness is because there has been an attempt to fill it with white grout and this has been smudged onto the adjacent concrete.

A continuous coherent crack 150ft long on the multi panel Apron indicates a serious structural loading which must be analysed and explained. This crack must not be covered up as if it was just a cosmetic blemish.
