## Analysis of the Damage to the Toddbrook Dam.

Graham Aldred B Sc.(Eng)

15 Dec 2019

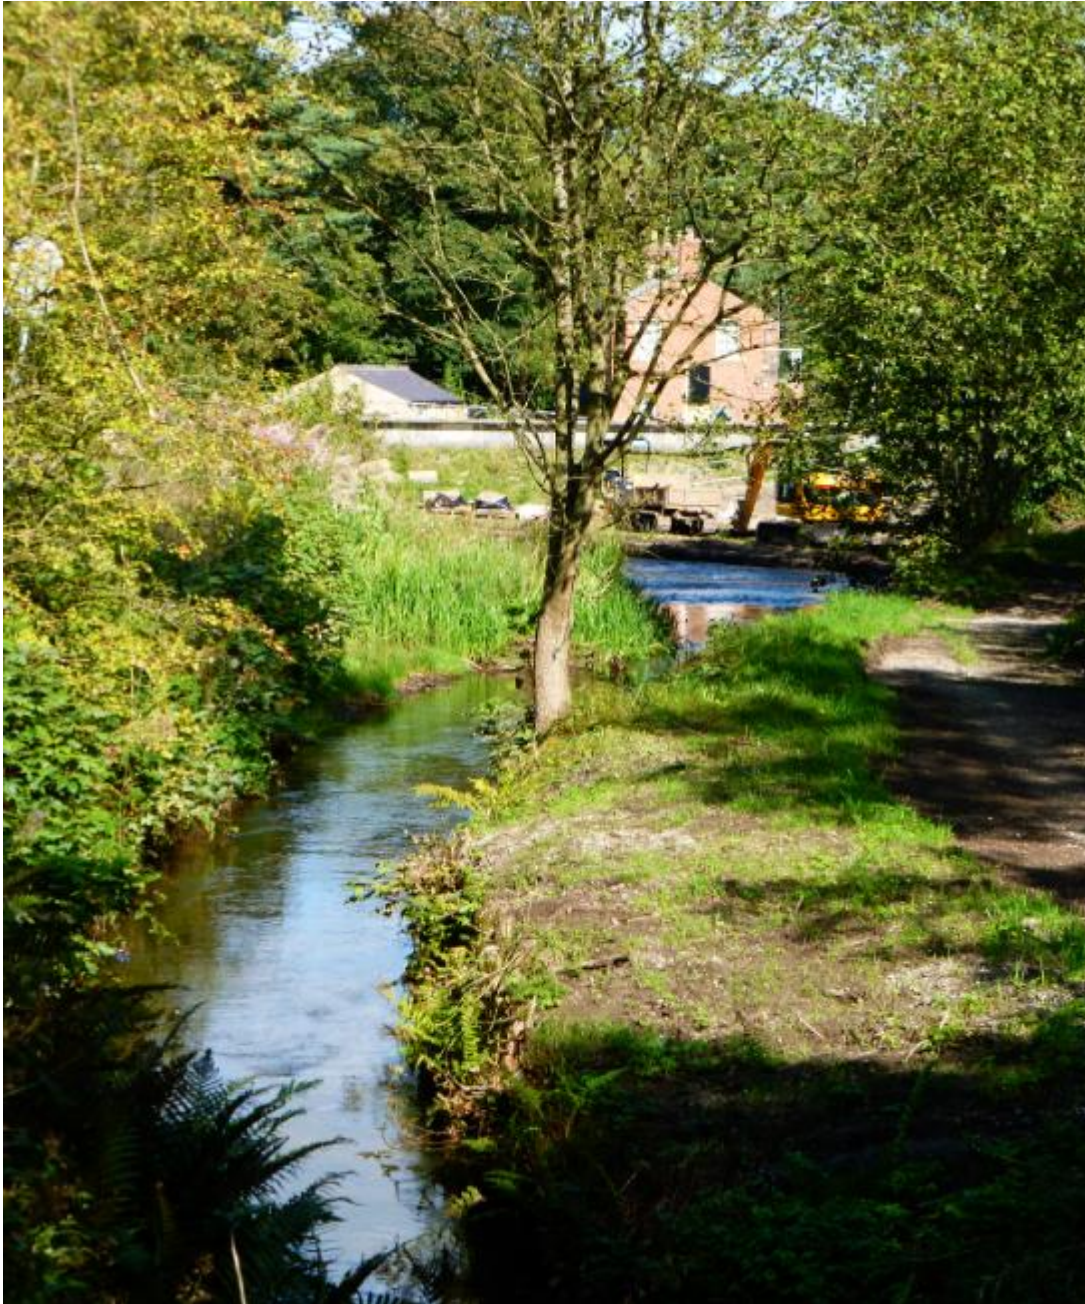
**Photo 1:** The Bypass Channel approaching the Convergence Basin. This channel should be wide and straight. Never maintained for over 20 years, it has been allowed to contract to half its constructed width by mud banks and weed growth. The safety of the Reservoir depends fundamentally on the flow rates that the Bypass channel system can achieve. This was the state when the dam was damaged.

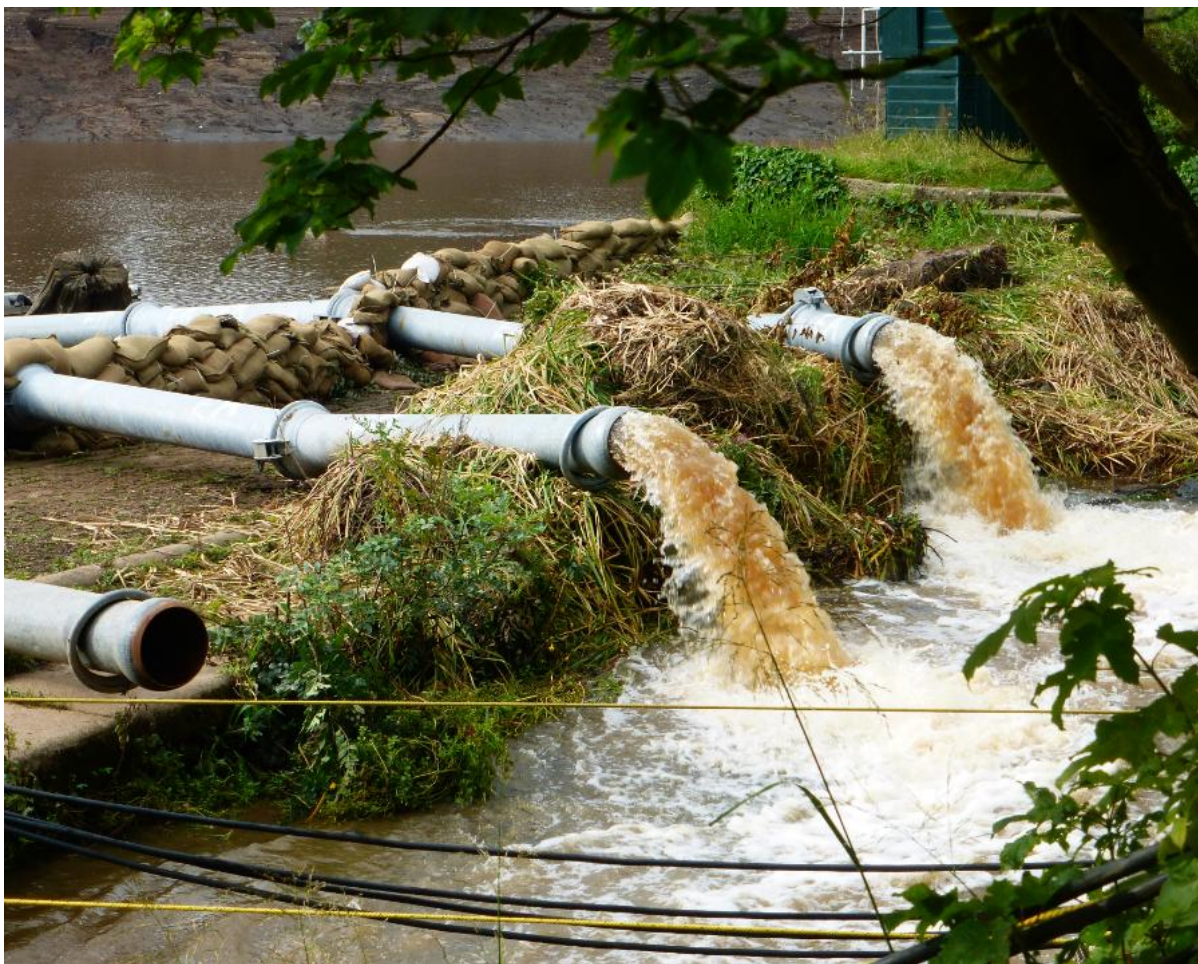
**Photo 2:** Pumping out the reservoir, showing a pile of weeds and mud obstructions which had to be removed initially from the Basin by the Emergency Team improve the flow when desperately trying to empty the reservoir.

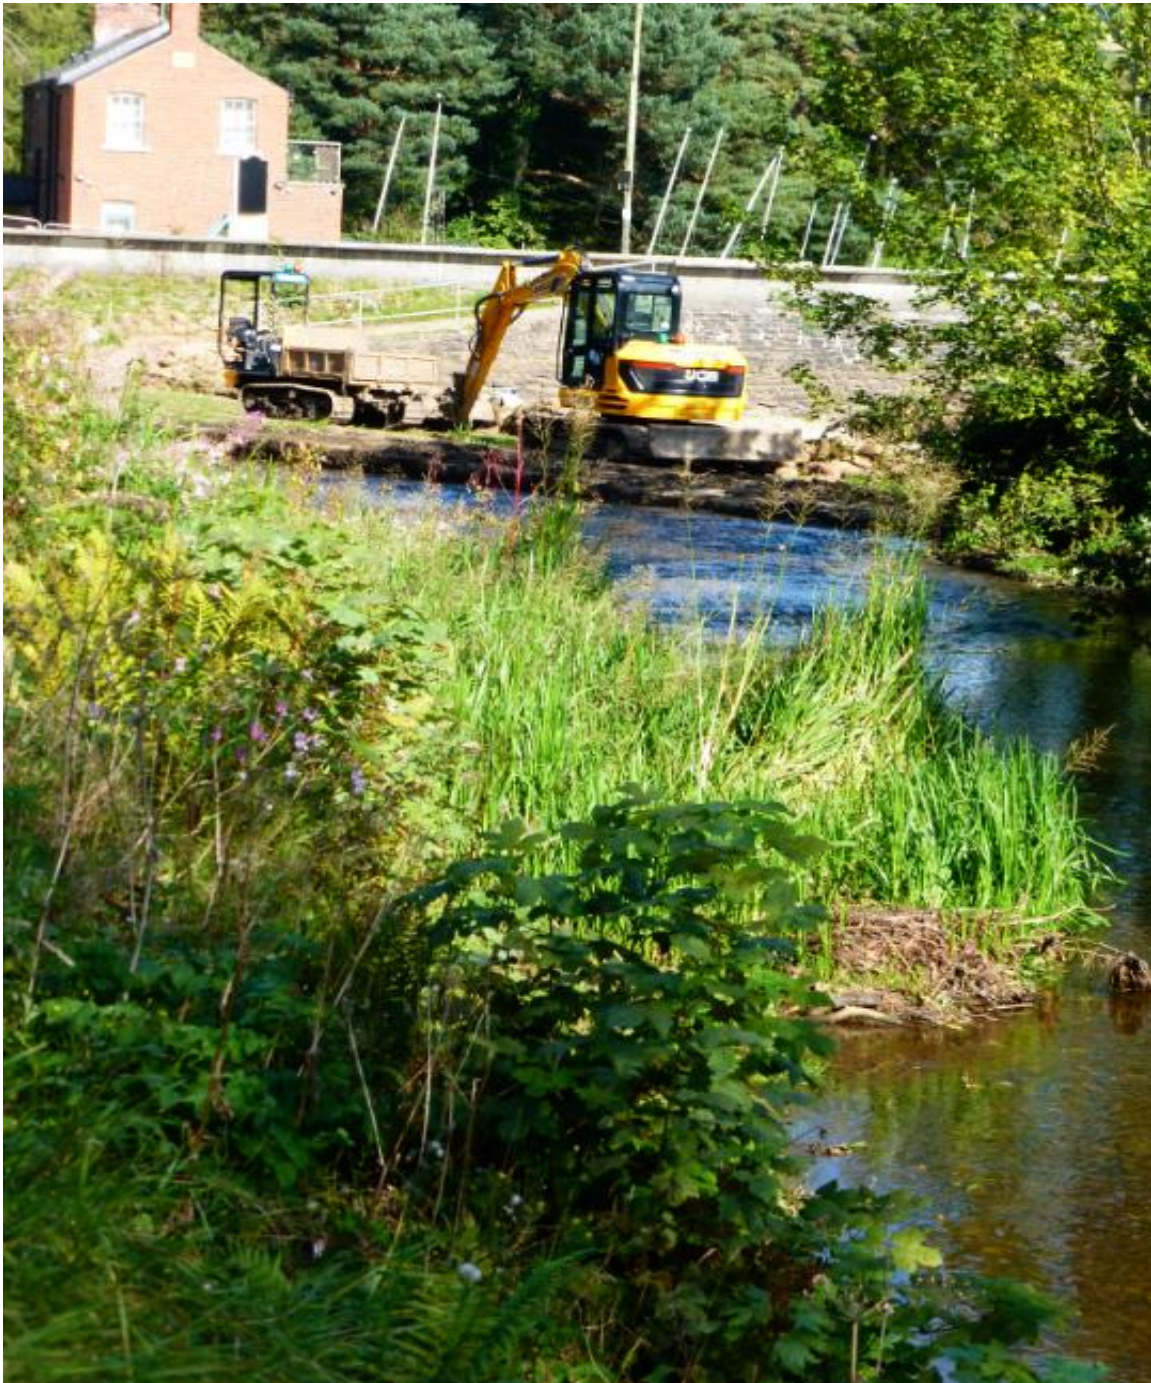
**Photo 3 :** A typical mud bank and weed obstruction in the Bypass..

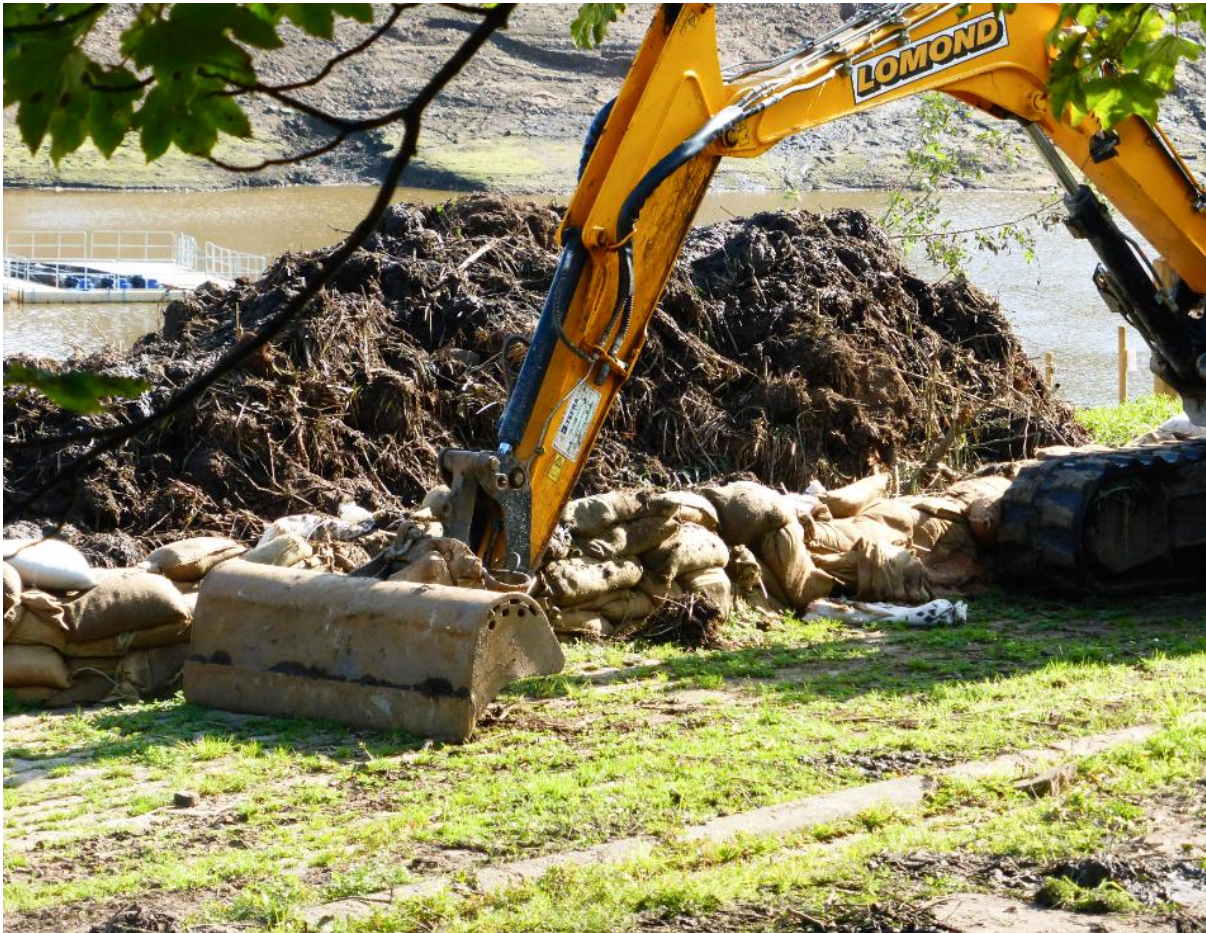
**Photo 4 :** Some of the many tonnes of mud ,weeds and stones that were dug out and removed from the Basin and last 100 m of Bypass channel several weeks after the incident. All this material unnecessarily occupied precious volume in the convergence basin during the flood and impeded the flow as the reservoir tried to drain over the primary Cill. The pile of mud is a measure of the consequences of not doing any routine maintenance to the Basin for over 20 years.

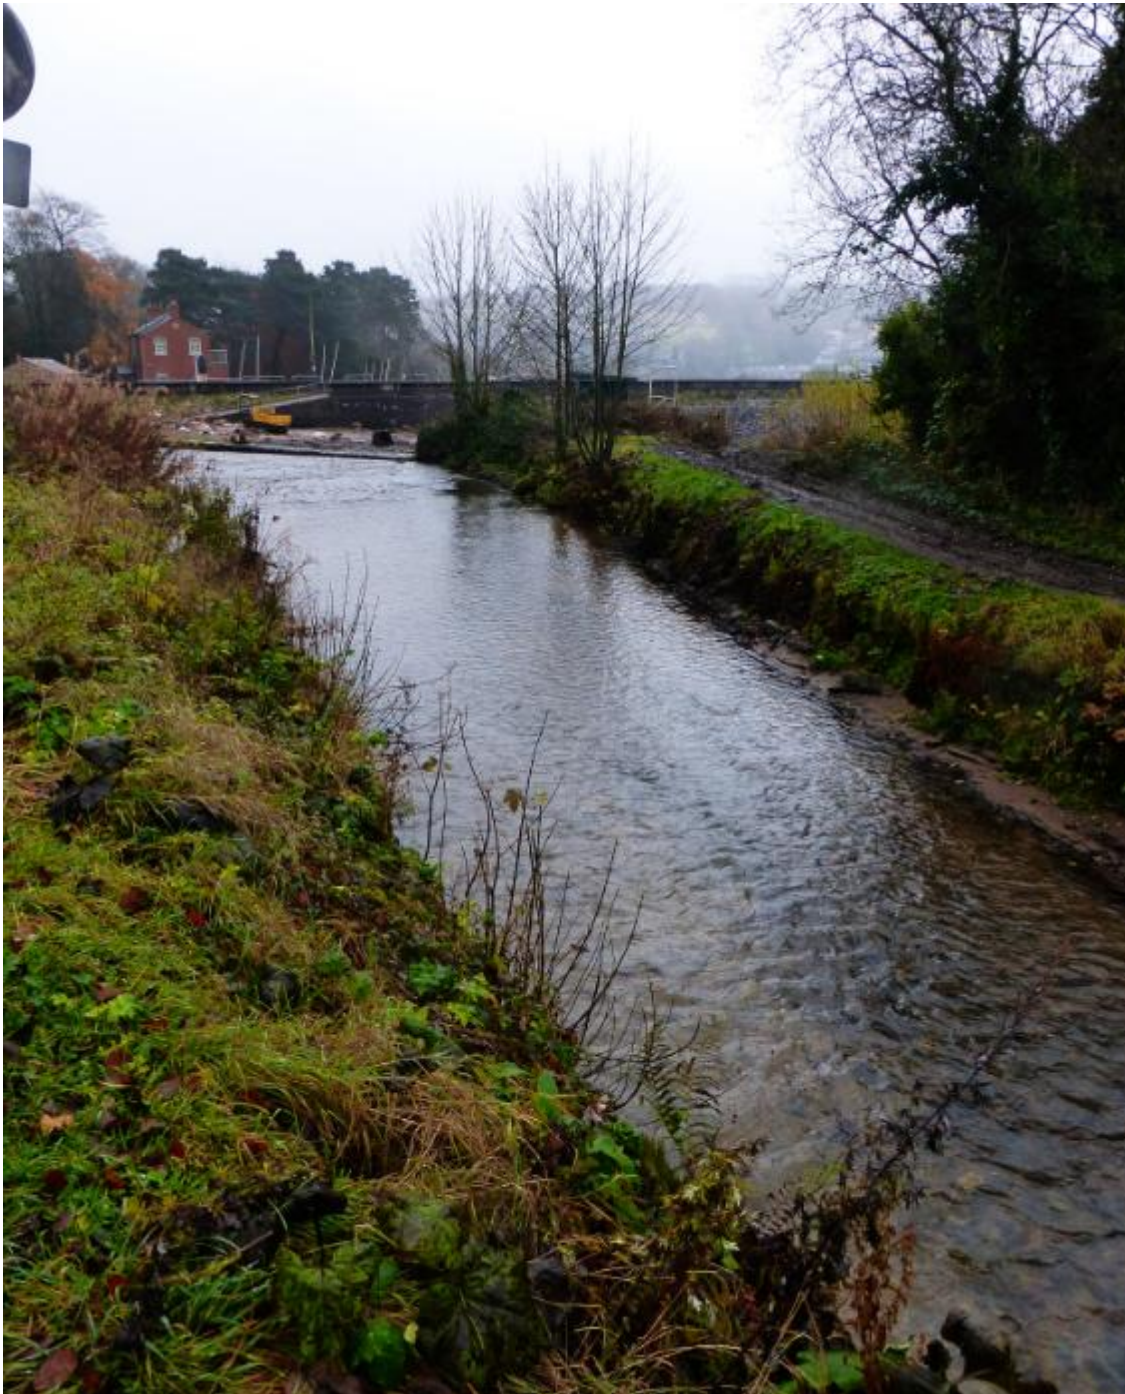
**Photo 4:** This is the Bypass channel that appears in Photo 1 but seen now (Nov.) after being properly and thoroughly cleared of all the mud banks, weeds and vegetation. It is more than double the width with nothing to choke or obstruct the flow. The Bypass now looks like the functional canal that it was engineered to be 180 years ago.

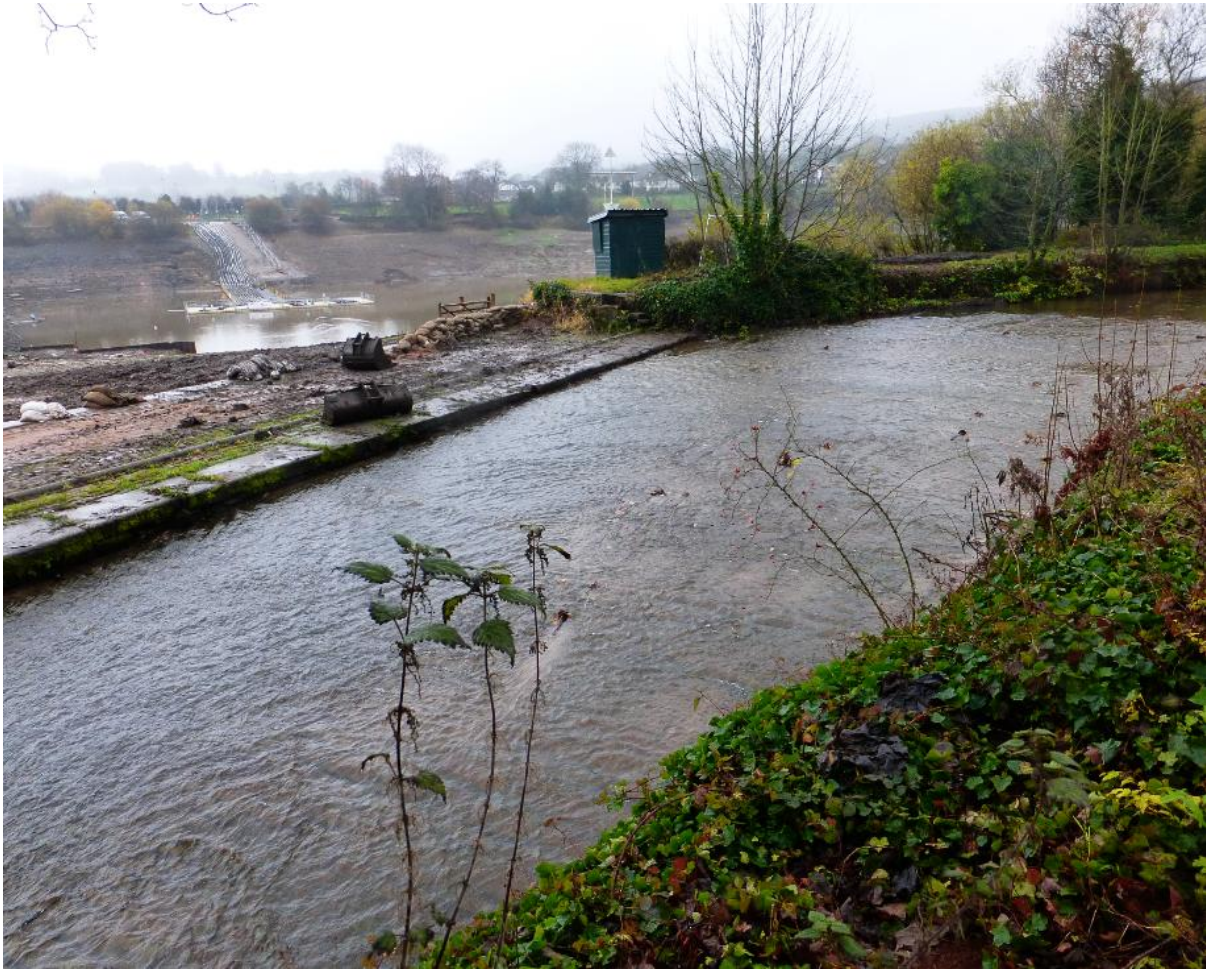
**Photo 5:** The 'Convergence Basin' now belatedly cleared of all obstructions (Nov). This is where Bypass water and Reservoir overflow water have to converge so maximum capacity here is crucial. There was massive congestion this year during the incident caused by allowing the reservoir to overflow and the loss of capacity caused by numerous mud banks and weeds.

But clearing out the Basin and Bypass is not enough, it will not alone guarantee future safety unless there is a resident reservoir keeper or a reliable hi tech alarm system to initiate full discharge actions to prevent overflowing. If this Basin was deepened here there would be no requirement for the dangerous and ineffective concrete spillway over the top of the earth dam to be repaired or replaced. ( Ref1)

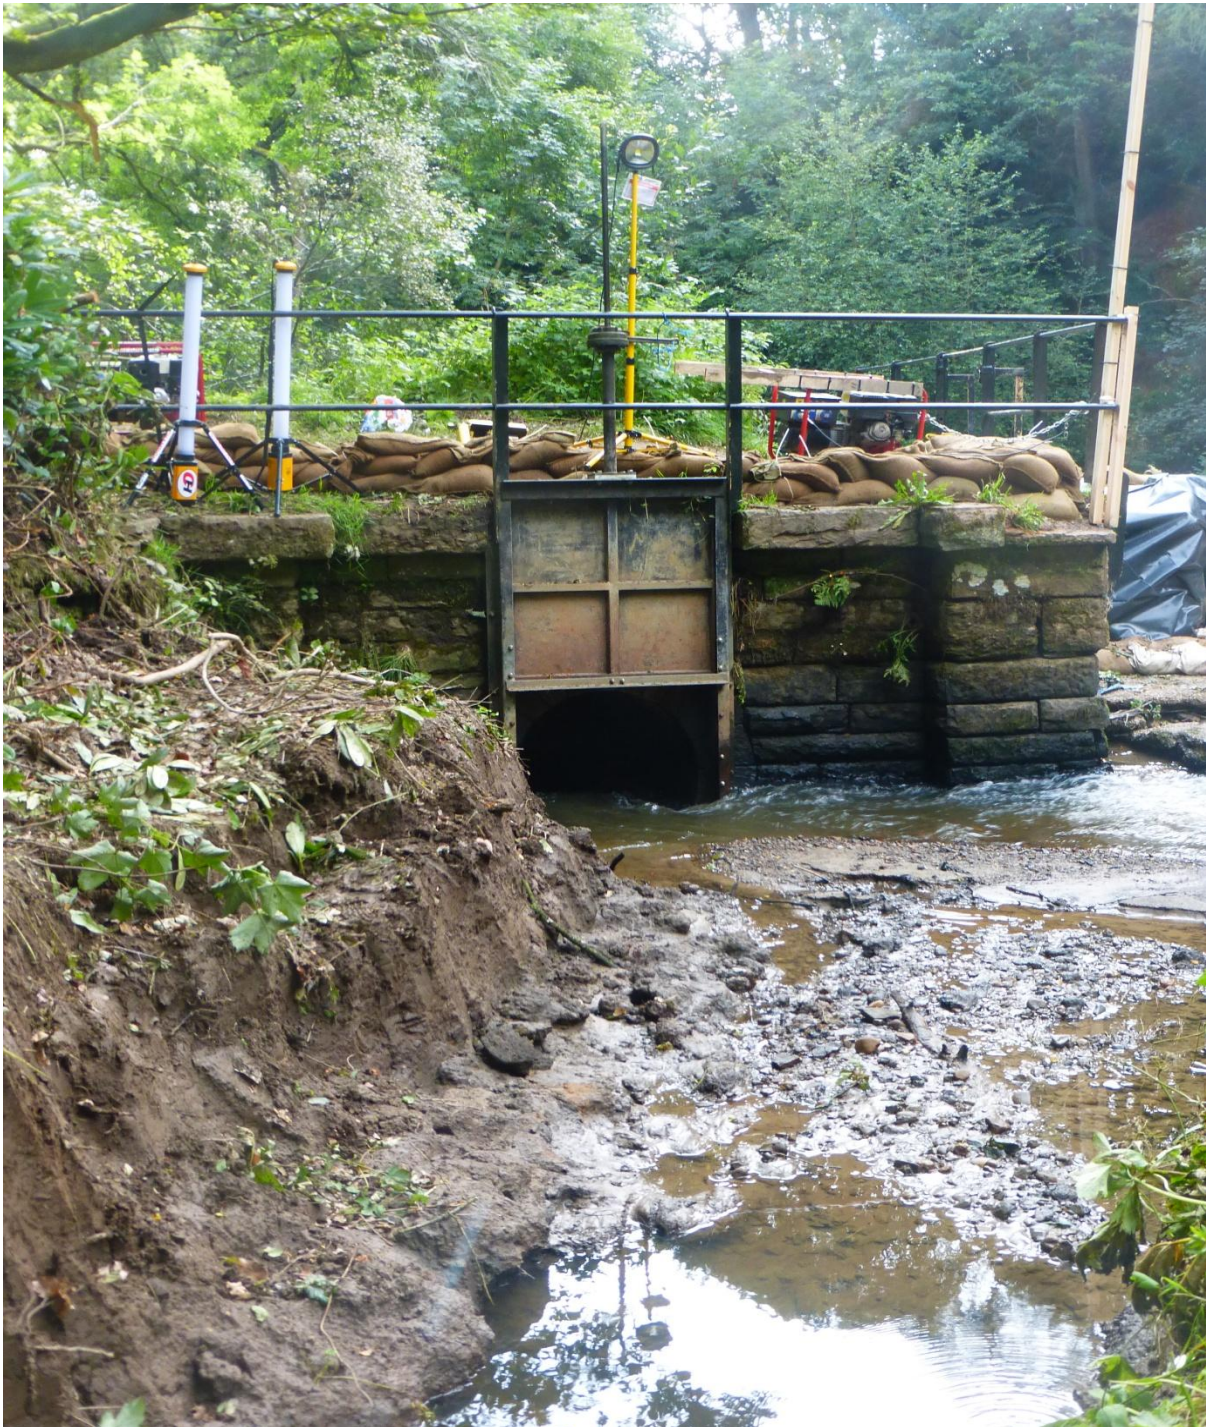
**Photo 1:** Taken 8 Aug after no rain for a week and the reservoir had been virtually drained showing the Bypass Gate had been raised for max flow to the Bypass Channel. I saw that this gate was virtually shut (6in.) and locked on 1 Aug. after the damage had started. Therefore most of the Todd brook had flowed into the reservoir and overflowed it for the last week of July.

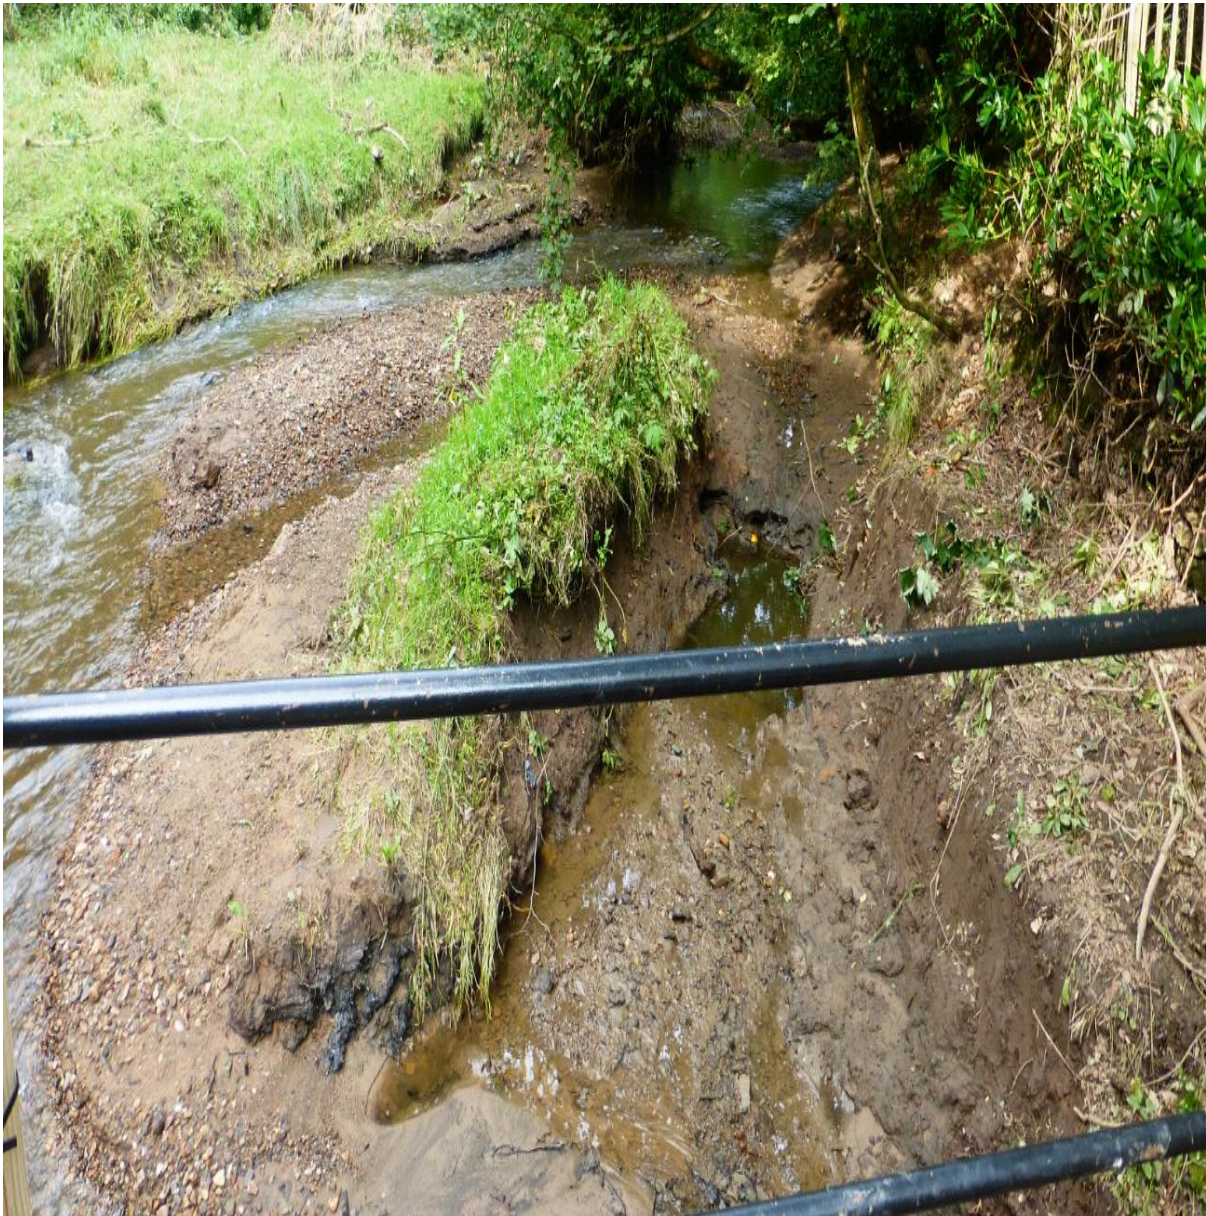
**Photo 2:** Looking up stream from above the Bypass gate. This shows the same huge mud bank in front of the bypass gate with the trench cut through it. The emergency team had to dig out this passage through the mud bank to cause direct flow during the crisis when trying to stop the reservoir from continuing to fill. This is just another illustration of the systemic neglect of the vital reservoir controls at Toddbrook.

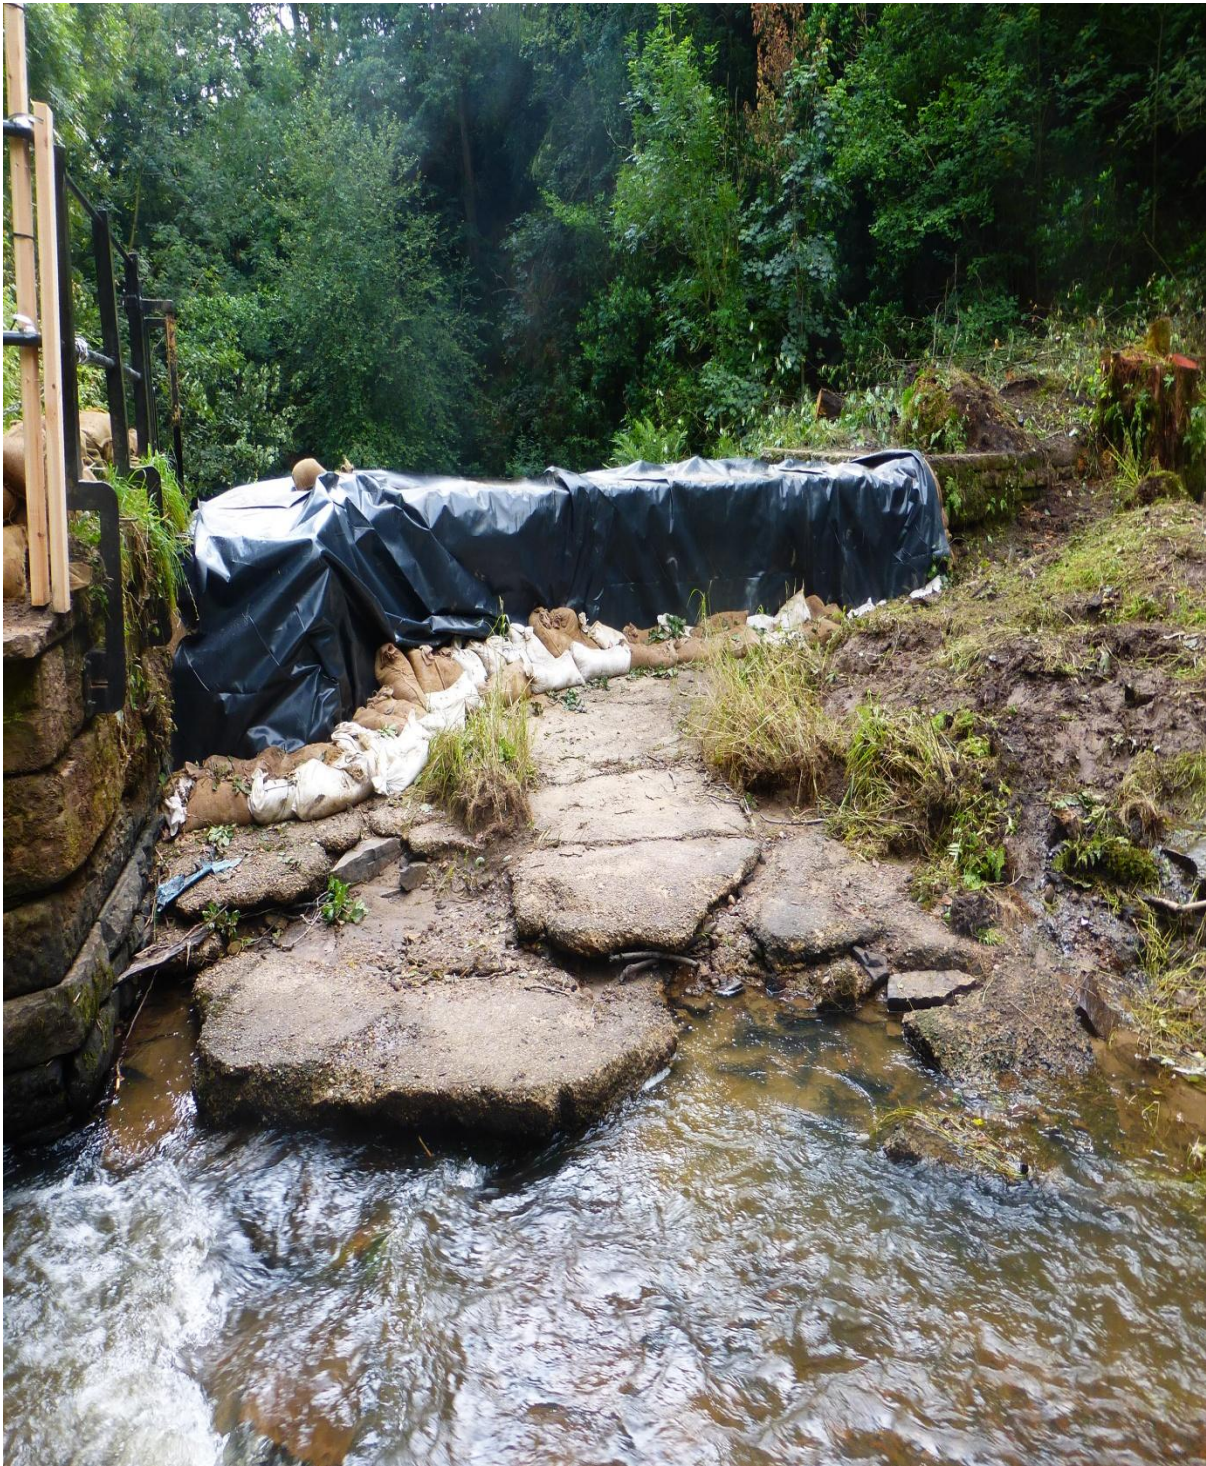
**Photo 3:** This neglected and curious mess is in fact the entrance to the weir to fill the reservoir. The throat of the weir has been blocked with Gabions under the sheet but the layers of broken concrete in front are always there, just part of this poor neglected old weir. In this photo all the water of the Todd Brook is going into the Bypass by the side route to the left, the direct flow into the bypass is still obstructed by the mud banks in photos 1&2 . There is not enough water to even cover the broken concrete which indicates how these irregular concrete lumps normally regulate and impede the input to the reservoir.

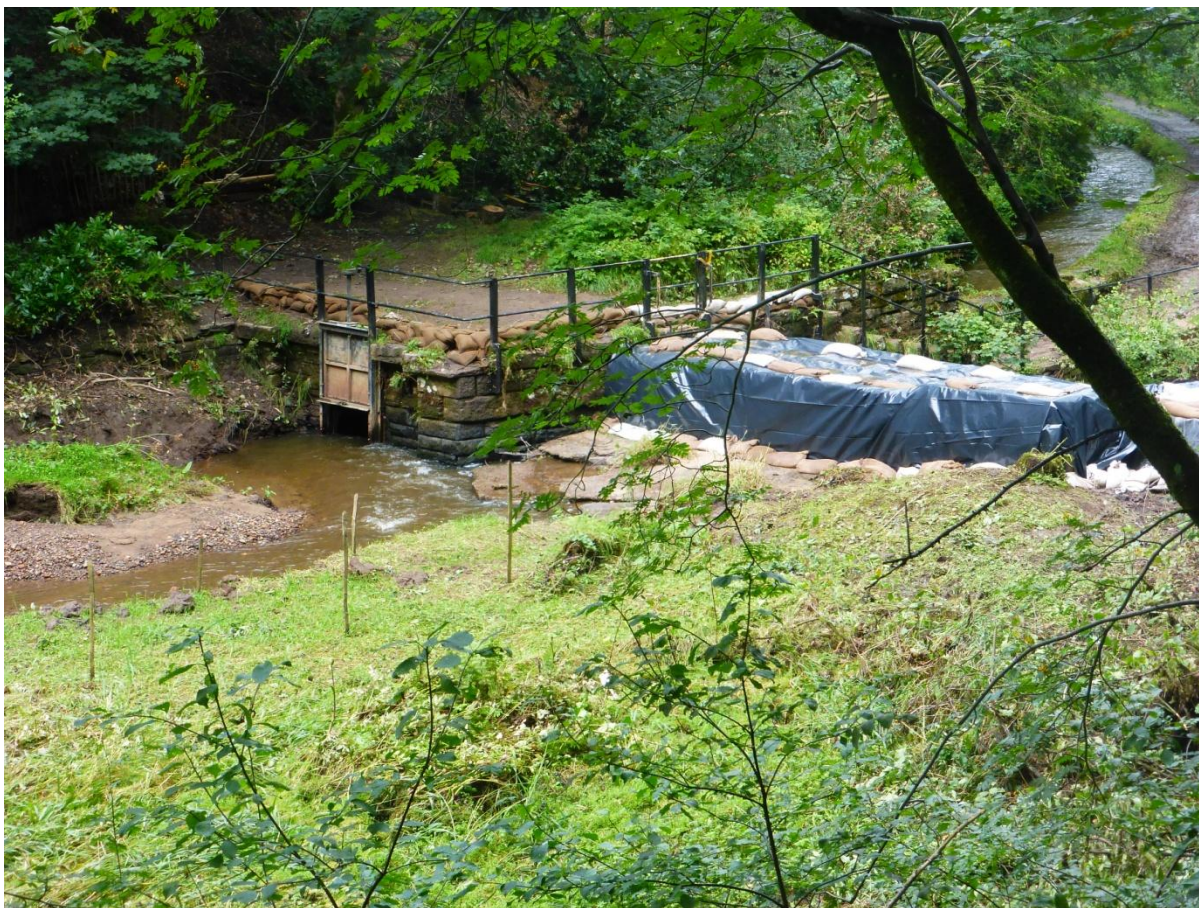
**Photo 4 :** The upstream view of the Weir and Bypass Gate illustrates the whole arrangement at the weir, the obstruction of the mud bank, also showing the Bypass channel running towards the Convergence Basin ( a mile away) by the footpath (top Right) .

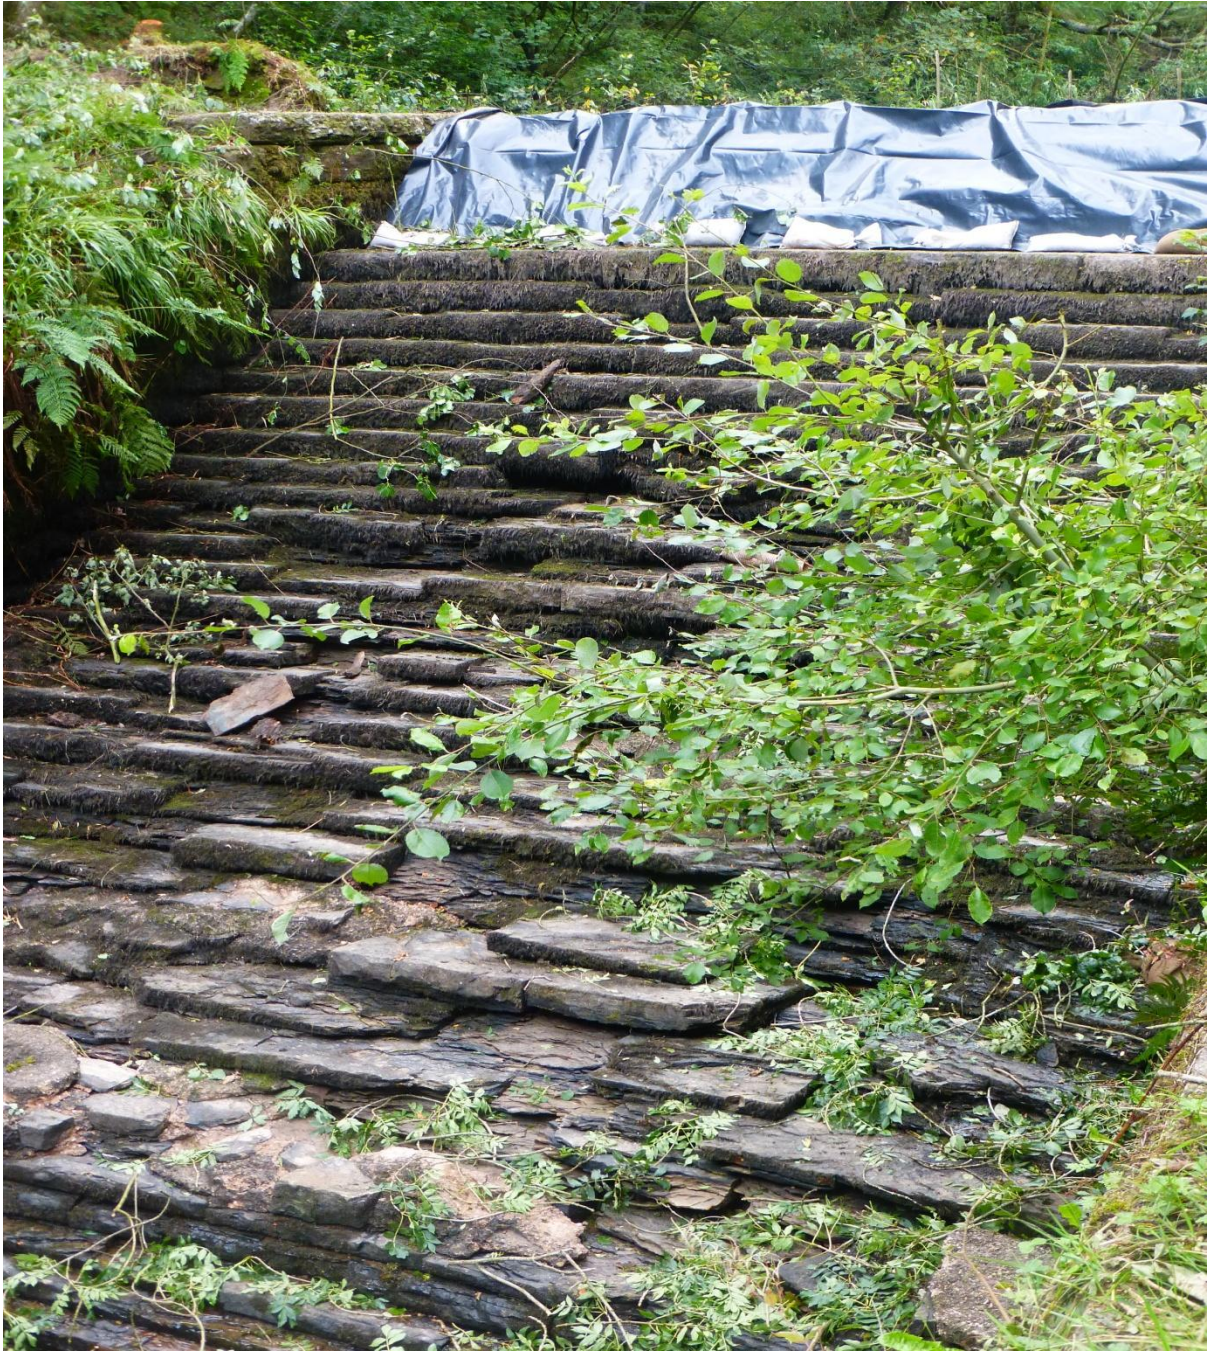
**Photo 5:** The downstream view of the weir itself after the incident in Aug 2019 showing the accumulation of 180 years of damage and neglect.

These photos show that the weir and the Bypass gate require extensive and major engineering redesign and repair. The weir provides the fundamental safety control for this reservoir. It has the only facilities to control the filling of the Reservoir.

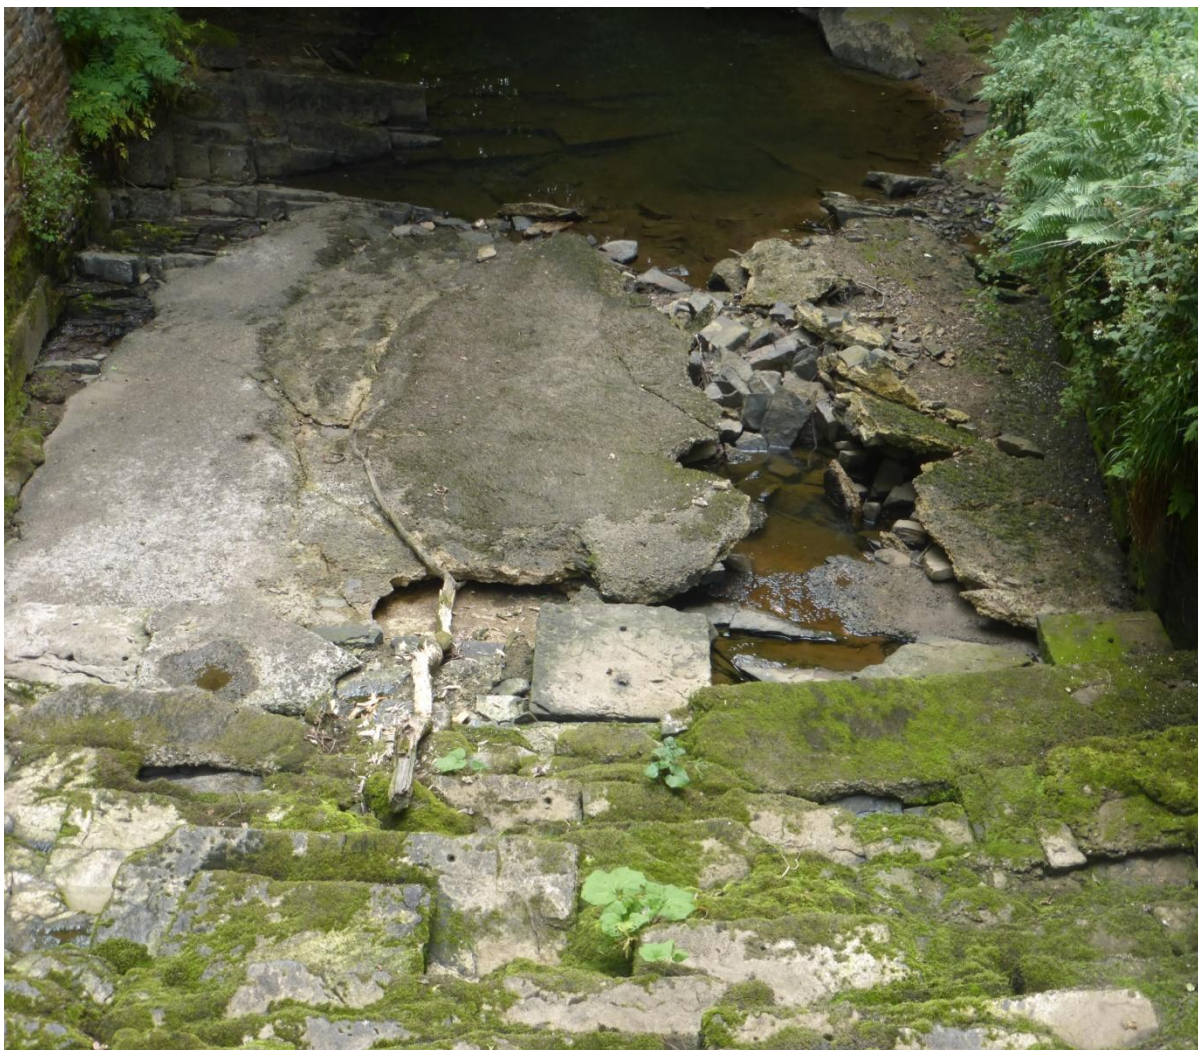
**Photo 6:** This was the state of the bottom of the weir in July 2017 showing failed historic attempts to prevent the undermining and destabilising the weir base by crude concrete infill repairs superimposed on each other. By Aug 2019 these repairs have already failed, previously attacked and broken by the power of successive floods, as photo 7 shows.

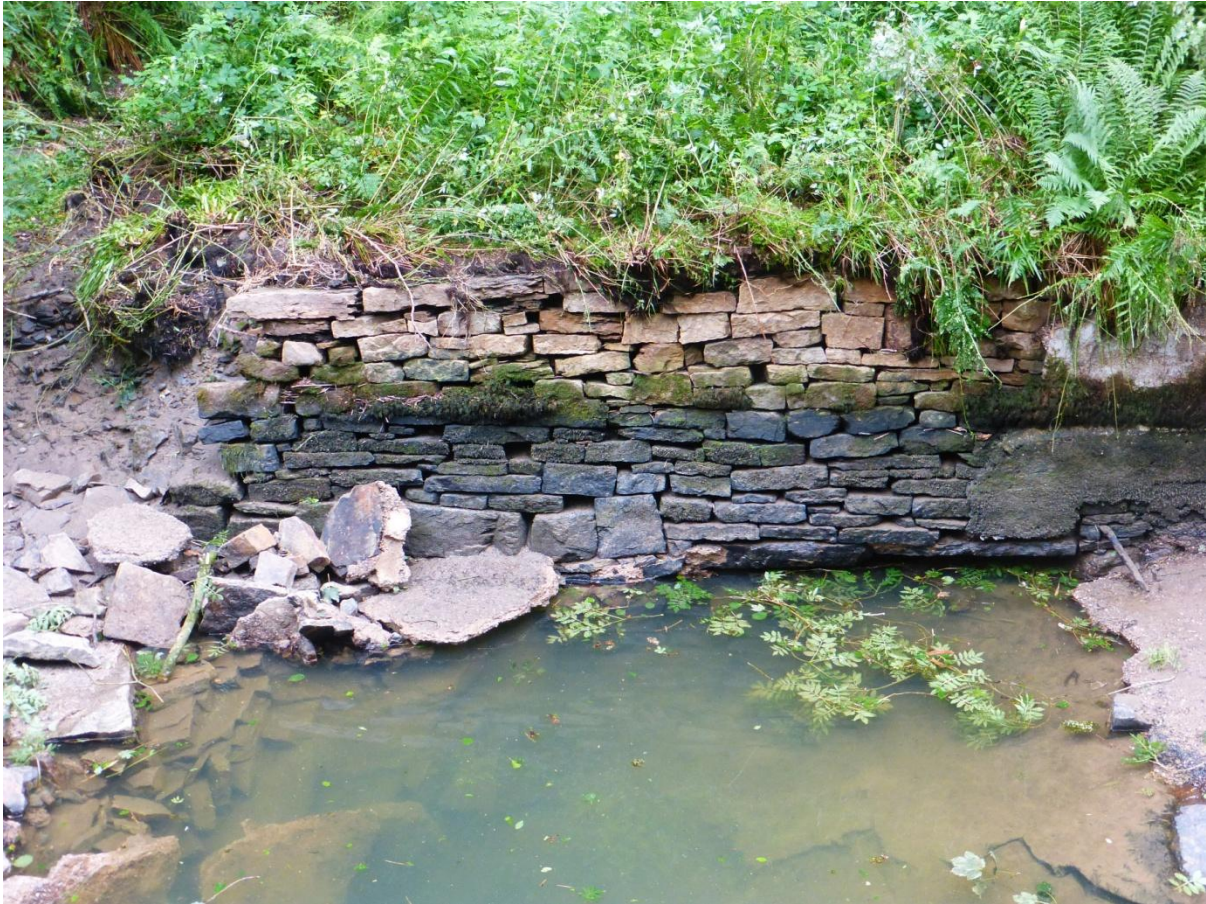
**Photo 7:** The foot of the weir, Aug 8 2019, after this year's flood. The damaged concrete of the crude repair in photo 6 has been washed away. The side wall at the LHS has been broken down by this year's flood that actually came round the back of the weir and pushed the side wall forward into the river. This side wall has no mortar, it's just a dry stone construction, utterly inappropriate as a side wall to guide the huge flow out of the weir.

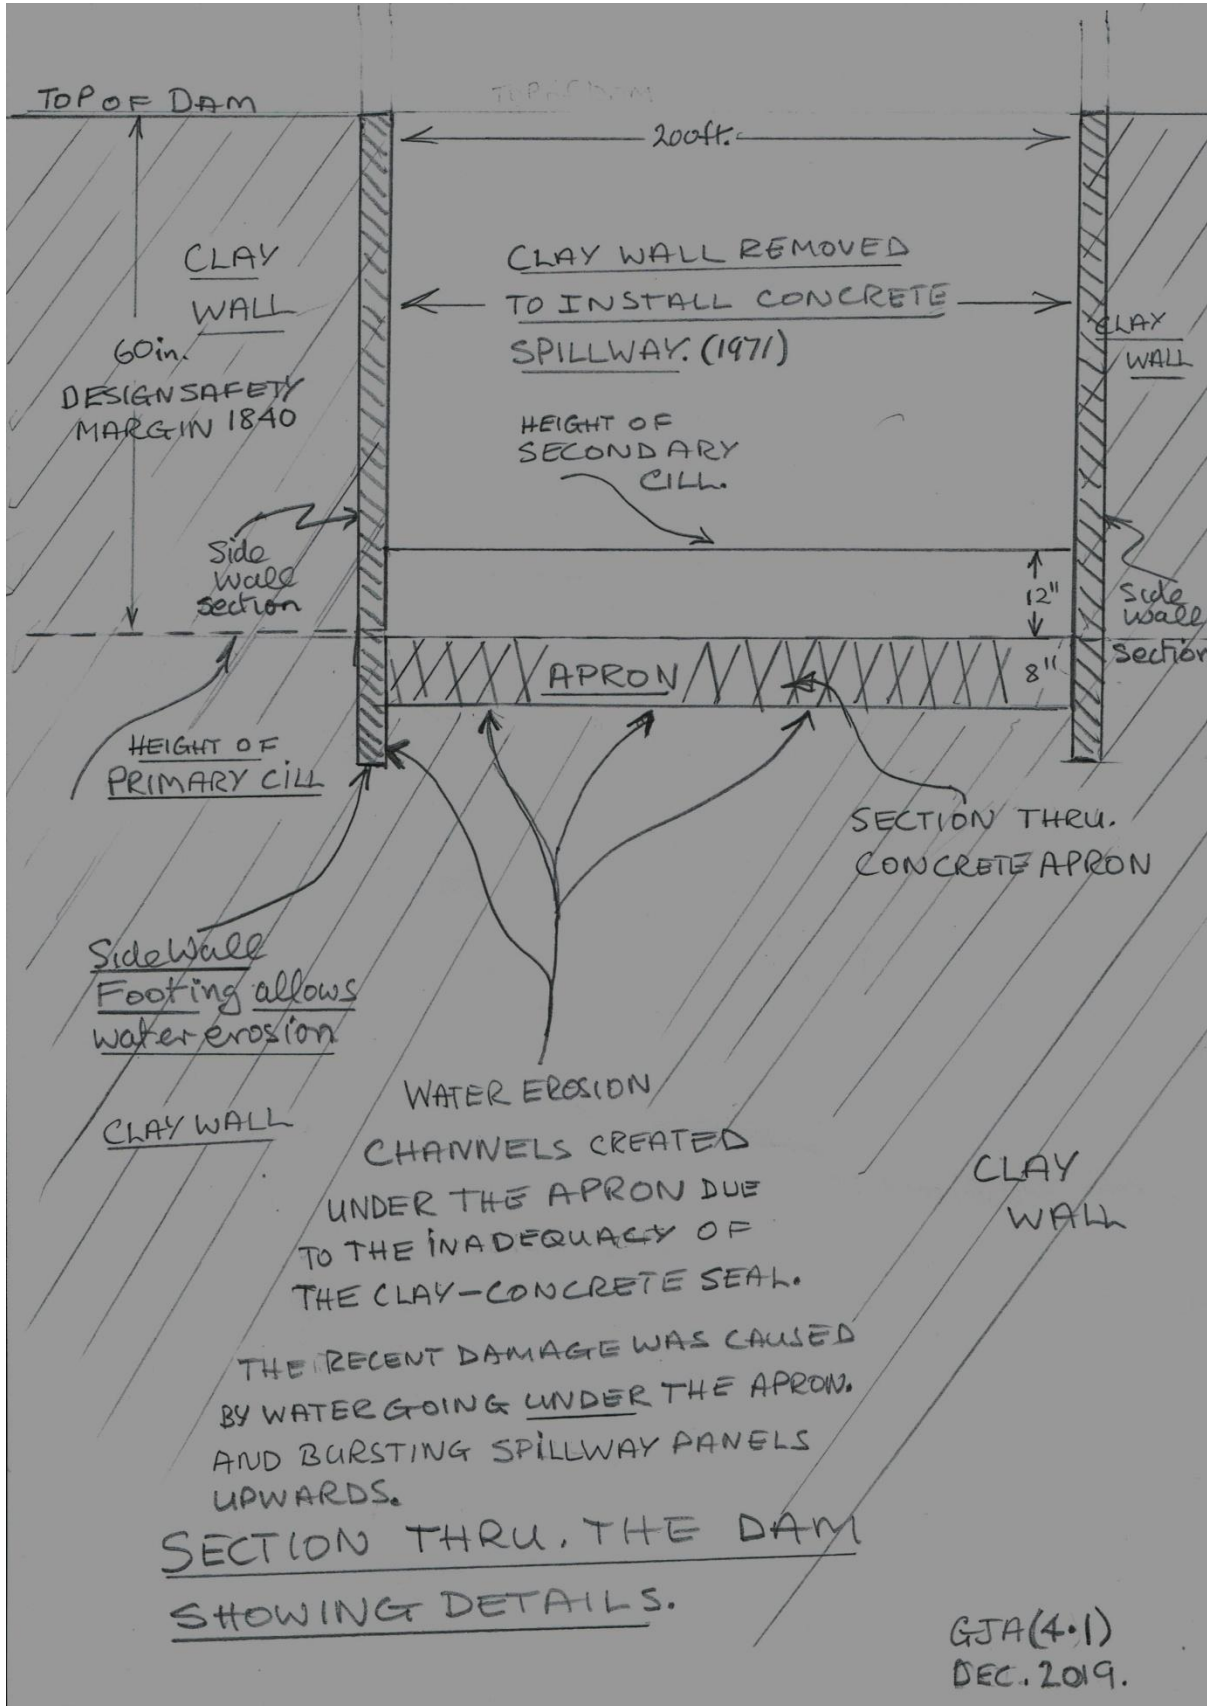
The last sketch (GJA 4.1) illustrates the serious consequences of the abutment walls and their footings on the top of the dam, which I have only just recently appreciated. They provide a direct deep route across the top of dam for water erosion to develop. I suspect that if there was a thorough investigation this is where the major cause would be found.
