Toddbrook Reservoir Incident.

16 February
2020

Proposed Modifications and Repairs.

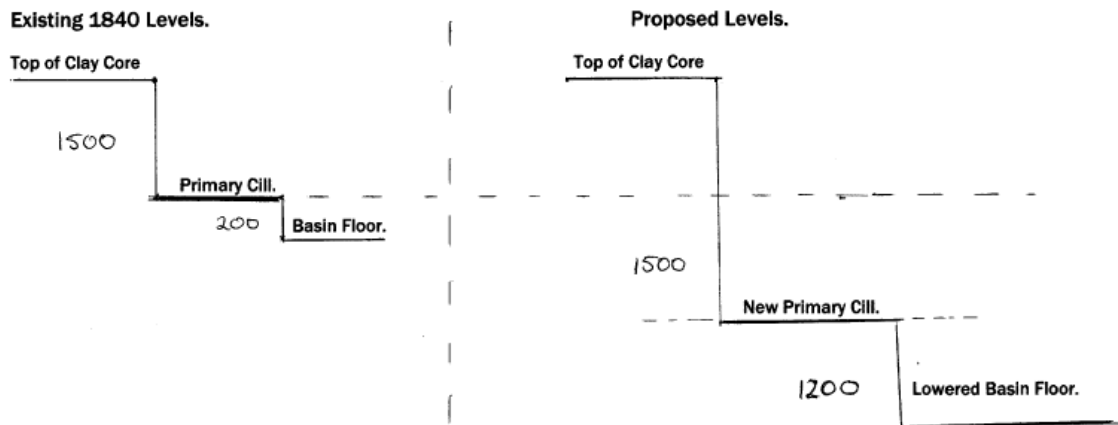
CBM 01: Toddbrook Convergence Basin Capacity Modification.

- Reinstates 1840 Safety Margin on the Dam.
- Removes Pressure on the Dam, level lowered by 1.5m.
- Isolates any overflow facilities from the Earth Dam.
- Allows Dam to be properly inspected after 50 years and repaired.
- Provides Six times increase in Convergence Basin capacity.

The maximum reservoir water level must be lowered by 1.5 m. by installation of a new lower Primary Cill in conjunction with work on the Convergence Basin. This is shown in diagrams CB1 and CB1.

If the Cill is lowered then so must the Convergence Basin. The sloping Basin floor should be reconstructed approximately 1.0- 1.2 m below the new Cill to provide a much greater capacity for the reservoir overflow to converge with a simultaneous large flow in the Bypass Channel.

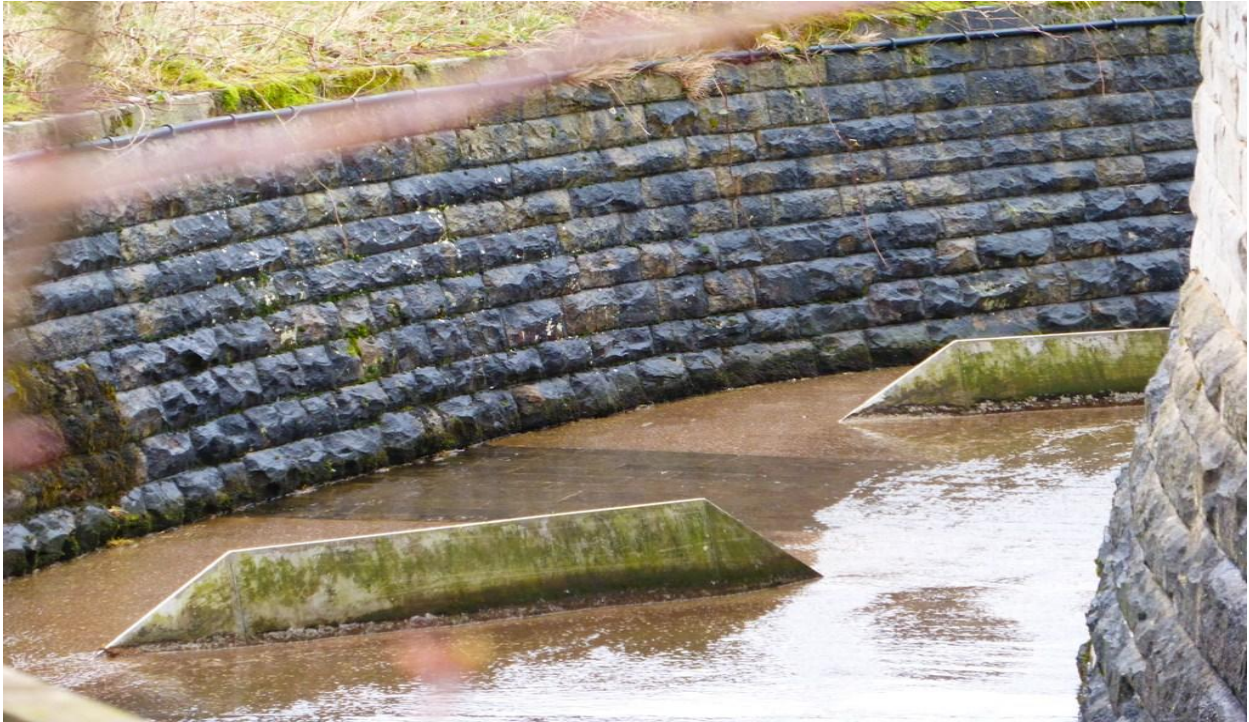
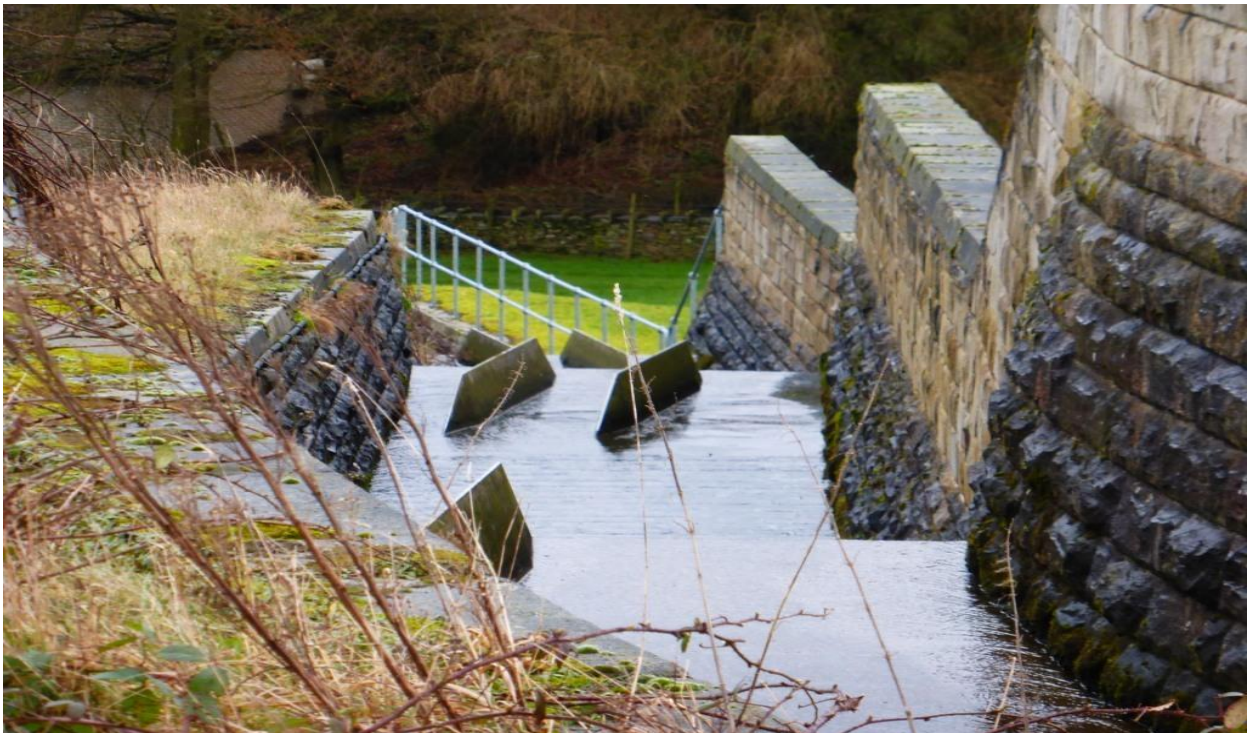
The Horse Coppice Reservoir Bypass Guide Blades. Ten blades steer the flow to avoid damage and high loads on the LH wall, exactly as is required at the Toddbrook Bypass Bend.

The new taper of the Basin exit channel floor would feather into the existing channel floor downstream leading to the bend due to the progressively steeper gradient. The sidewalls of the bend should be streamlined and contoured in concrete to ensure a much more efficient flow to enable a more efficient drainage rate out of the new Convergence Basin. In addition the flow should be managed and directed by long alloy guide blades inserted into the Bypass floor approaching and in the bend. There is an excellent example of this flow steerage and control method using about 10 tailored blades installed for the same purpose on the Horse Coppice Reservoir Bypass bend in Lyme Park. The Bypass there has to execute a tighter steeper bend than at Toddbrook, which endorses the feasibility of my proposal.

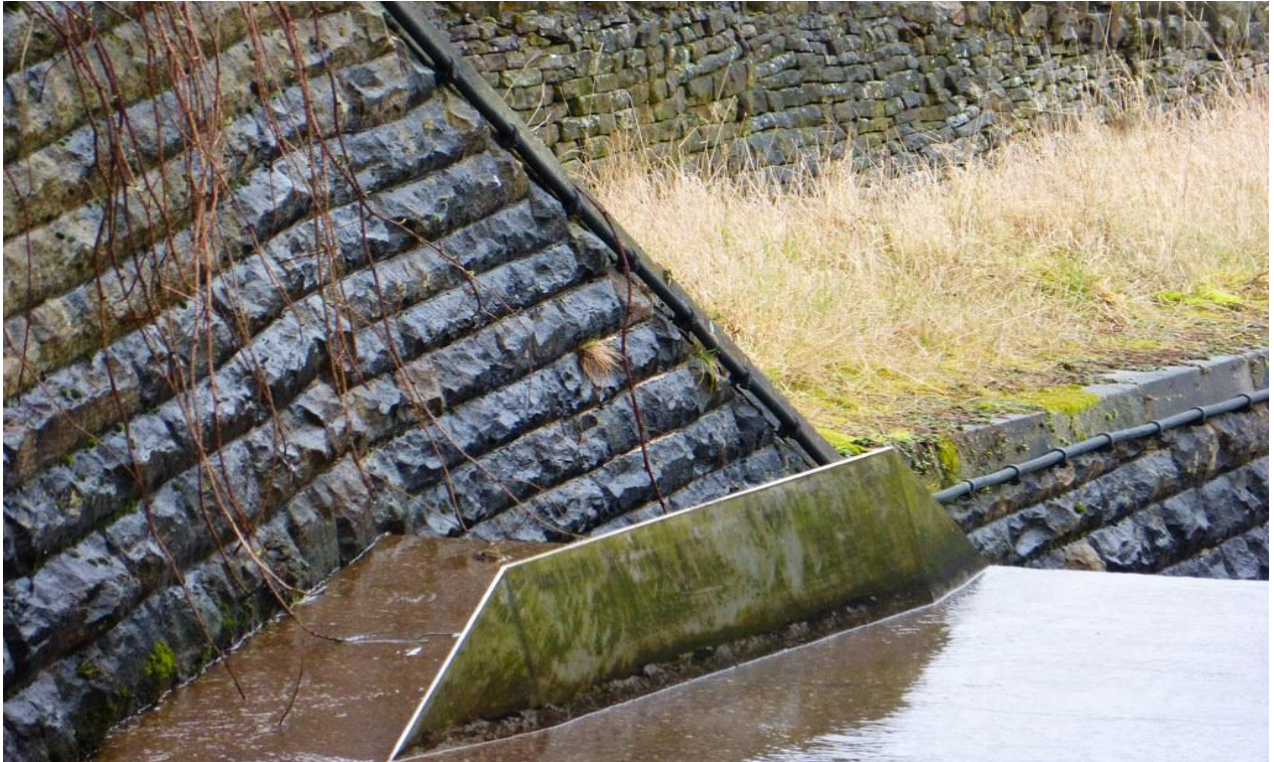
The Horse Coppice Reservoir, Lyme Park ...More details....

The blades are precisely placed at angles and in positions on the Bypass Floor. There are three active planes on some blades as seen here which modify the direction of flow in a progressive sequence. This scientific arrangement fully demonstrates an existing solution for the Toddbrook Bypass, it both endorses and vindicates the modification proposals for the Bypass channel described in this paper.

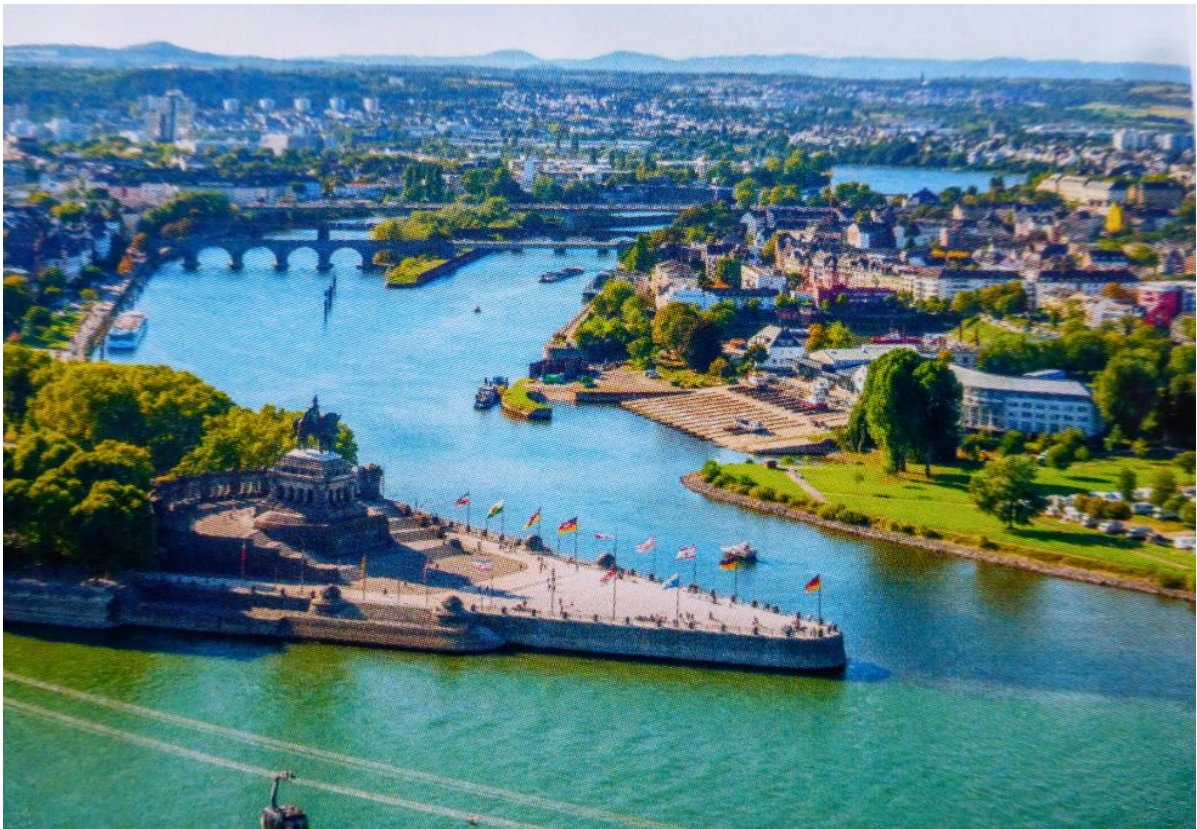
Below: 630 miles to the south, the Mosel merges with the Rhine at Koblenz.

Typical Example: The orderly flow convergence of the two great rivers is achieved by the guidance structure and the directionally curved river banks.

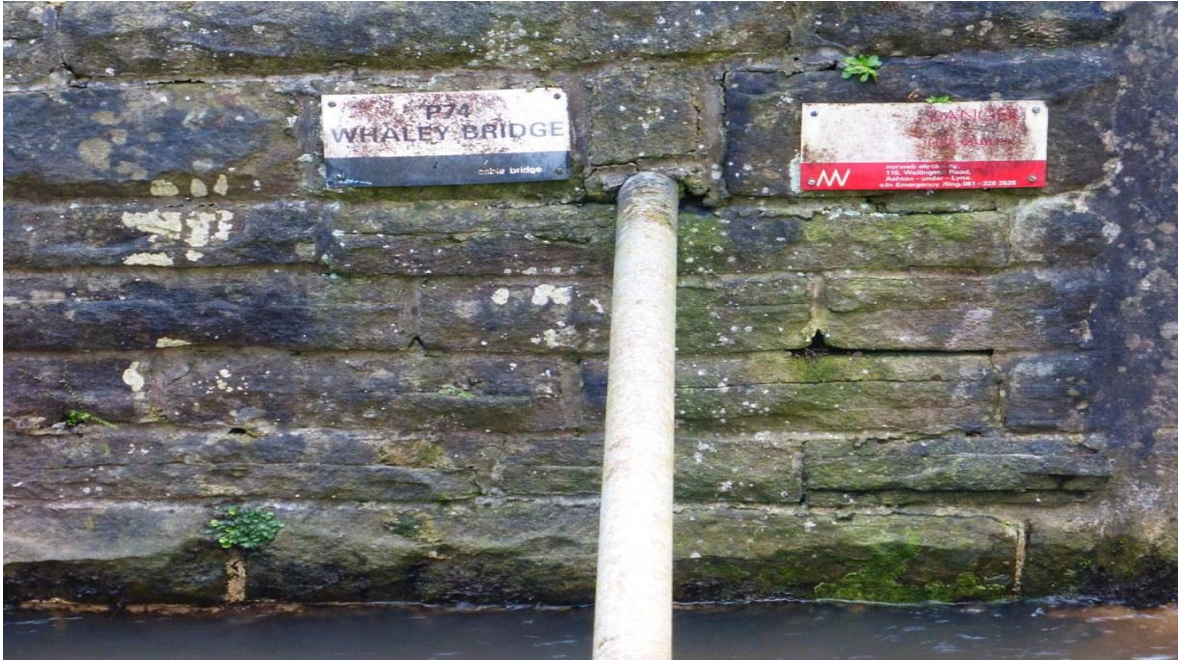
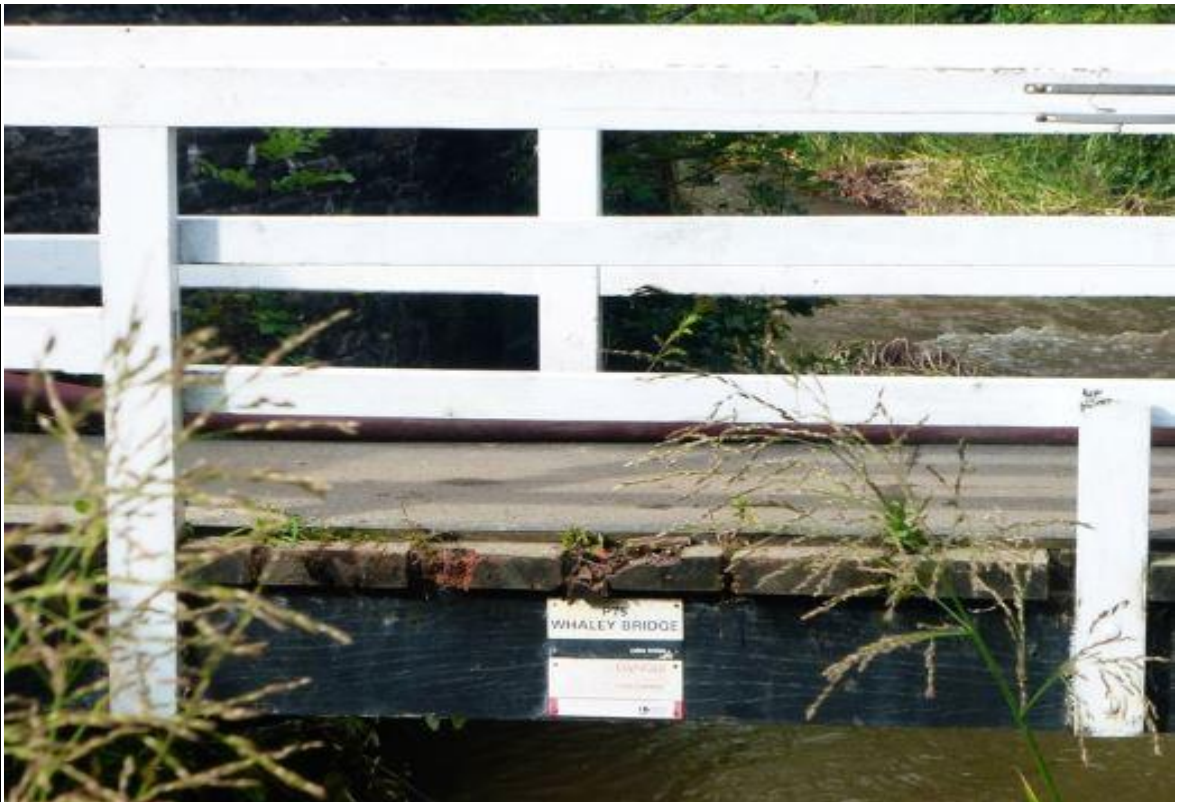
The photo below shows a potentially live cable P74, crossing the 3m Bypass without any proper support on the bend by the ex warden's house. It is part of the local grid and will have no local fuse or breaker. It is incredibly dangerous, less than 1m above the Bypass floor and would have been underwater on Aug 1st. I am certain that it is the power supply to the redundant flow chart recorder (fitted in the British Waterways era) which is located in the yard just over the wall behind the cable. The arched cabinet roof is visible from the road. This is not the supply for the ex-wardens house, which I believe is supplied by the more heavily insulated cable labelled P75 which crosses the Bypass clamped to a rotting beam under Footbridge No.1 nearby. P75 may also supply the sailing club ?

I strongly recommend that P74 should be electrically disconnected at source and removed by the Electricity North West for safety reasons and to allow the future work on the Bypass bend to be conducted unimpeded by such a dangerous element. At the same time the Authority should be asked to inspect the condition and safety of the P75 cable because FB No 1 is rotting away and was scheduled for replacement in October 2019 so the cable would have to be disturbed quite soon.

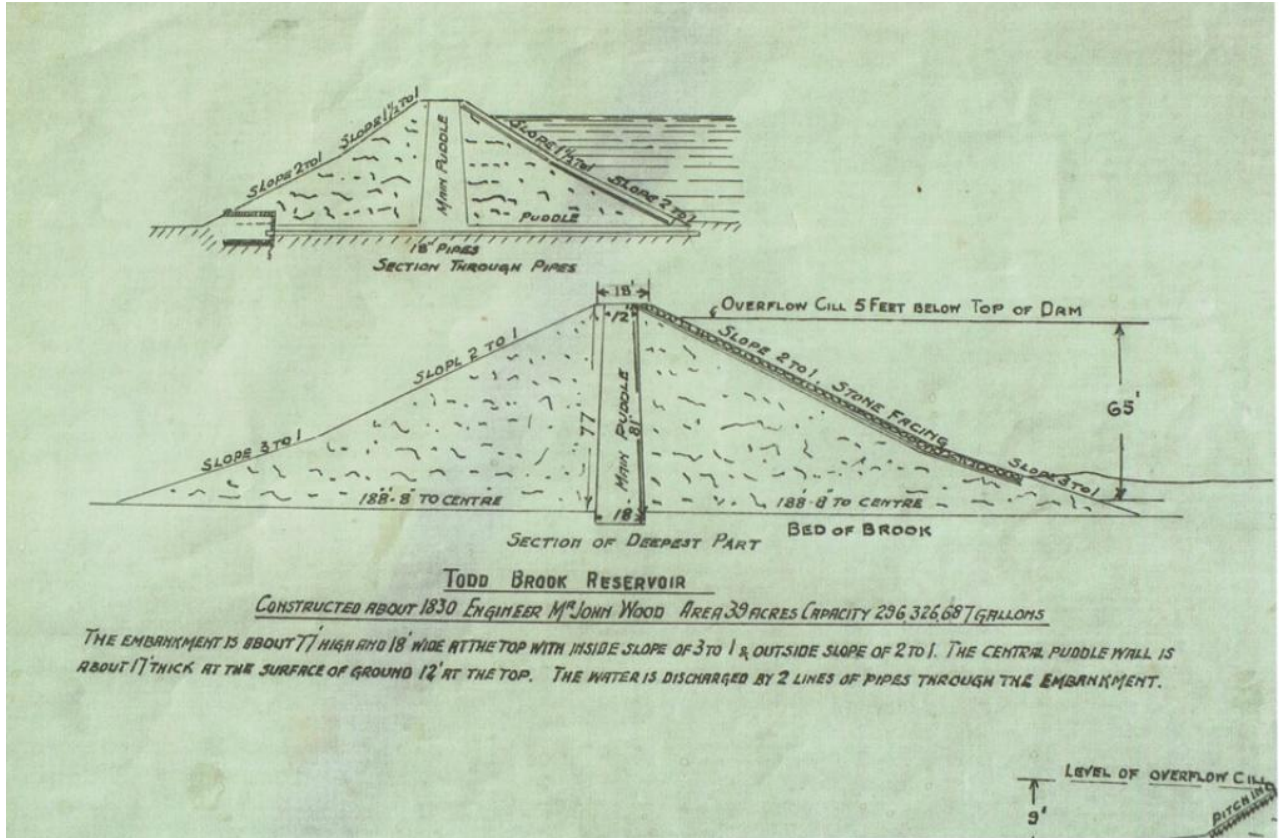
The Original Toddbrook Dam Design Specification 1830.

The note “**Overflow Cill 5 feet below Top of Dam**” on the RH side defines the 5 ft. (1.5m) safety margin for the Toddbrook Dam which was destroyed 48 years ago by British Waterways in 1971. This Safety Margin must now be reinstated right across the dam by lowering the maximum water level as I have described if the CRT want to achieve Safety Approval to operate this High Risk Reservoir above Whaley Bridge School and Town.
