**Toddbrook Reservoir  
Independent Review Report  
By Professor David Balmforth**

**10 February 2020**

Overall, I have determined that the most likely cause of the failure of the auxiliary spillway at Toddbrook Reservoir on the 1st August 2019 was its poor design, exacerbated by intermittent maintenance over the years which would have caused the spillway to deteriorate.

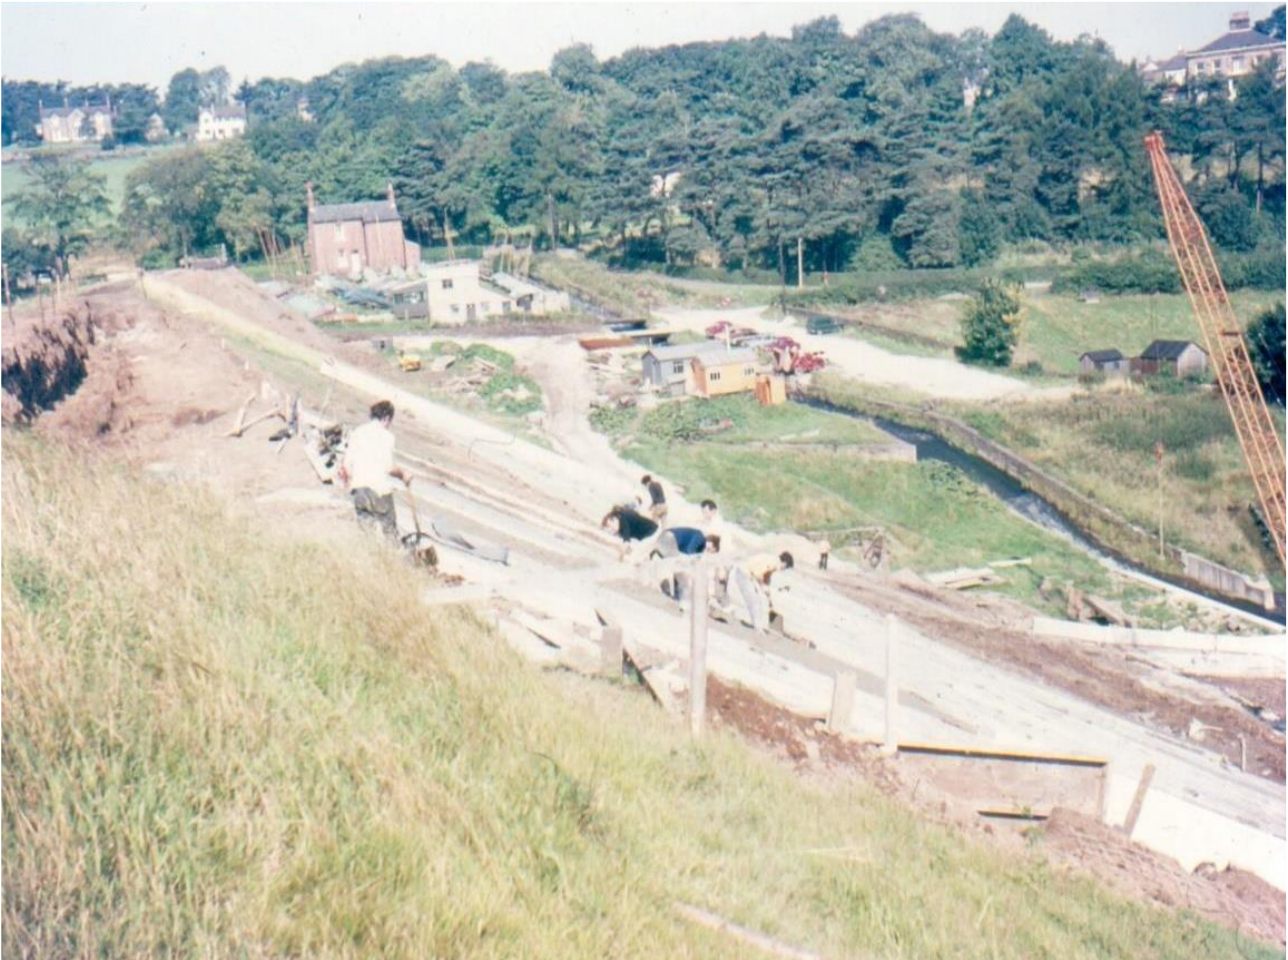
**Figure 3. Construction of the Auxiliary Spillway on the Earth Embankment Dam in 1969**

On the 12<sup>th</sup> December 1964, an extreme rainfall event damaged the original (primary) spillway. This led to the Inspecting Engineer requiring the overflow capacity to be increased considerably. Between 1969 and 1970, an auxiliary spillway 76m long and

0.26m above the original spillway crest, was constructed on the face of the embankment (fig 3).

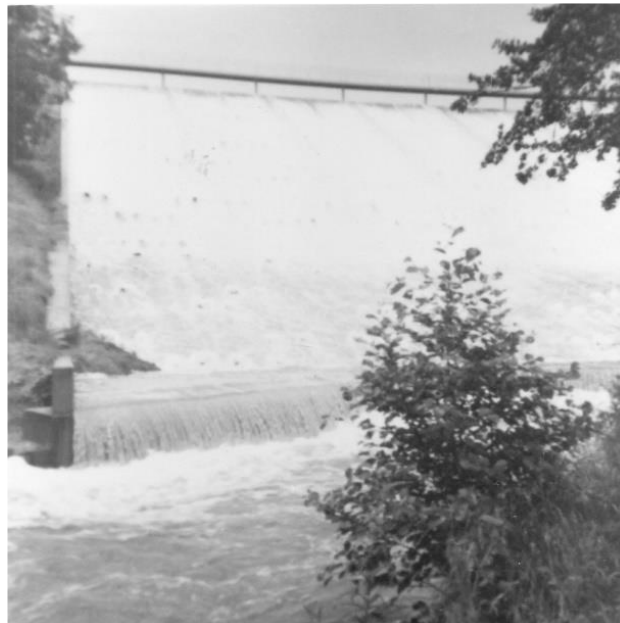
**Figure 8. Spillway in Operation, July 1973**

About 160mm of rain fell on the catchment between Saturday 27<sup>th</sup> July and Wednesday 31<sup>st</sup> July 2019. The rain was well forecast and fell in two separate events, the first occurring over the 27<sup>th</sup> to the 29<sup>th</sup> July closely followed by a more severe event from the 30<sup>th</sup> July to 1<sup>st</sup> August 2019. These were rare events, with the second having an annual probability of occurrence of around 1%. They resulted in a substantial discharge down the auxiliary spillway for a sustained period. Though serious, these events were considerably less than the probable maximum flood which the spillway should have been able to accommodate. A number of previous events are reported (1973, 1998 and 2007) when a significant flow was discharged down the spillway, apparently without incident (fig 8). Up to the 1<sup>st</sup> August 2019 the reservoir had remained full for many months.

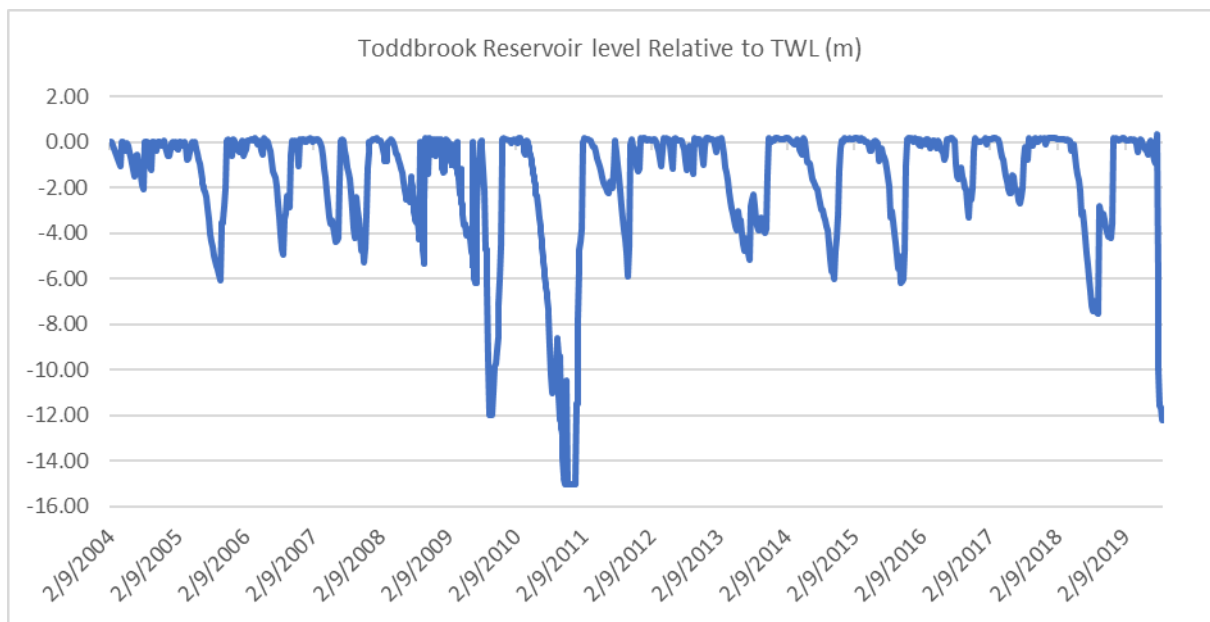
**Figure. B1 Reservoir Levels in relation to Top Water Level from 2004 to 2019**

Records indicate that the reservoir remained at or above top water level (TWL) level for several months each year during the winter (fig B1). The top water level (TWL) of the reservoir is the level of the primary weir crest, which is +185.67 mOD. The crest of the 76.2m long auxiliary weir was supposedly set 260mm above that level, but it has recently been established that it is now only about 180mm above TWL. In fact, the difference is 164mm on the left side and 184mm on the right side, implying a slight, 20mm dip towards the left. Survey pins sited on the downstream ends of the crest slabs indicate a level drop of approximately 75mm towards the left side of the 76.2m long weir crest. The weir is likely sited over the central clay core of the embankment whereas the slabs featuring the survey pins are sited over the downstream fill.

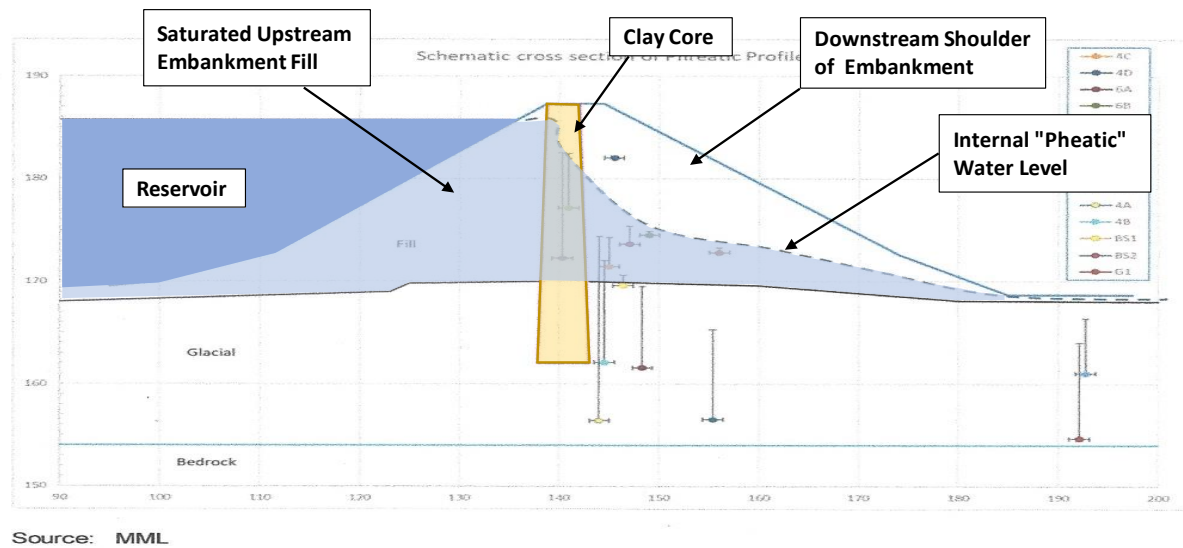
**Figure. B6 Measured phreatic water levels within the embankment**

It is clear then that there were routes for water to pass through and/or under the auxiliary weir crest slab. However, it is not necessarily the case that these would have continued under the downstream chute slabs, nor that such crest seepages would have led to any significant migration of material. The downstream shoulder material is essentially permeable and well graded, albeit with zones of variability. It would not therefore be prone to internal fines migration through suffusion (the ability of fine material to pass into and through voids in a coarse matrix, such as gravel). It is also likely that gravity would take any seepages coming beneath or through the auxiliary spillway crest downwards through the fill material rather than them continuing under the chute slabs. Figure B6 shows the phreatic water surface within the embankment recreated in the recent Mott MacDonald study based on measured piezometer levels. It illustrates the very low phreatic (pore water pressure) levels in the downstream shoulder, indicating a free draining material.

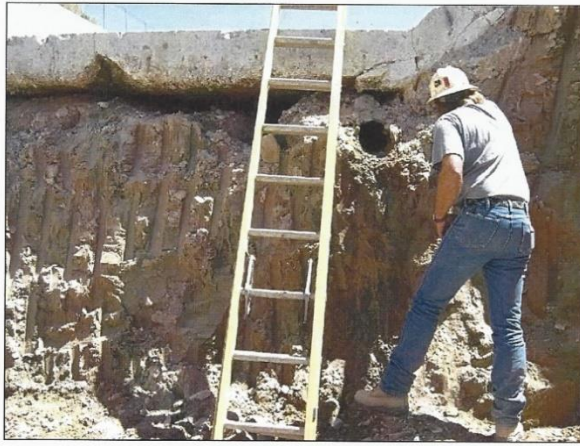
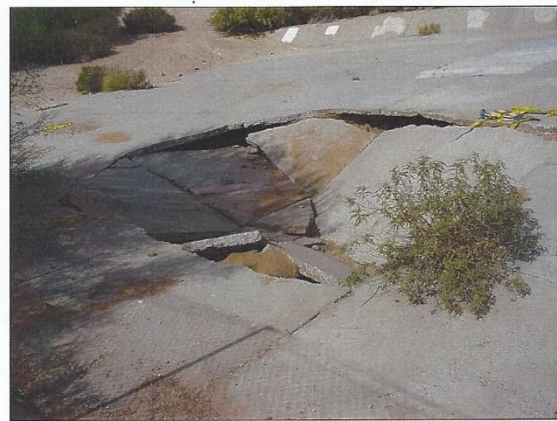
### Figure. B9 Illustrations of two chute slab failures taken from the referenced USBR report

This phenomenon has caused many chute invert slab failures. In December 2007 the United States Bureau of Reclamation (USBR) issued a Report on the matter entitled; *“Uplift and Crack Flow Resulting from High Velocity Discharges Over Open Offset Joints”*. The Report contains illustrations which are reminiscent of the failure at Toddbrook (fig B9). It also states that; *“Uplift on chute slabs due to the transmission of pressures through open cracks and/or joints has long been an area of concern at the Bureau of Reclamation and damage has occurred on numerous occasions due to this phenomenon”*. The “uplift” in this case means the pressure generated under the slab through jet injection, causing it to lift. It goes on to say that associated, *“erosion of foundation materials resulting from flows into cracks or joints (are) a significant problem on soil foundations.”*

Figure 3.—Undermining of the chute slab has occurred due to flow entering at joints and cracks and transporting foundation material through unfiltered drains.

Figure 4.—Structural collapse of the slab system occurs when enough undermining has occurred to cause loss of support. This damage is typical of slabs placed on soil foundations (note: this slab is not reinforced so failure is more evident).

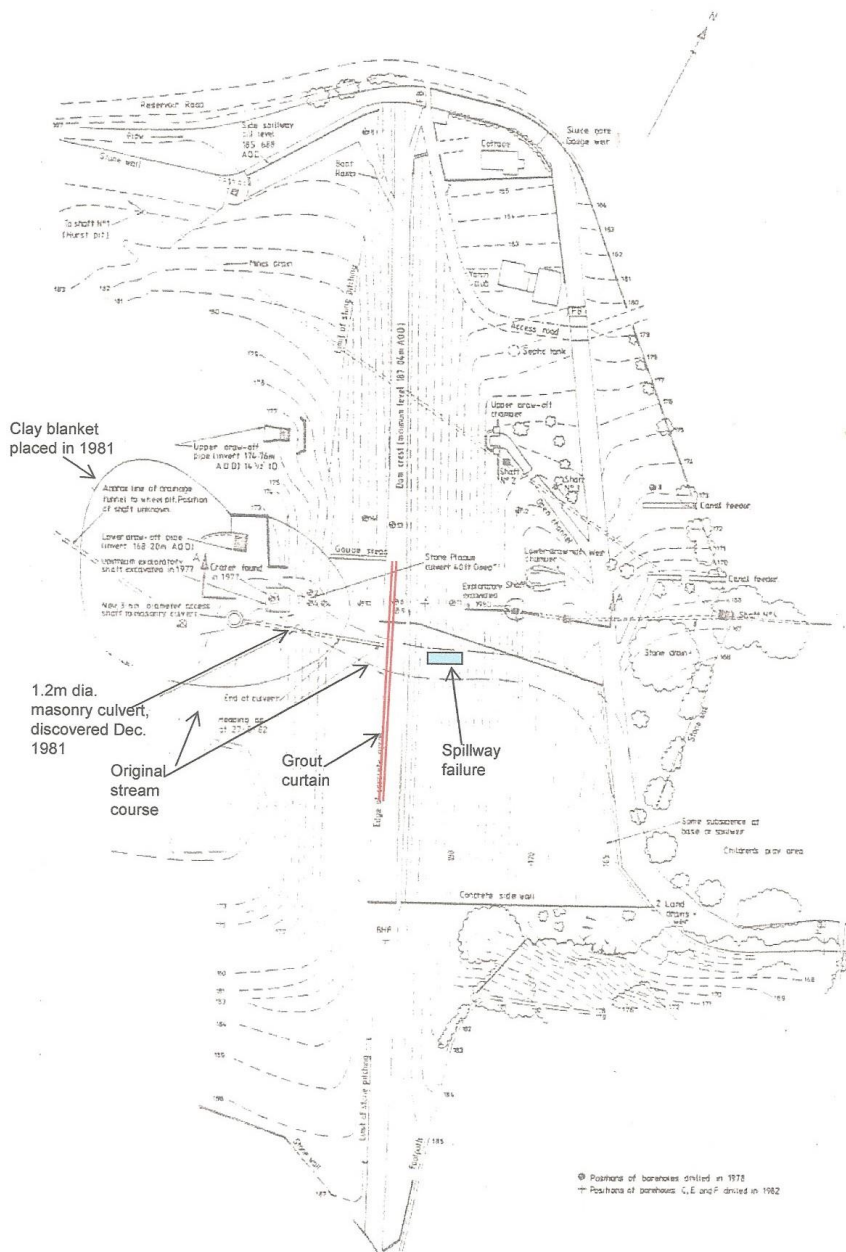
**Figure C1. Plan showing location of grout curtain and clay blanket remedial works (Based on British Waterways Drawing HH /BWB /02/03, 1984)**

Remedial works in 1981 involved placing a 1.2m compacted clay blanket layer over part of the reservoir floor and the upstream slope where the depression occurred, as shown in Figure C1. During the placing of the clay blanket, the masonry culvert was discovered. Tracer tests showed this to have formed a leakage path through the dam. Figure C1 shows it terminating on the upstream side of the core.

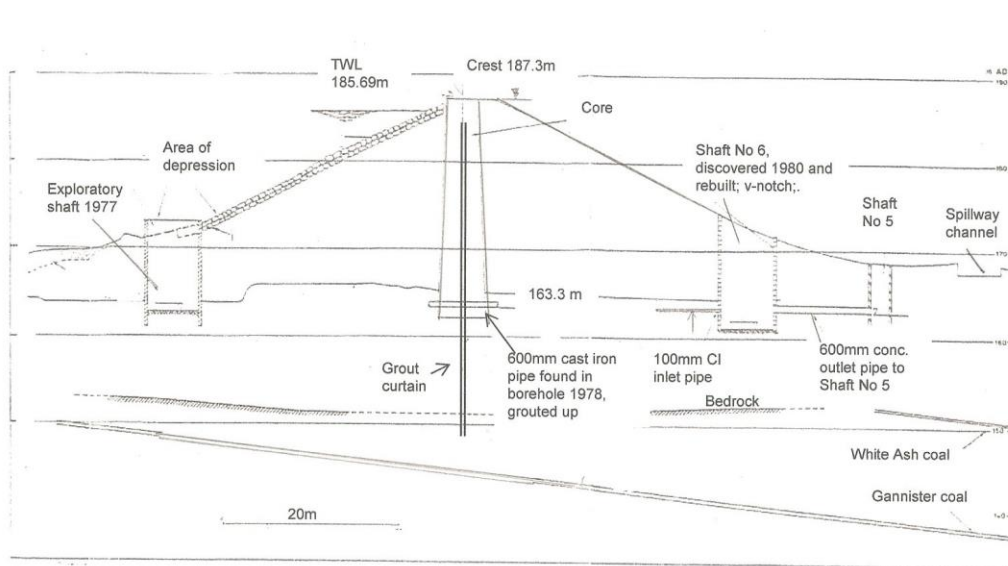
**Figure C2. Section showing location of grout curtain various investigation and monitoring shafts (Based on British Waterways Drawing HH /BWB /02/03, 1984)**

Concerns and uncertainty that leakage and possibly internal erosion could take place through the core and foundation, led to a grout curtain being installed in 1983. Grout takes (a “take” is the amount used) varied significantly. One large grout take, some 1400kg of cement (approximately 5 cubic metres of grout), occurred between 15m and 25m below crest level, and was injected below the auxiliary spillway crest slab at the level of the original stream bed, where the masonry culvert was built, just upstream of the core. Elsewhere grout takes of up to 3400kg of cement (approximately 11 cubic metres of grout) were recorded. A cement/bentonite/water grout mix was used, typically 10/1/30 but varying depending on its use. Apart from reducing leakage through and under the core, the grout would have strengthened the core, increasing its shear strength against potential deep-seated slope instability.
