## Analysis of the Damage to the Toddbrook Dam.

Graham Aldred B Sc.(Eng)

15 Dec 2019

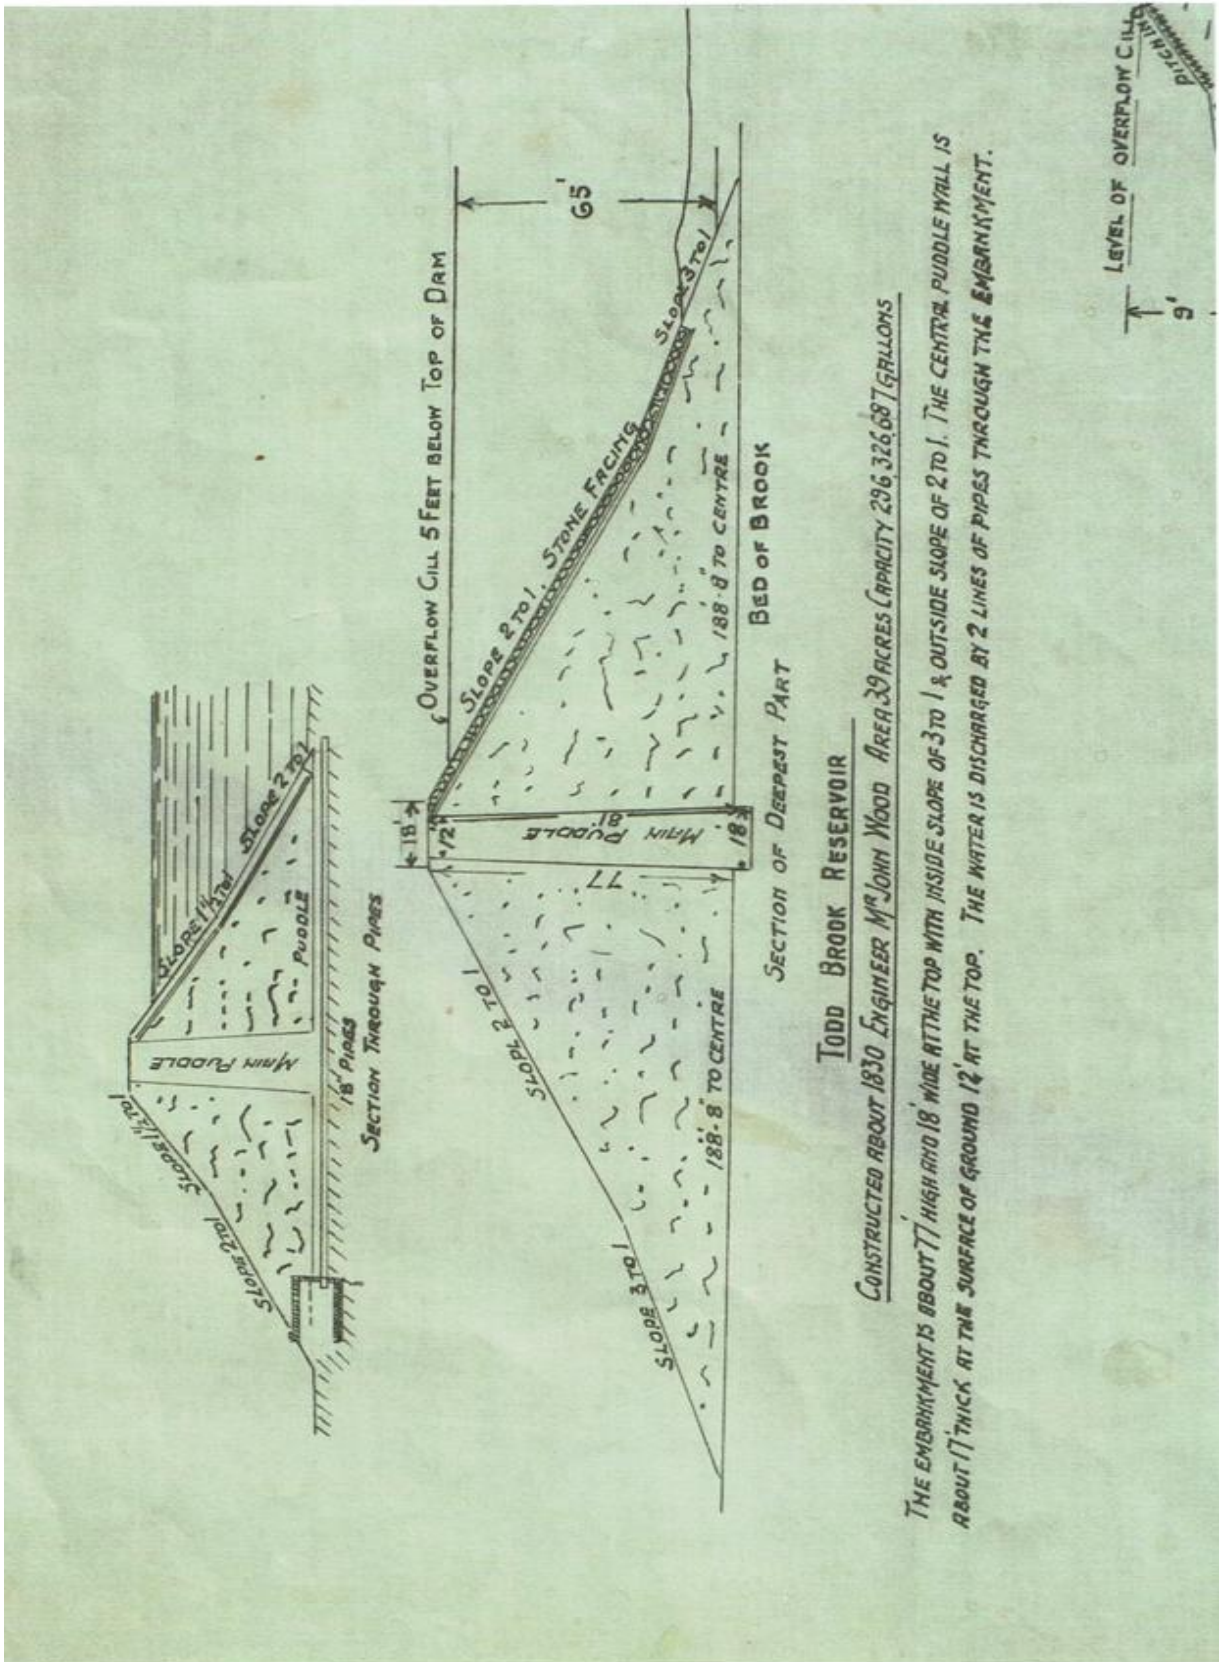
The Original 1831 specification of the Dam.

Note the vital Safety Specification about. " **Overflow Cill 5 feet below Top of Dam.**" This safety margin was destroyed by British Waterways in 1971 by construction of the concrete Spillway.
